Palo Verde Nuclear
Generating Station

**Subject: Palo Verde Nuclear Generating Station (PVNGS)
Units 1, 2, and 3
Docket No. STN 50-528, STN 50-529, and STN 50-530
License No. NPF 41, NPF 51, and NPF 74
Licensee Event Report 2009-001-00**

4. TITLE
 Safety Injection System Recirculation Alignment Results in Unanalyzed Condition

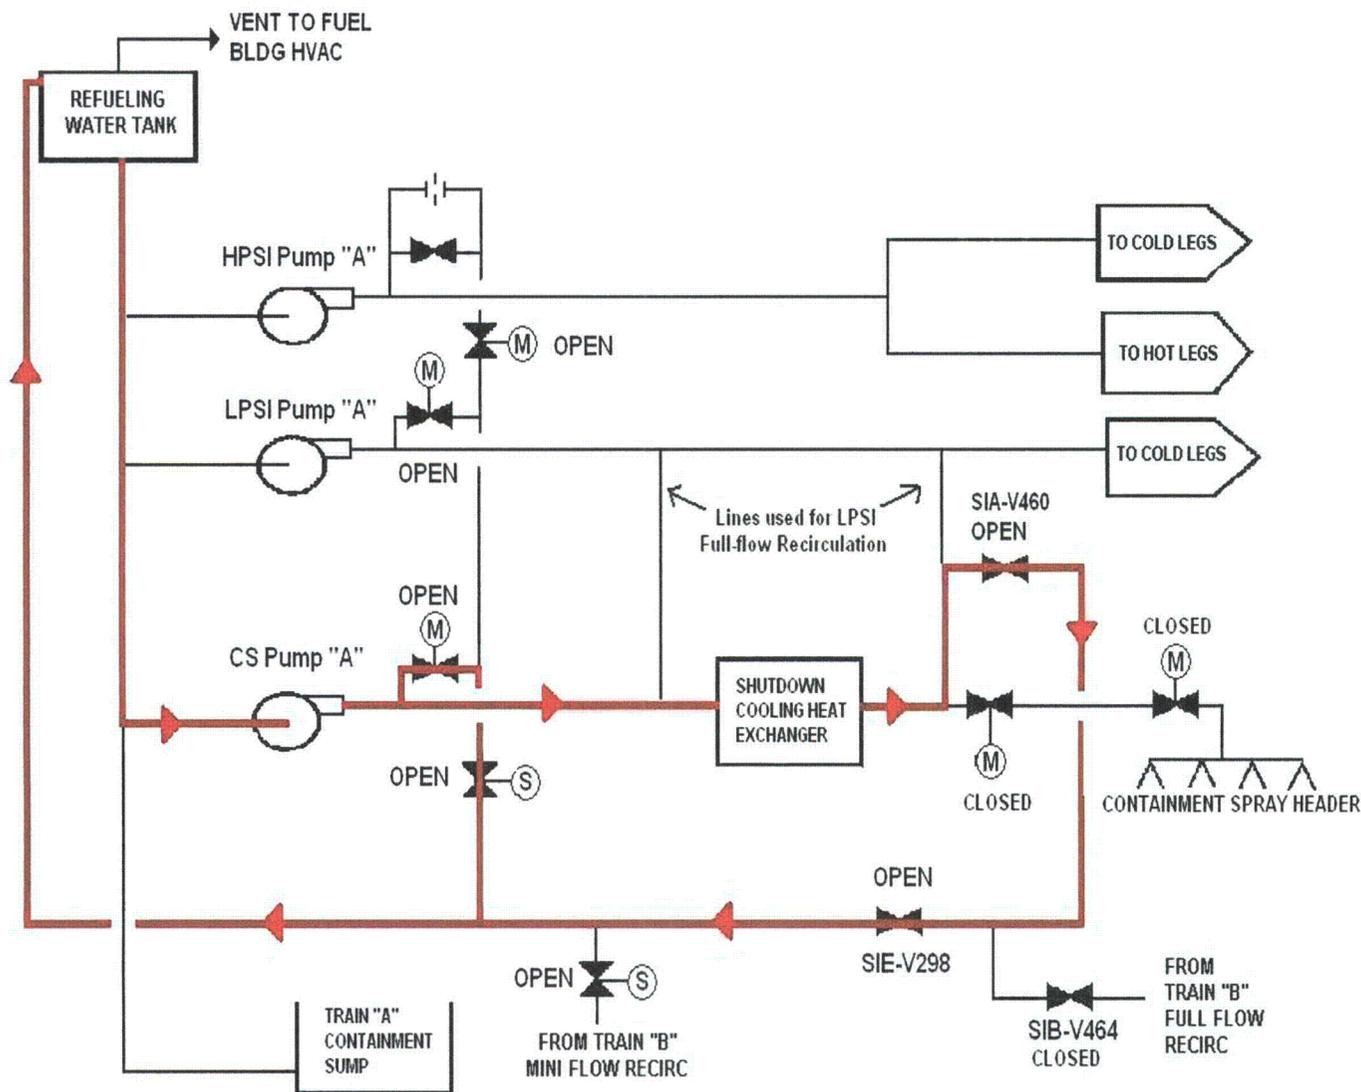
Figure A – Containment Spray System Full-flow Recirculation Alignment

The SI piping arrangement also permits full-flow from the HPSI, CS or LPSI pumps to be directed to the common RWT return pipe. For full-flow recirculation using the "A" LPSI or CS pump, discharge flow is routed through manually operated valve SIA-V460 and through the common RWT return pipe manually operated valve SIE-V298. Similarly, the "B" train full-flow recirculation, using CS or LPSI pump flow, is routed through manually operated valve SIB-V464 and through the common return pipe valve SIE-V298. These three valves are normally locked-shut in accordance with operating procedures. These procedurally controlled alignments provide a means of recirculating the RWT for operations such as surveillance testing, cooling the RWT prior to a refueling outage, and

to minimize RWT boron stratification. Figure A provides a simplified diagram of CS "A" in the full-flow recirculation alignment.

recirculation of the other SI pumps as a result of the increased pressure in the individual mini-flow recirculation lines. Station personnel concluded on February 18, 2009, that the full-flow recirculation of the RWT using either a CS or LPSI pump could potentially adversely impact one or more SI pumps' mini-flow rates because of the resulting increased pressure in the mini-flow lines.

- Use of a LPSI pump at flow rates greater than 2500 gallons per minute (gpm) would reduce the opposite train LPSI mini-flow recirculation below the minimum requirement.
- Use of a LPSI pump at flow rates greater than 3200 gpm would reduce mini-flow recirculation of both CS trains below the minimum requirement.
- Use of a CS pump at flow rates greater than 2450 gpm would reduce mini-flow recirculation of the same train LPSI pump below the minimum requirement.
- Use of a CS pump at flow rates greater than 2600 gpm would reduce mini-flow recirculation of the opposite train LPSI pump below the minimum requirement.
- Use of a CS pump at flow rates greater than 3150 gpm would reduce mini-flow recirculation of the opposite train CS pump below the minimum requirement.

The station discontinued use of the RWT LPSI and CS full-flow recirculation methods and the respective portions of the procedures were placed on administrative hold to prevent their use. The RWT common return line isolation valve SIE-V298 was tagged shut to prevent the alignments.

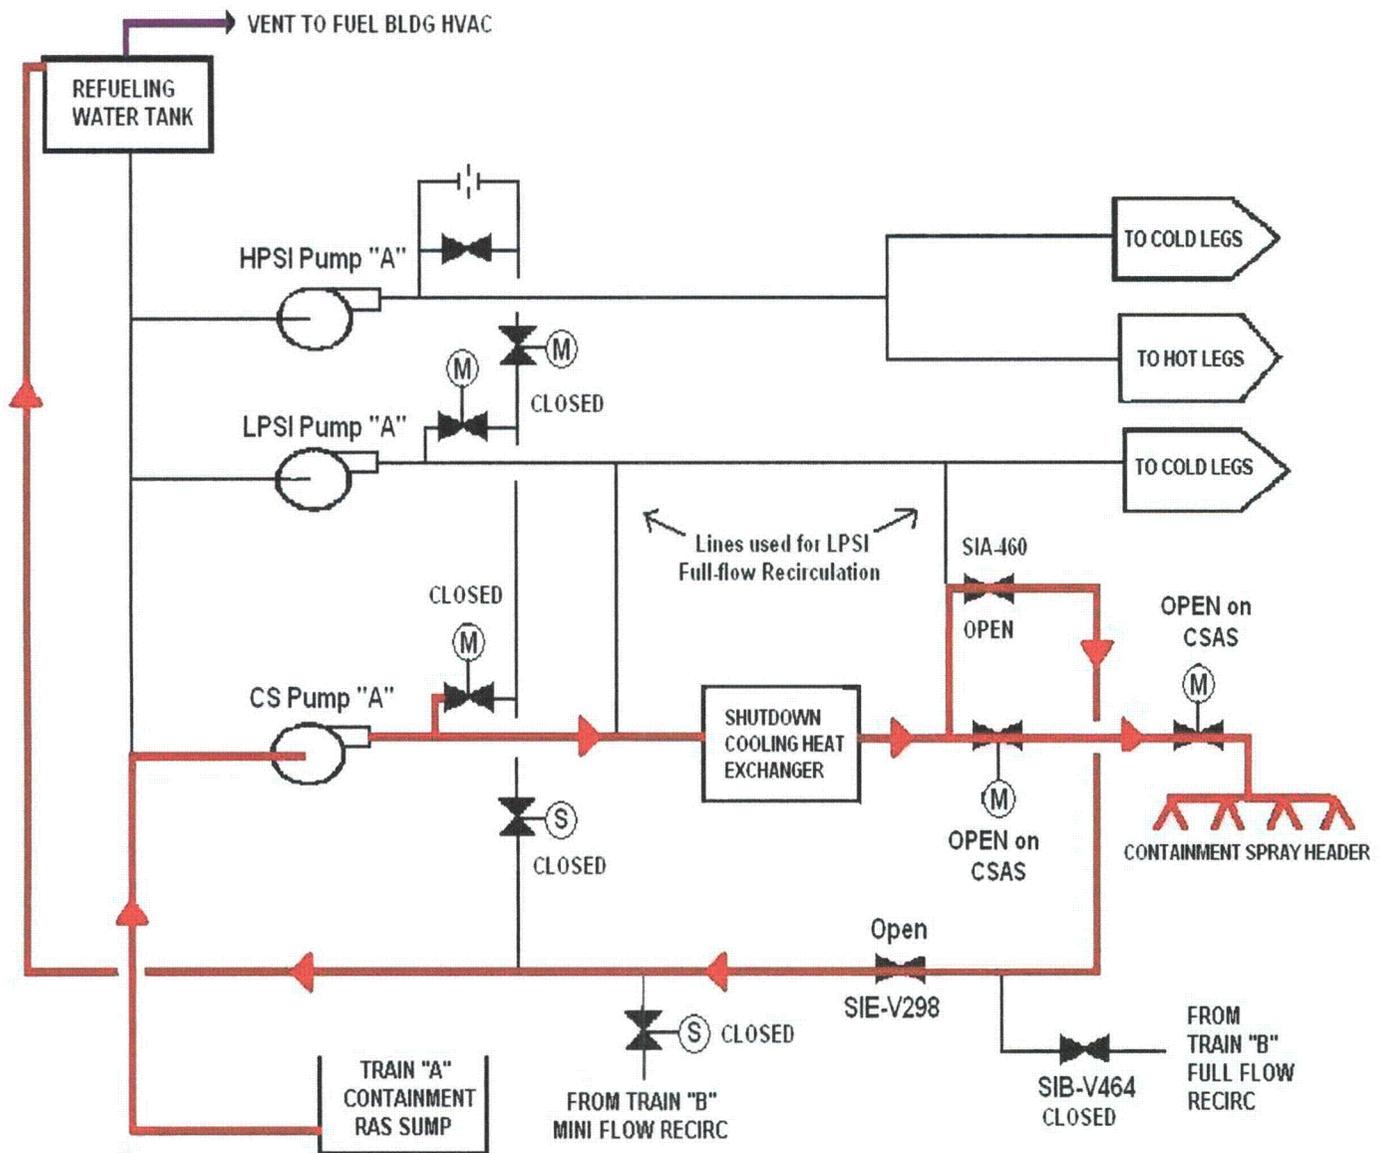
Figure B – Post “RAS” Containment Spray System Full-flow Recirculation Alignment

It was also determined if normal SI system alignment is not restored prior to a RAS, the CS and LPSI full-flow recirculation alignment could result in a containment bypass flow path to the RWT. Figure B at the end of the report provides a simplified diagram of the CS full-flow recirculation flow path if alignment was not restored prior to a RAS occurring. The bypass flow path could also adversely affect SI pump available net positive suction head (NPSH) because containment sump level would decrease.

The plant was in an unanalyzed condition when either LPSI or CS was aligned for full-flow RWT recirculation. In this alignment, mini-flow rate requirements for other SI pumps may not have been met under some accident scenarios and the potential existed for pumping water from the containment sump to the RWT if a RAS had occurred without the system being realigned.

The identified full-flow recirculation alignments could have prevented the fulfillment of the safety functions of the SI systems to remove residual heat and mitigate the consequences of an accident. This could have occurred through a combination of pump damage due to the lack of mini-flow recirculation and the loss of available NPSH after RAS actuation. Additionally, the alignments could have resulted in the loss of the safety function to control the release of radioactive material as a result of the containment bypass flow after a RAS occurs.
