Re: Blythe Power Plant Turbulence

Analysis of Turbulence Over the FPL Blythe Power Plant

Date of Report: November 19, 2004
ESI File # 17667C

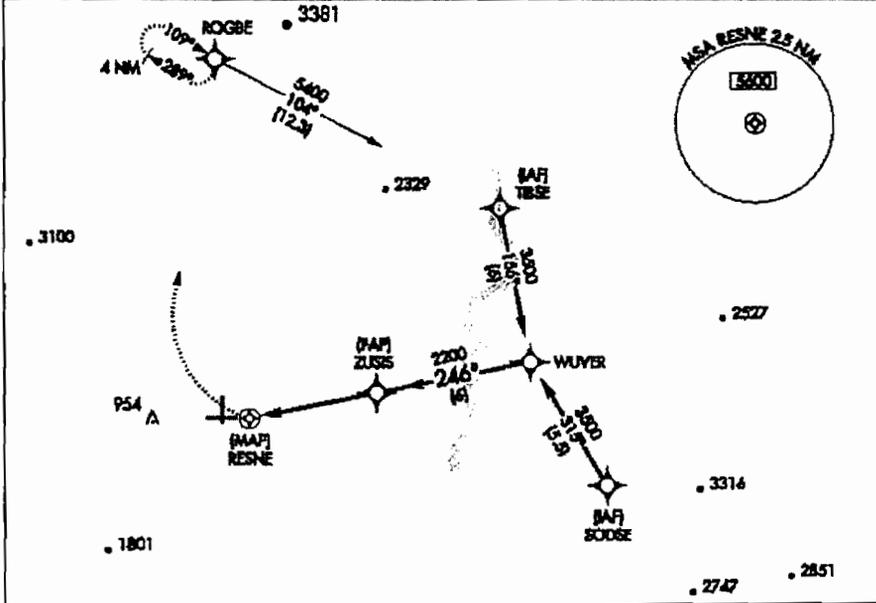
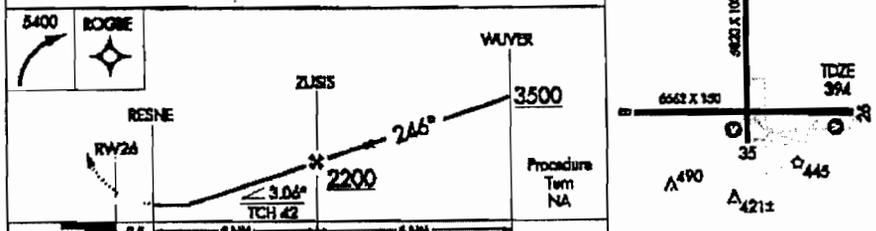
Figure 1 RNAV Approach to Runway 26

There are no published limitations on visual traffic patterns except to avoid overflight of a residential area to the south of the airport. There are three certified instrument approaches to the Blythe Airport; the approach plates of the approaches to Runway 26 are shown in Figures 1 and 2.
