**PHASE II ENVIRONMENTAL SITE ASSESSMENT  
RETENTION BASINS  
RIVERSIDE CANAL POWER COMPANY  
GRAND TERRACE, CALIFORNIA**

**March 1999  
Project No.: 993-1986**

**PHASE II ENVIRONMENTAL SITE ASSESSMENT  
RETENTION BASINS**

**RIVERSIDE CANAL POWER COMPANY  
12700 TAYLOR STREET  
GRAND TERRACE, CALIFORNIA**

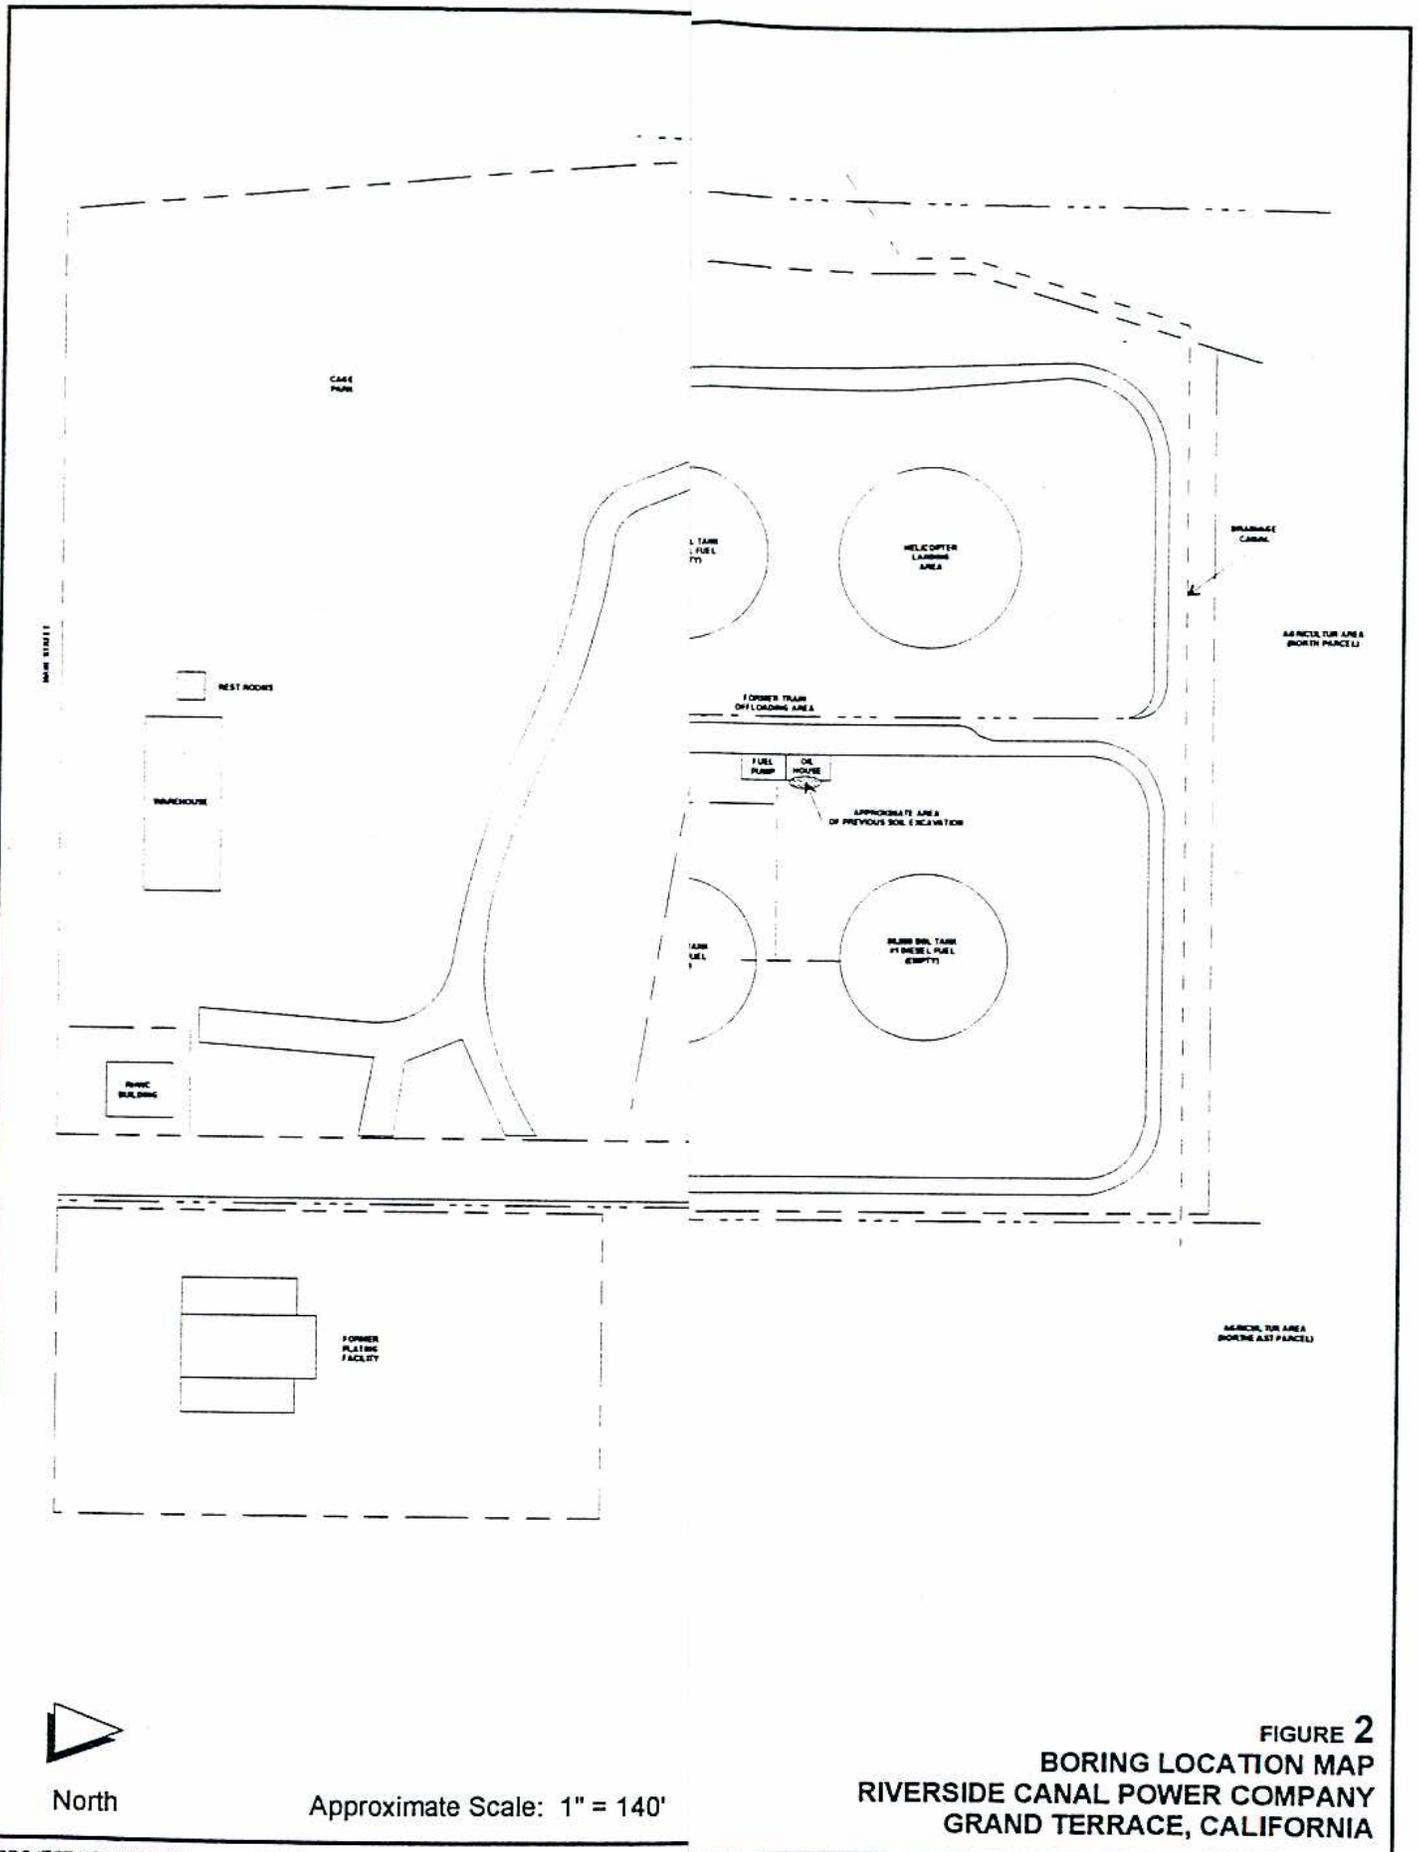
**FIGURE 2**  
**BORING LOCATION MAP**  
**RIVERSIDE CANAL POWER COMPANY**  
**GRAND TERRACE, CALIFORNIA**

Soil samples were collected beneath each retention basin on February 26, 1999 using a CME 75 truck-mounted drill rig. Layne Christensen Company of Fontana, California was subcontracted to provide the direct push services. The approximate boring locations are shown on the Site Layout Map, Figure 2.

Slant boring B1 was drilled twelve feet north of the western retention basin at an approximate 20° angle (Figure 2). Soil samples were collected at 10, 20, 30, 40, 50, 60, 70, and 80 feet of drilling distance, corresponding to actual depths of approximately 9, 19, 28, 38, 47, 56, 66, and 75 feet below ground surface. Sample B1-80 was thus collected

approximately 75 feet below the center of the western basin. Similarly, slant boring B2 was drilled twelve feet north of the eastern retention basin at an approximate 20° angle. The sample designation, approximate sample depths, and headspace readings for each sample are indicated in Table 1.

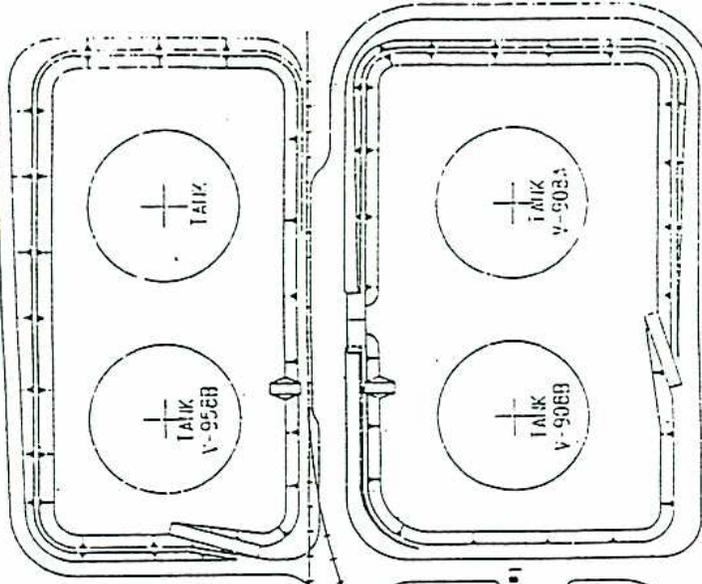
LOCATION OF BASINS

shown on Figures 2 and 3. The location of the basins and background boring (H-1) are shown on Figure 1.

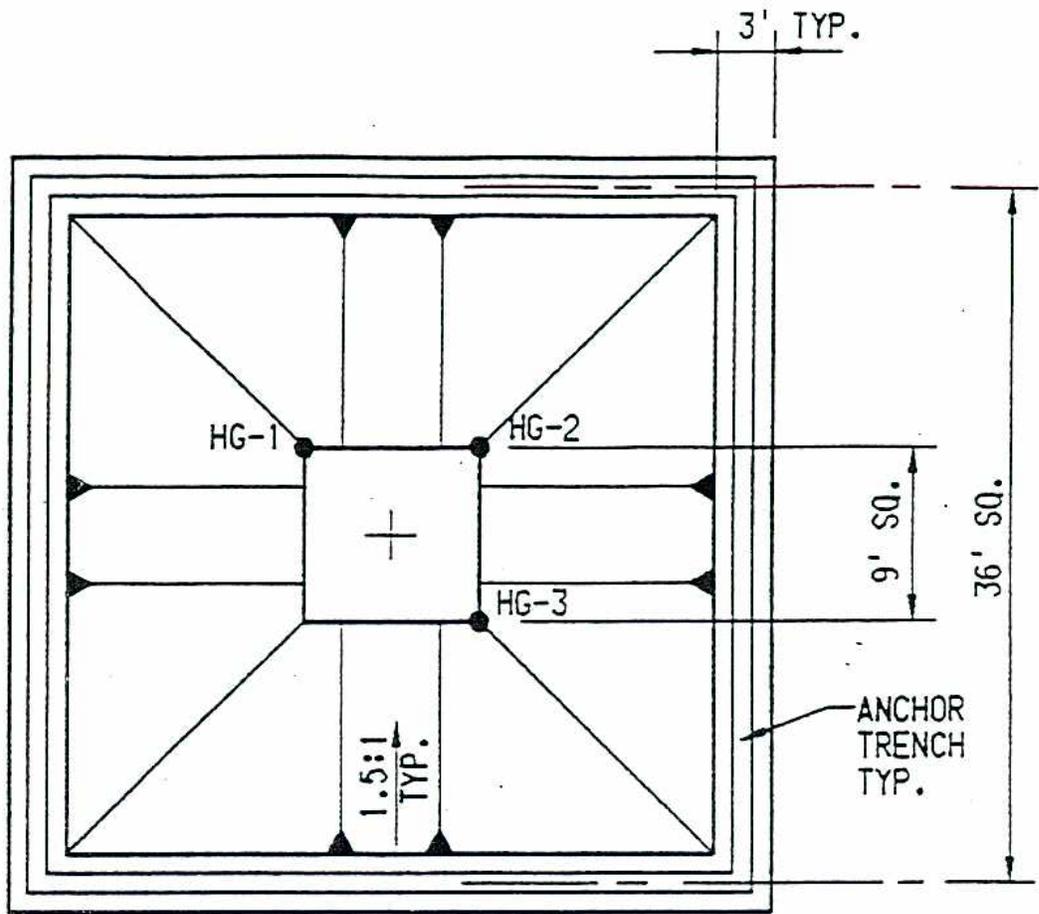
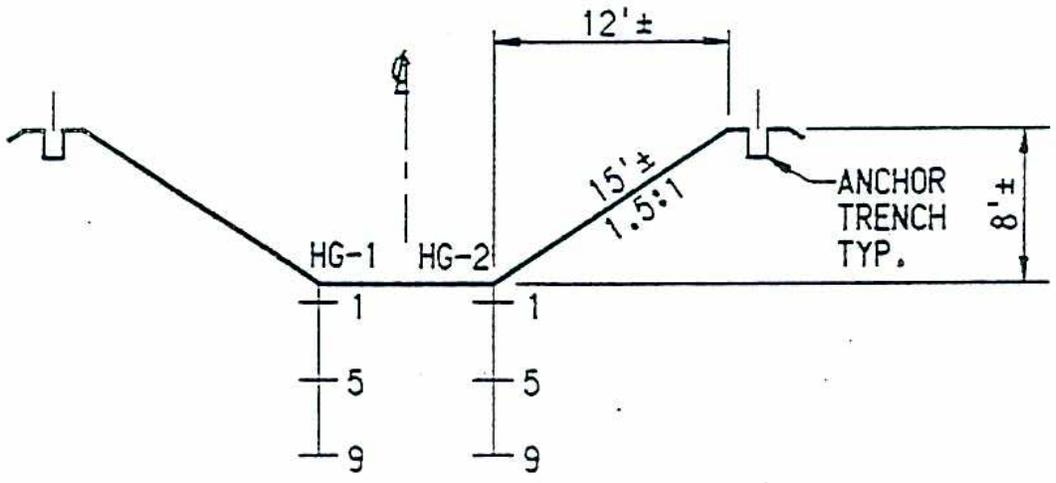
HIGHGROVE GENERATING STATION  
EAST RETENTION BASIN  
FIGURE 2

The soil beneath the East and West basins were investigated using two methods: a soil gas survey and soil sampling. Three exploratory borings were advanced within each basin for a total of six holes. The locations of the holes are
