Subject: Mariposa Energy Project (09-AFC-03)
Supplement A - Data Adequacy Responses

APPLICATION FOR CERTIFICATION
SUPPLEMENT A
RESPONSE TO DATA ADEQUACY REVIEW

FOR THE
Mariposa Energy Project

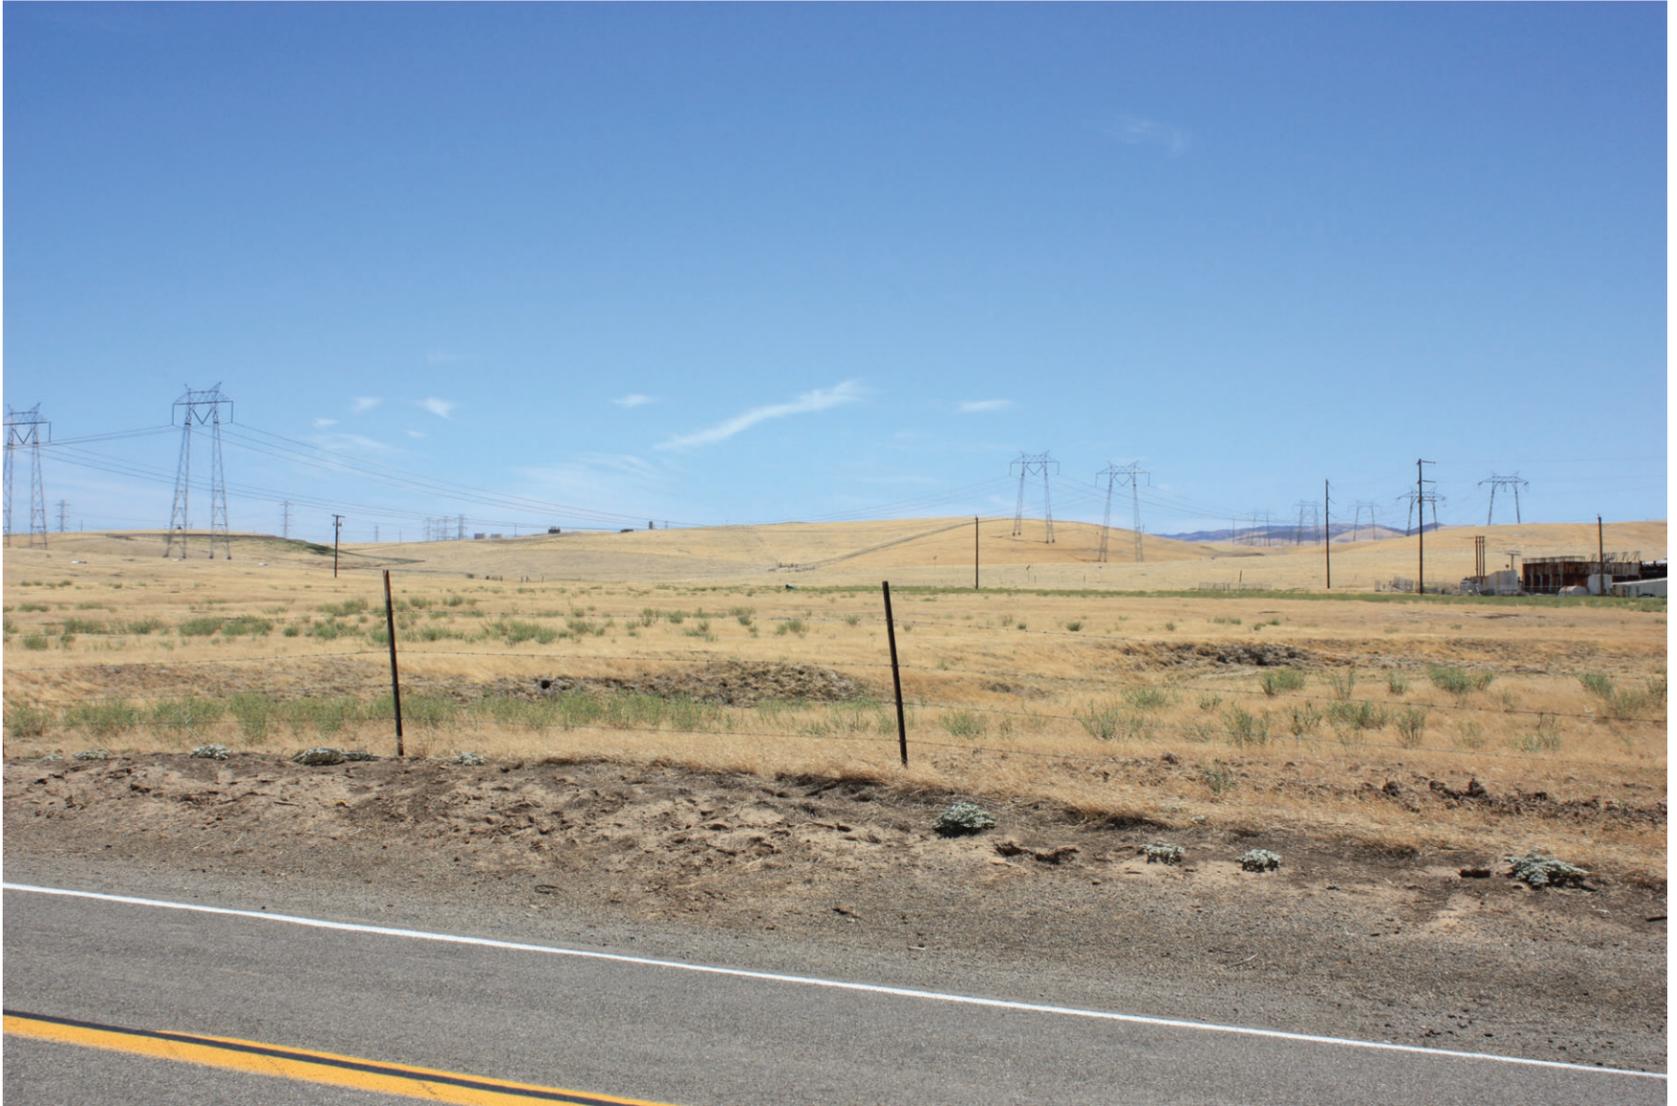
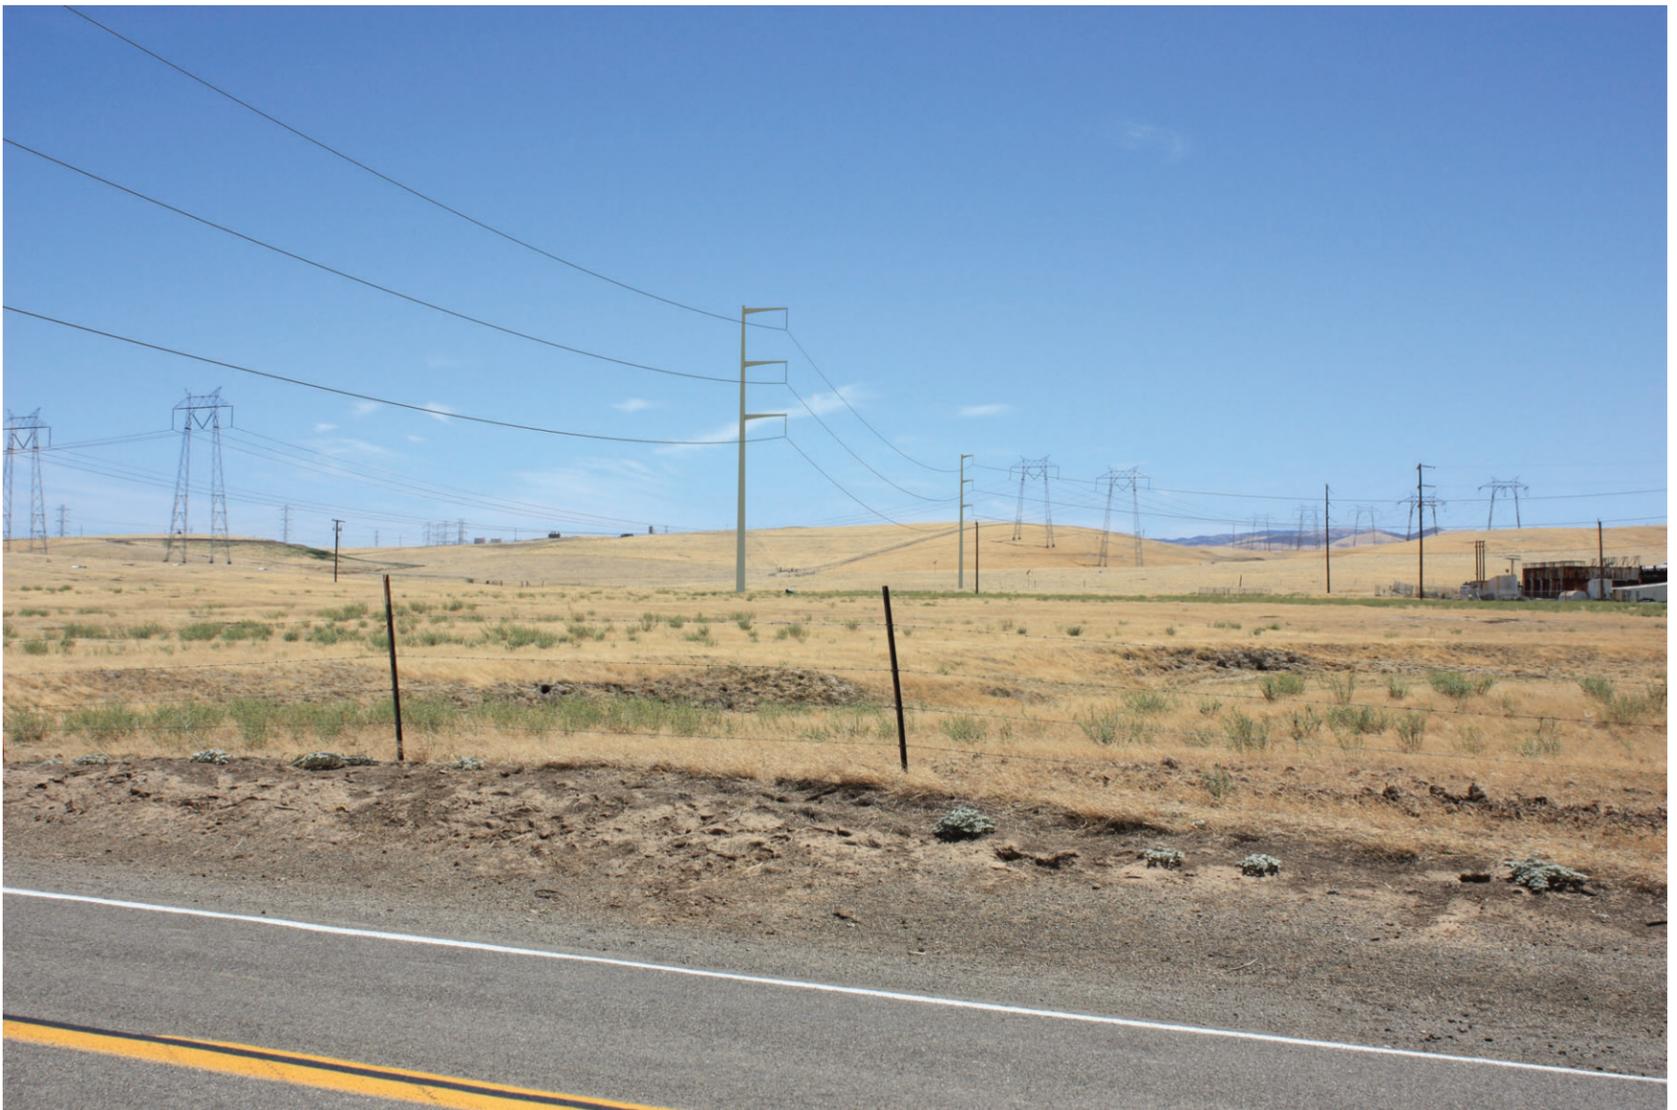
FIGURE DA2.0-3A
VIEW TO SOUTH FROM DRIVEWAY AT
PG&E BETHANY COMPRESSOR STATION
Mariposa Energy Project
Alameda County, California

View of proposed transmission alignment between Project Site and Kelso Road. Kelso Road is in the foreground; the Byron Cogen Plant is in the right side of the view.

View with transmission line simulated.

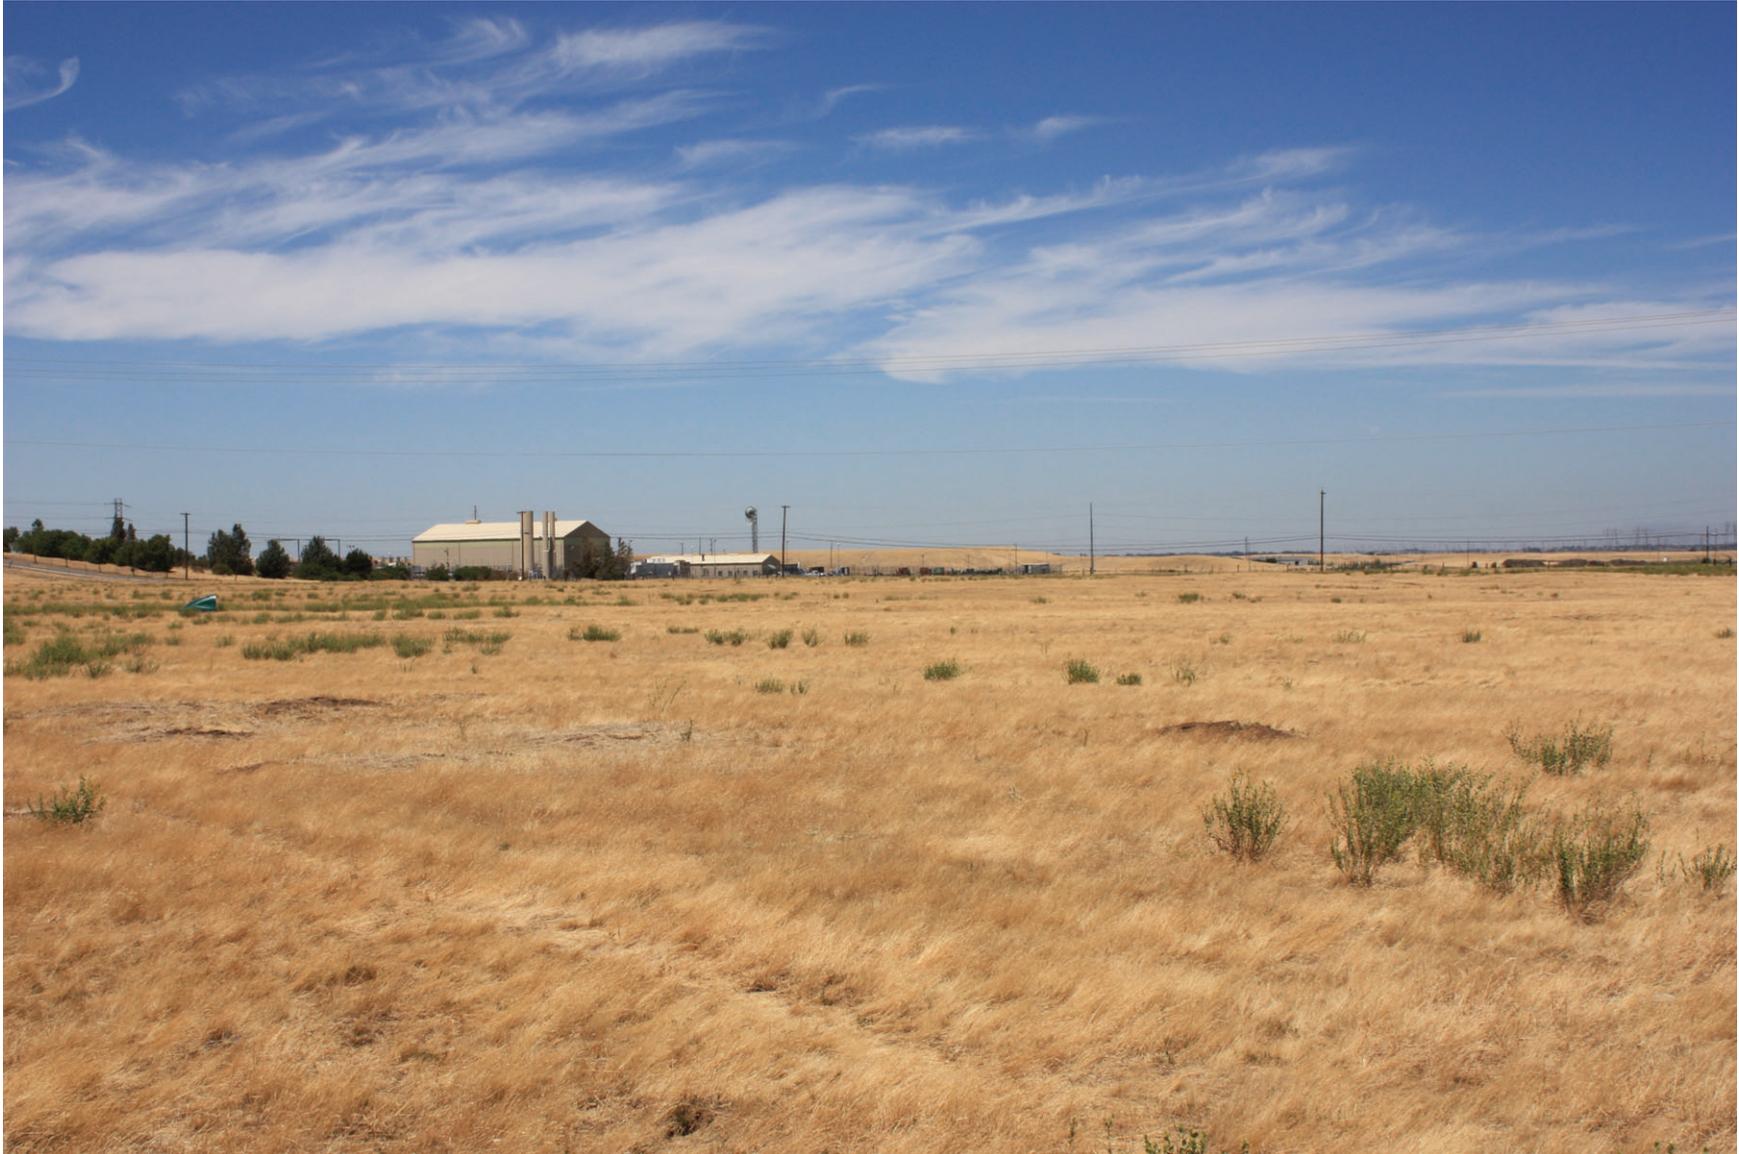
FIGURE DA2.0-4A
VIEW TO NORTH FROM TRANSMISSION ALIGNMENT AXIS
Mariposa Energy Project
Alameda County, California

View of proposed transmission alignment between Project site and Kelso Road. PG&E's Bethany Compressor Station is visible beyond Kelso Road.

Response: Full-page color photographic reproductions depicting a representative aboveground section of the transmission line route, prior to and after construction, are provided in Figure DA2.0-3A. The vantage point presented is representative of the view from Kelso Road, which is accessible by the public. Photographic reproductions depicting current conditions of additional portions of the route are provided in Figures DA2.0-3B and DA2.0-4A and B, as requested by Staff.

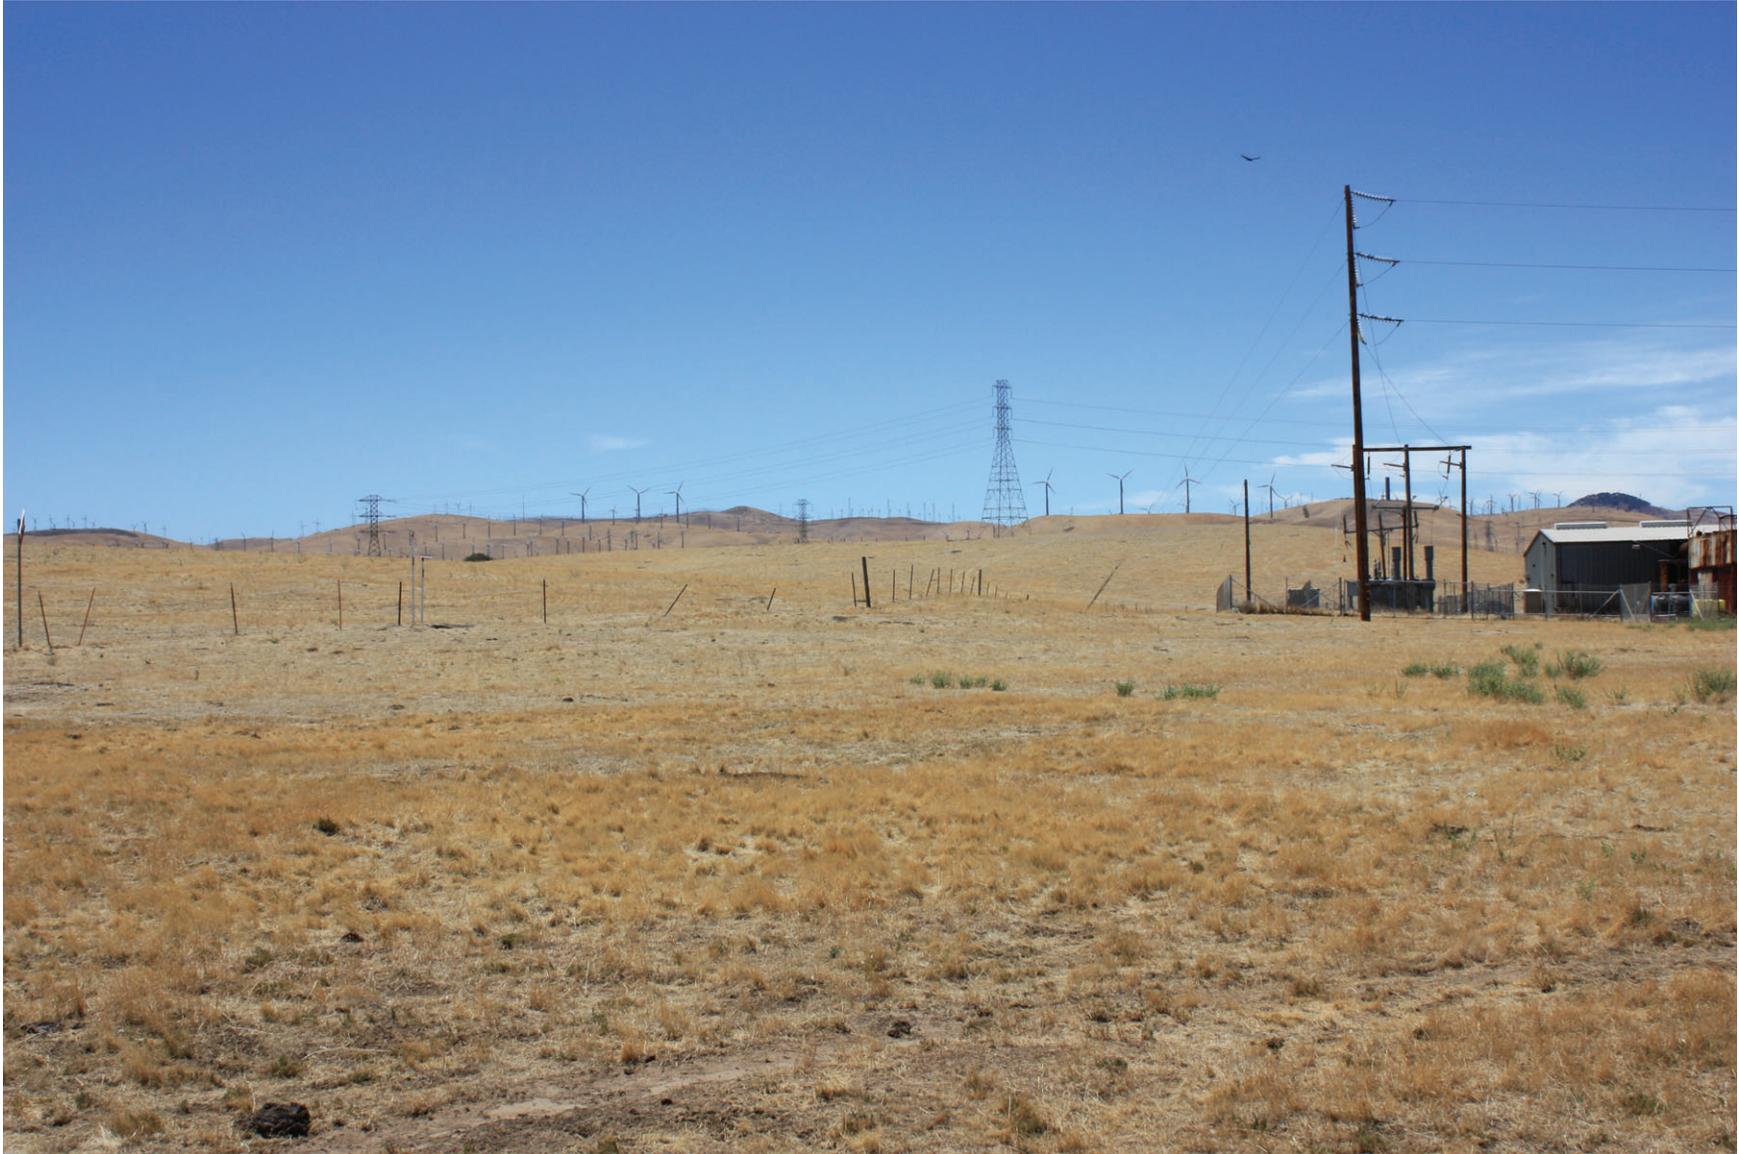
FIGURE DA2.0-4B
VIEW TO WEST FROM TRANSMISSION ALIGNMENT AXIS
Mariposa Energy Project
Alameda County, California

View of proposed transmission alignment where it would extend from Project site toward the alignment axis. The Byron Cogen Plant is visible in the right side of the view.

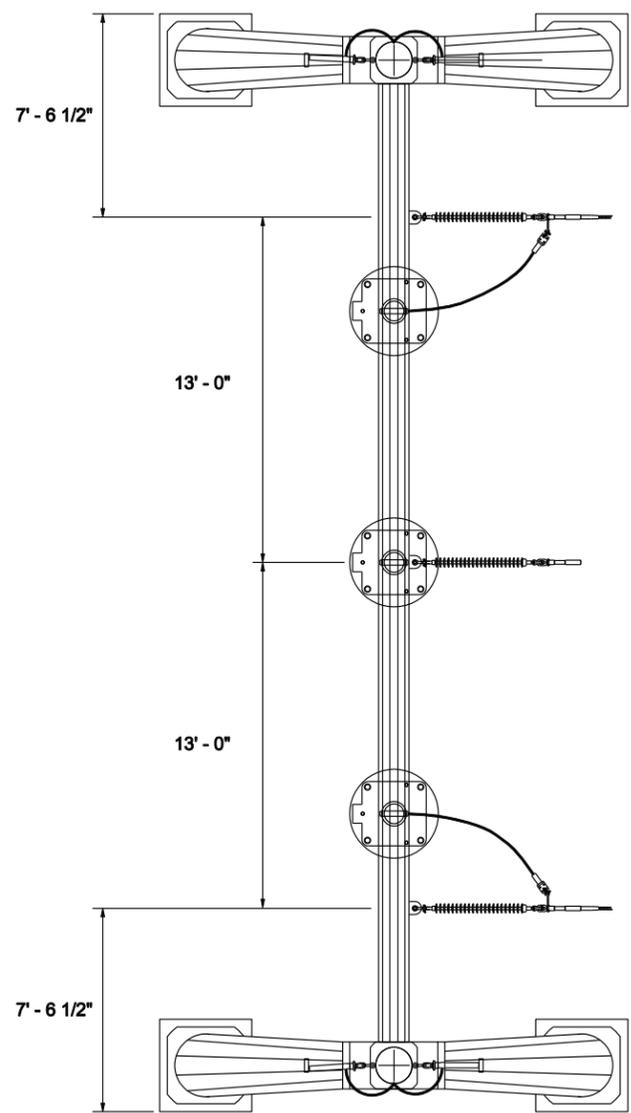
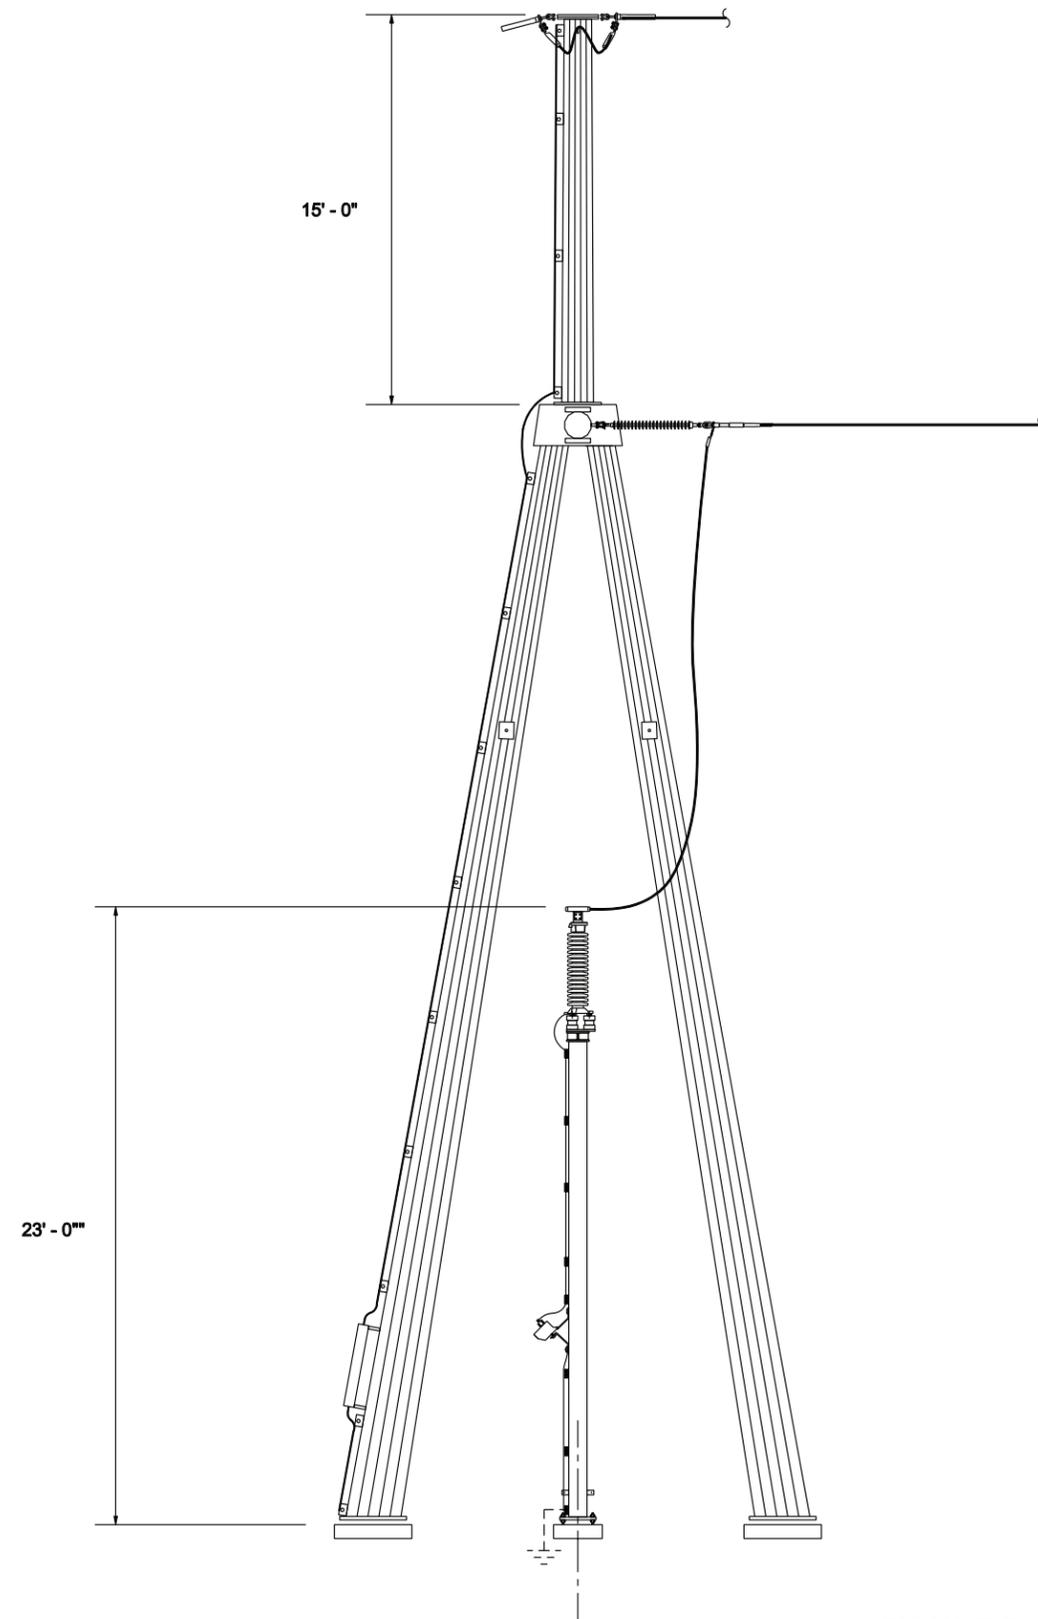
FIGURE DA3.0-1
DEAD END STRUCTURE
 Mariposa Energy Project
 Alameda County, California

1. HEIGHTS ASSOCIATED TO EACH CABLE CORRESPOND TO THE DISTANCE BETWEEN THE LOWEST POINT ON THE CABLE TO THE EARTH.
2. RIGHT OF WAY WILL TYPICALLY BE 150 FEET WIDE. RIGHT OF WAY REQUIREMENTS MAY VARY FROM THE 150 FOOT WIDTH DEPENDING ON EXISTING FACILITIES OR OTHER CO-LOCATION OPPORTUNITIES.
3. CONDUCTOR SHALL BE: ACSR, DRAKE, 795 KCMILS WITH A CAPACITY OF 922A.

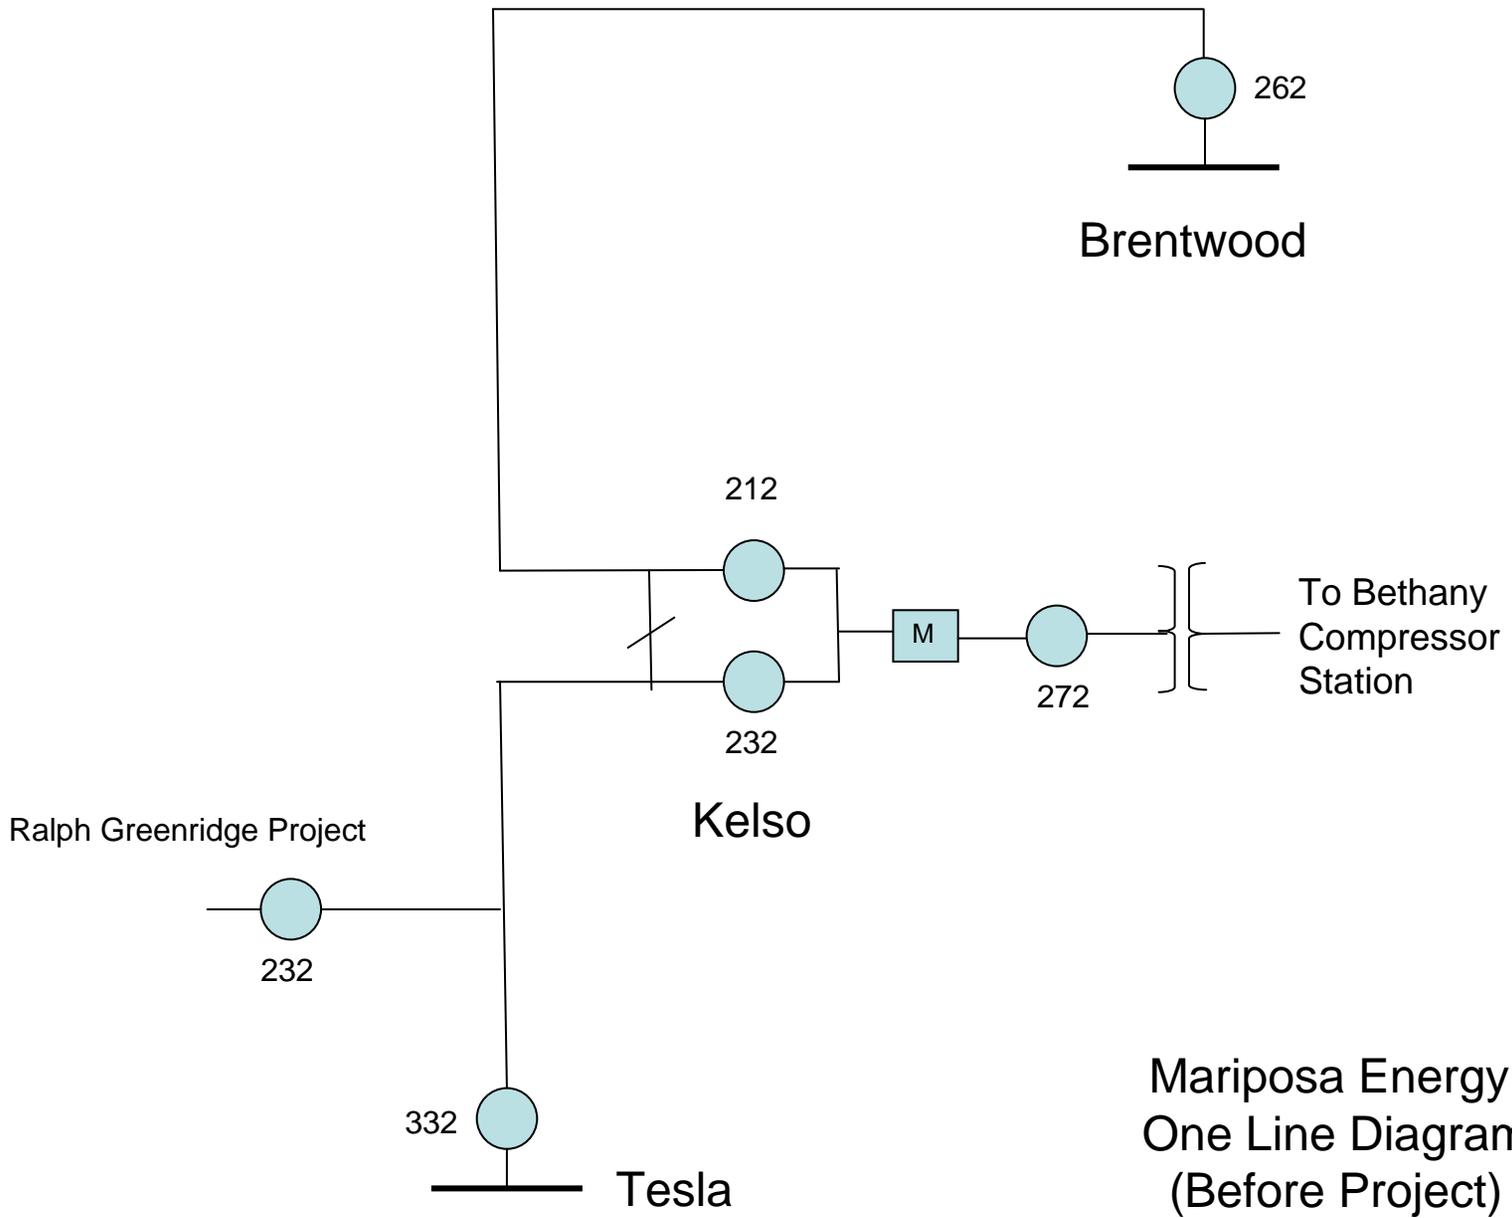
Mariposa Energy
One Line Diagram
(Before Project)

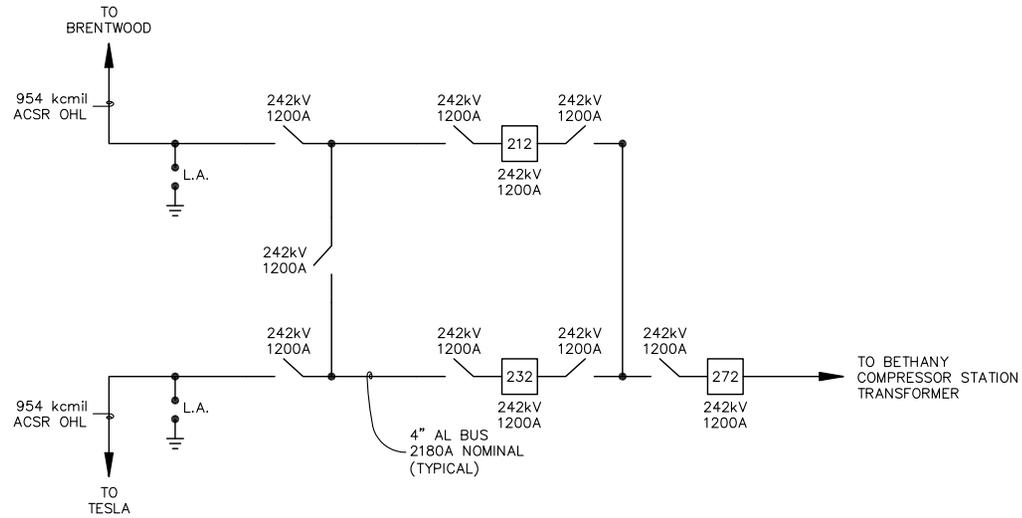
PROJECT NUMBER:
 10-00174-01000
 SHEET 1 OF 1
 DRAWING NUMBER:
 171-01000-SK5.A

DIAMOND POWER
 KELSO GENERATION PROJECT
 KELSO SUBSTATION
 EXISTING CONDITIONS

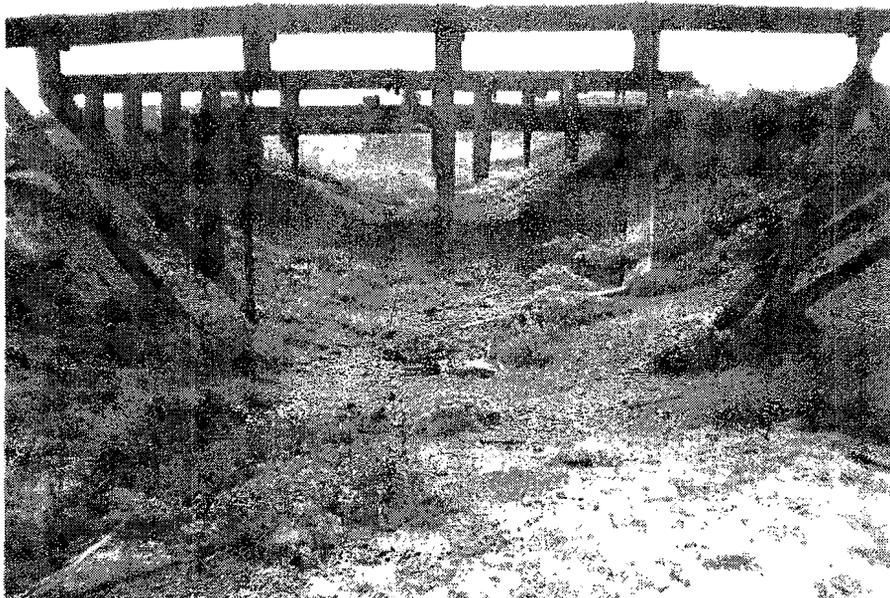
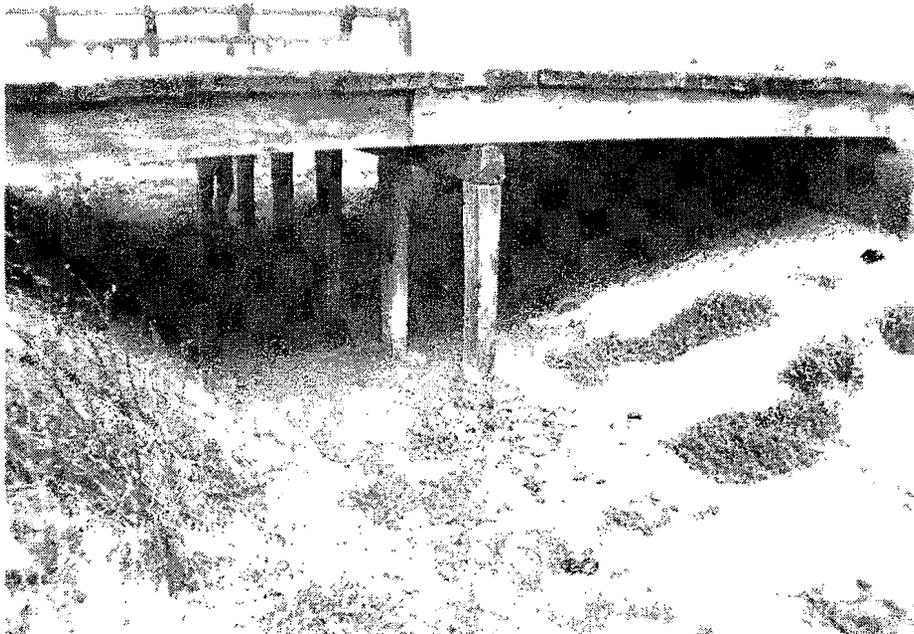
Photo of bridge over Byron Bethany Irrigation District Main Canal (No.9), Segment 3 near UTM point G; view towards South

Photo of bridge over Byron Bethany Irrigation District Main Canal (No.9). Segment 3 near UTM point G; view towards South

Photo of bridge over Byron Bethany Irrigation District Main Canal (No.9), Segment 3 at UTM point G; view towards northeast

Photo of bridge over Byron Bethany Irrigation District Main Canal (No.9), Segment 3 at UTM point G; view towards north
