Subject: Mariposa Energy Project, Clean Water Act Section 401 Water Quality Certification Application

**CALIFORNIA REGIONAL WATER QUALITY CONTROL BOARD
CENTRAL VALLEY REGION**

**SECTION 401 WATER QUALITY CERTIFICATION
APPLICATION FORM**

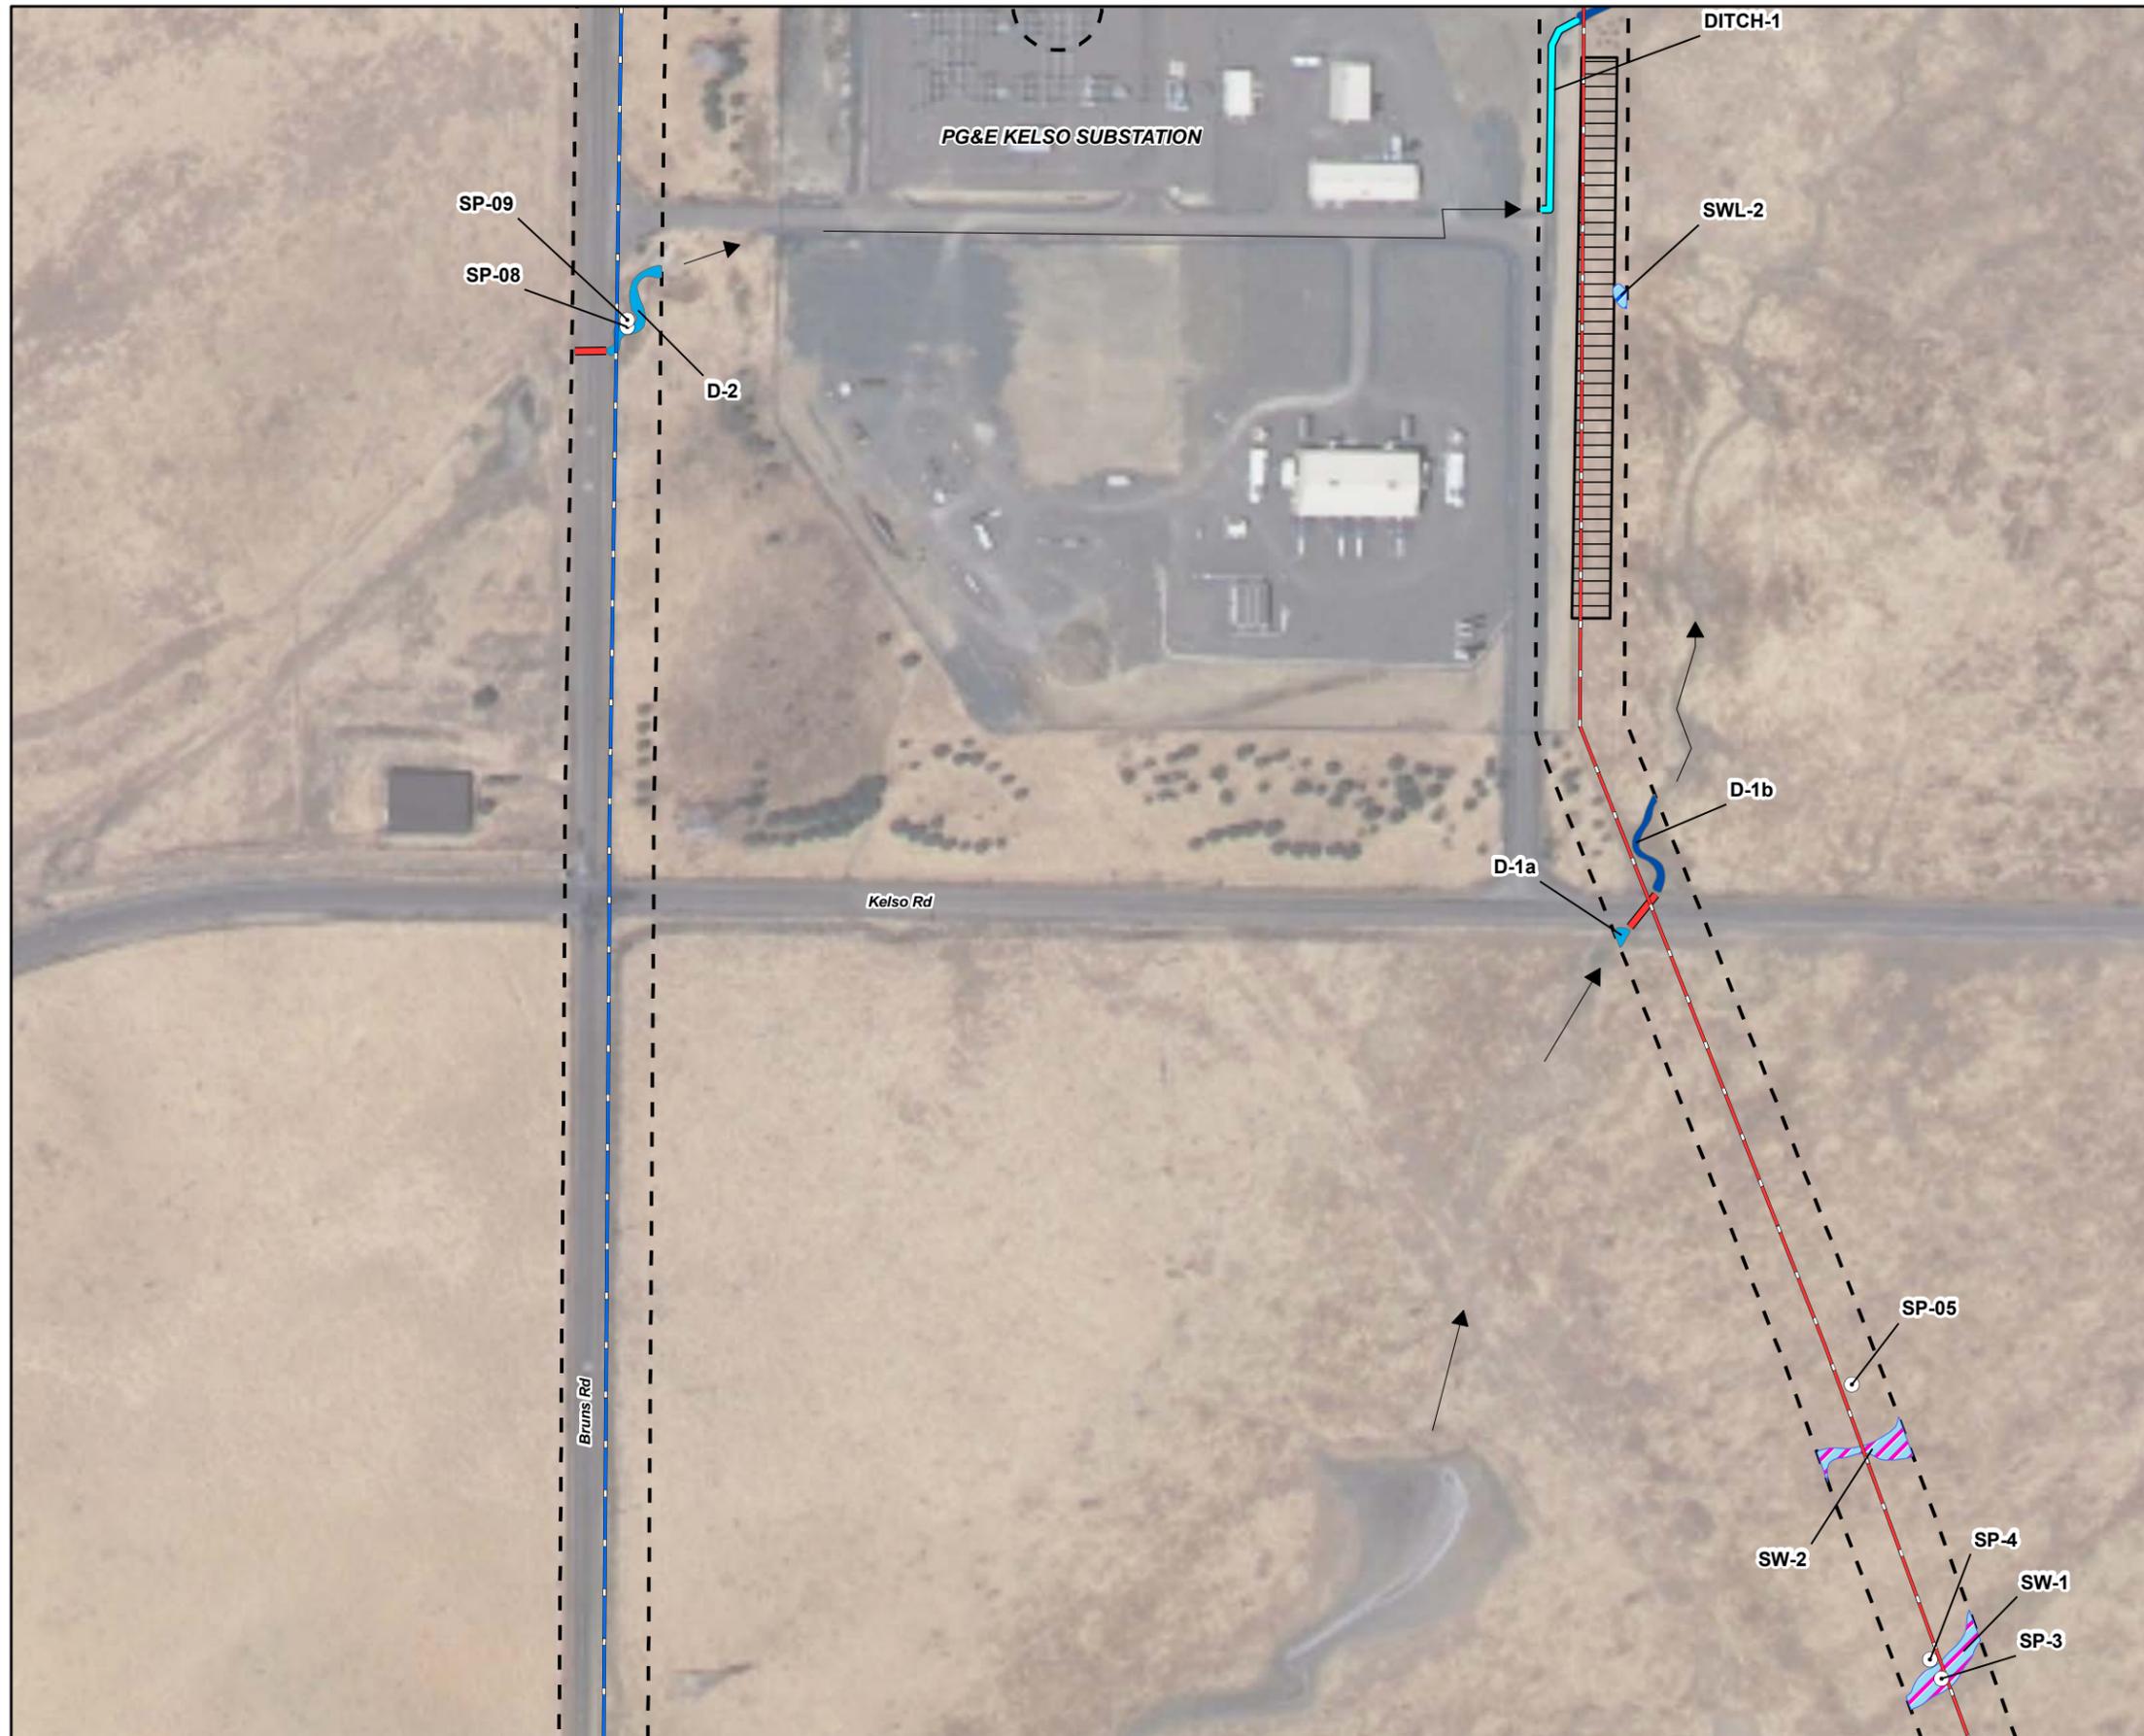
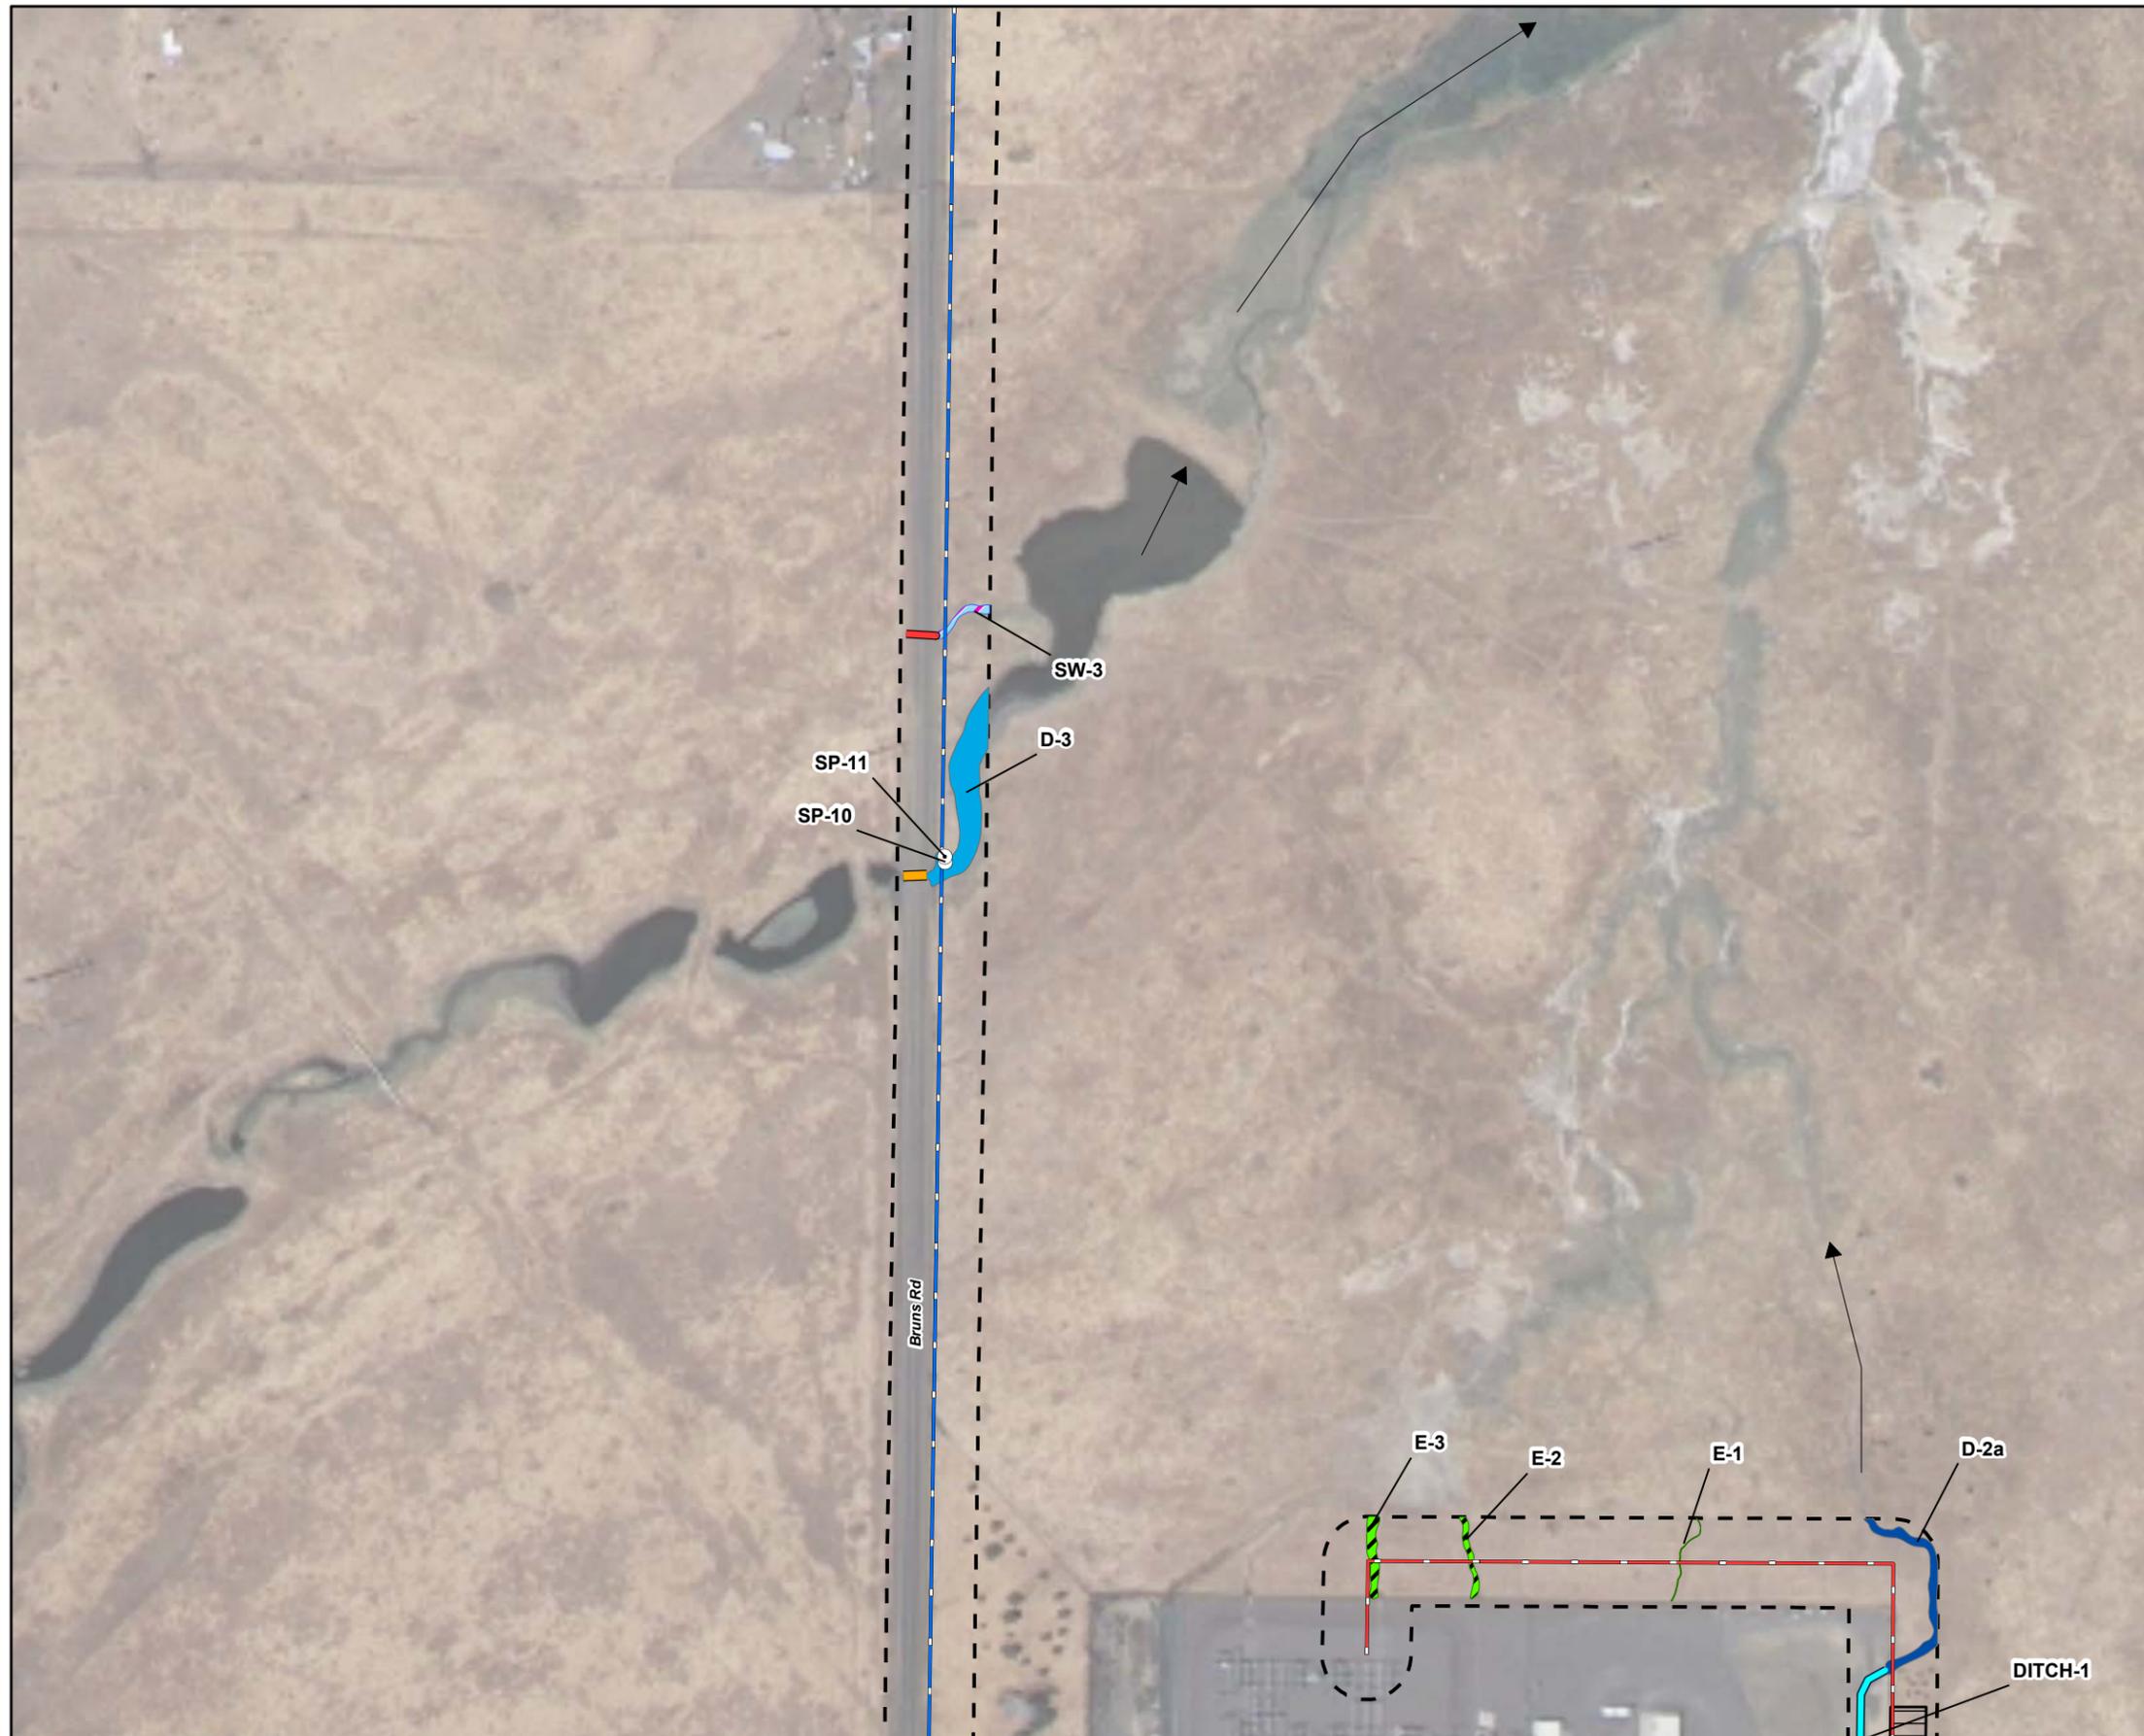
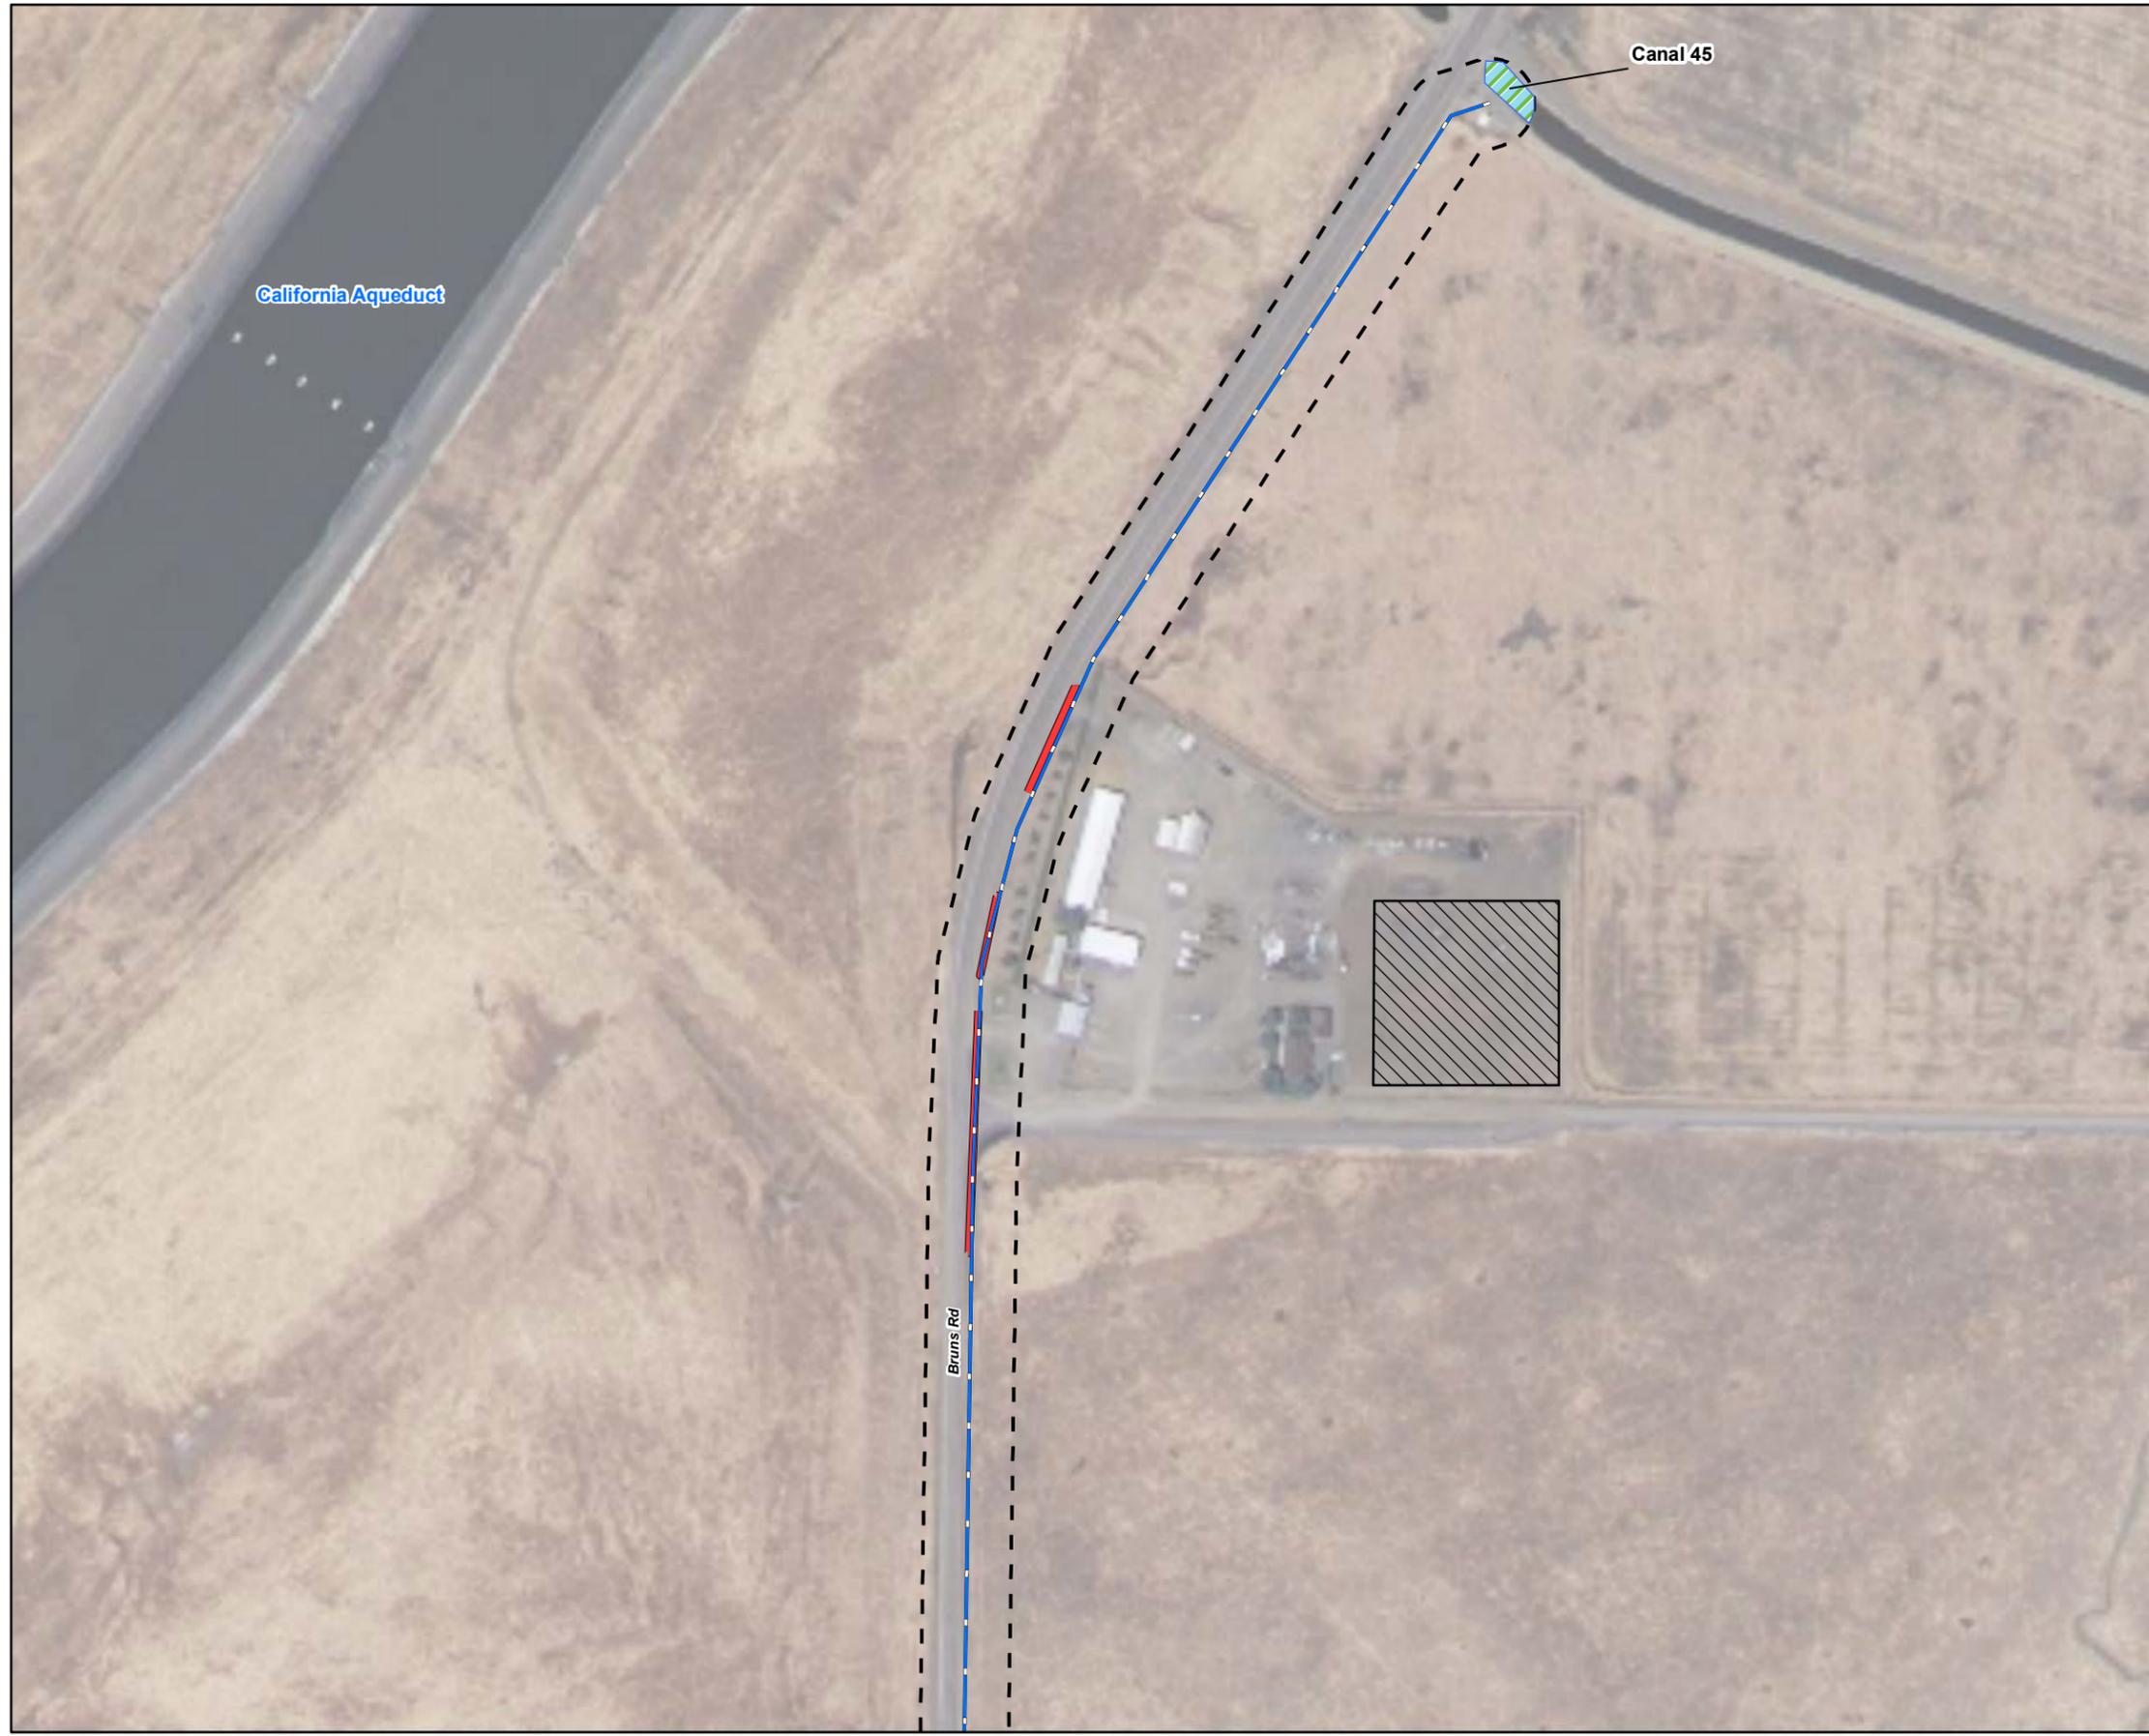
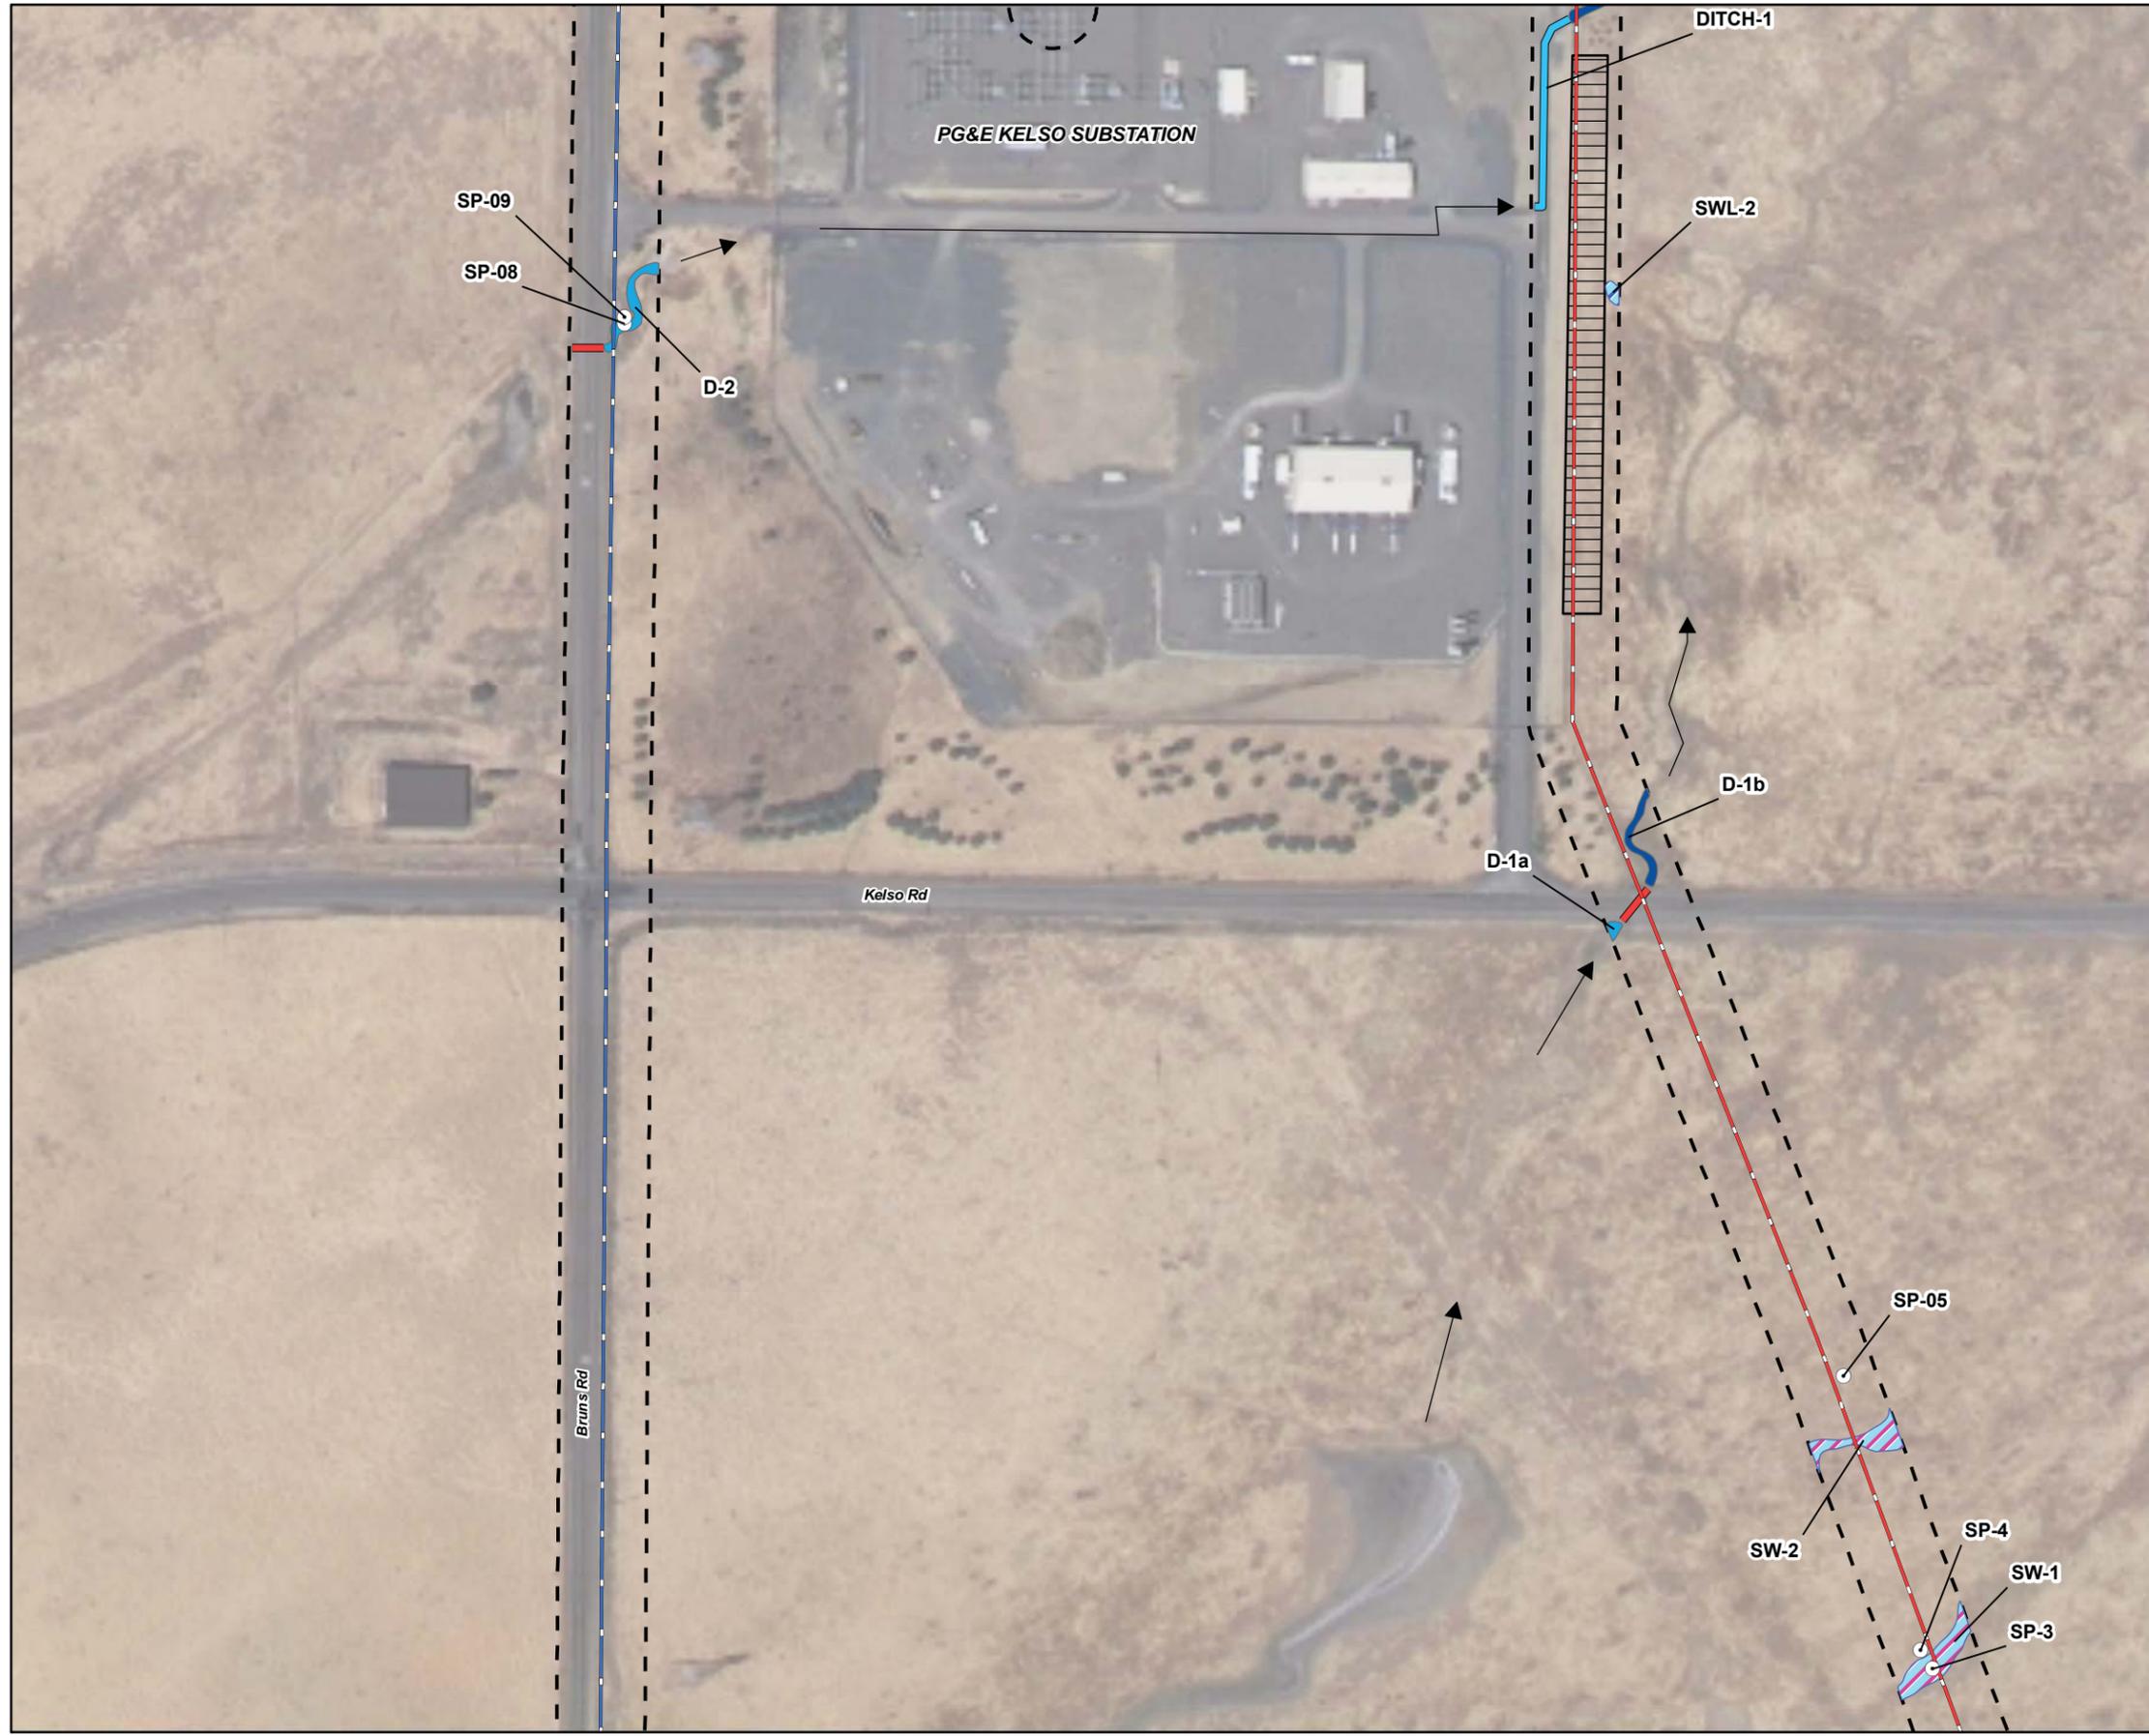
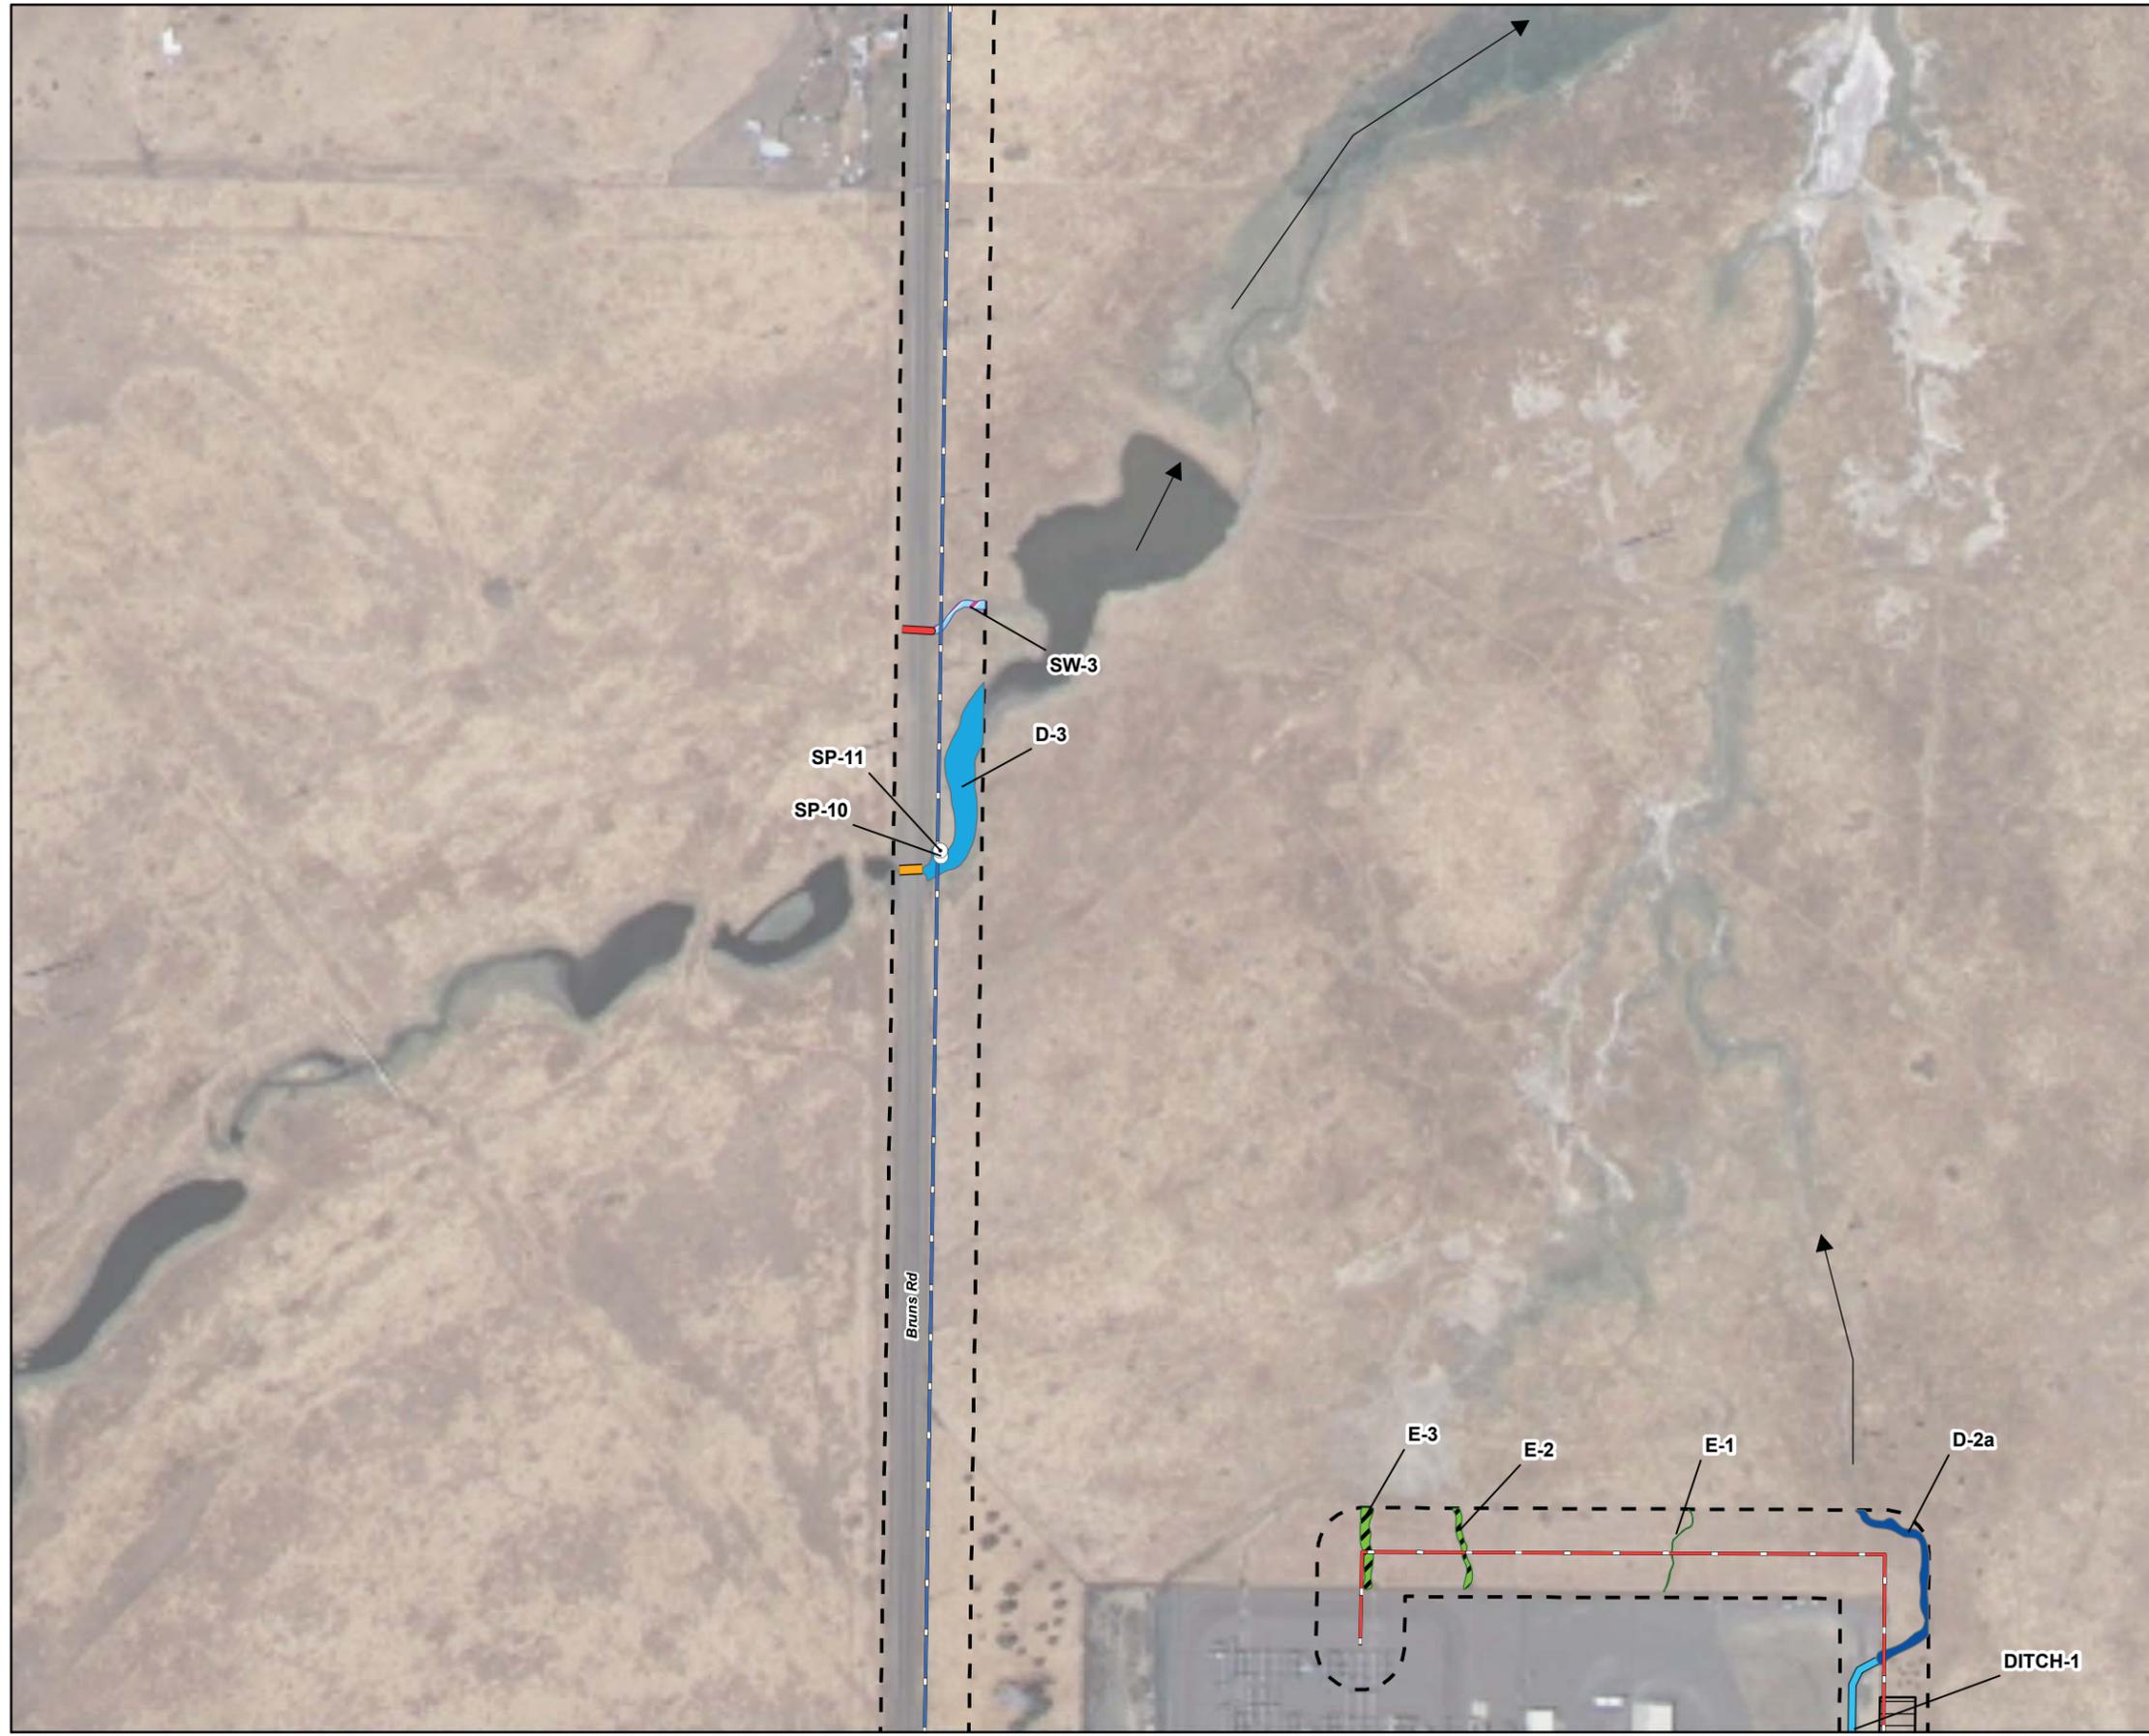
FIGURE 2-1
WETLAND DELINEATION
 MARIPOSA ENERGY PROJECT
 ALAMEDA COUNTY, CALIFORNIA

Three weakly expressed, low topographic swales were observed in the Project area. Two swales were observed along the transmission line route south of Kelso Road (Figure 2-1; Map 2) and one swale was observed along the service water pipeline route north of Drainage Wetland D-3 (Figure 2-1; Map 3).

This drainage is located immediately north of the Alameda County line along the east side of Bruns Road (Figure 2-1; Map 4). The shallow, well-defined channel is characterized by dense cattails (*Typha latifolia* and *T. dominingensis*) growing in the center of the channel with dense saltgrass growing around the outer edges. Mexican rush (*Juncus mexicanus*) and curly dock are also present in scattered locations. The soil at the outer edge of the channel is a strongly alkaline, dark grayish-brown (10 YR 4/2) fine sandy clay loam to clay loam. No redoximorphic features were noted in this area, possibly due to the high soil pH; however, hydric conditions were presumed to be present based on the level of inundation and abundant, lush OBL and FACW vegetation in this area. Shallow water was observed flowing from a 36-inch-diameter cmp under the road into this area during the surveys. The channel continues to flow to the east into a larger wetland area. This feature is included as a Palustrine Emergent Semi-Permanently Flooded (PEMF) wetland on the National Wetland Inventory Map (Appendix B).

A large alkali sink wetland is present immediately north and directly abutting Drainage D-4 (Figure 2-1; Map 4). Within the Project study area, this feature is characterized by saltgrass and common rusty molly (*Kochia californica*) with scattered sand spurry, alkali heath (*Frankenia salina*), and common spikeweed (*Centromadia pungens*). The surface soil is a strongly alkaline, dark grayish-brown (10YR 4/2) fine sandy clay loam to a depth of 8 inches. From 8 to 24 inches, the soil is a very dark grayish-brown (10 YR 3/2) clay loam that is also strongly alkaline. No redoximorphic features were observed in the upper part of

The third swale (SW-3), is found along the water supply line, just north of Drainage D-3 on the east side of Bruns Road. A 12-inch-diameter cnp is located under the road just west of the swale feature. Within the Project study area, the swale is generally weakly expressed and exhibits no ordinary high-water mark or evidence of recent flow. Vegetation in this area is similar to the adjacent California annual grassland and includes species such as soft chess, Italian ryegrass, and saltgrass with scattered gumweed, alkali heath, and coyote thistle. To the east of the Project study area, closer to the open water, the swale is characterized by a dense cover of lush saltgrass. Because this swale appears to convey very infrequent and low-volume flows and short-duration flow, it was not considered to be subject to jurisdiction under the Federal CWA.

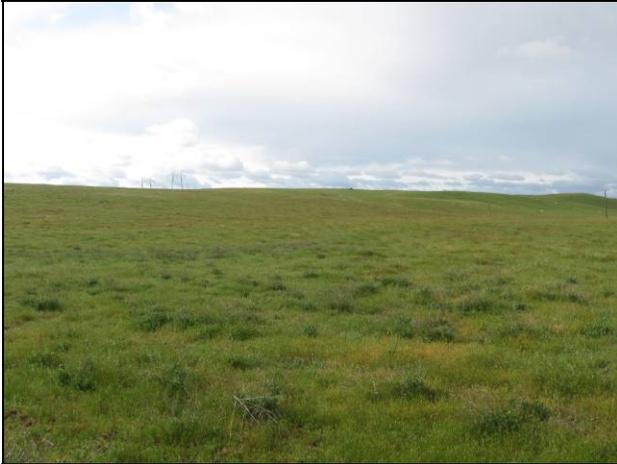
PROJECT SITE
Looking to the south-southeast from the existing access road

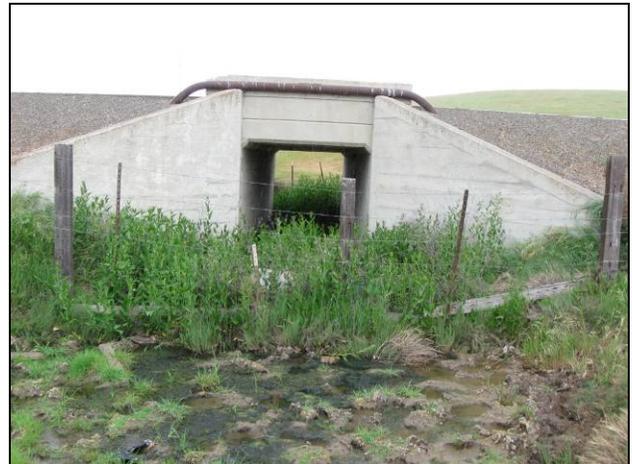
DRAINAGE WETLAND (D-1)
Looking east from Bruns Road

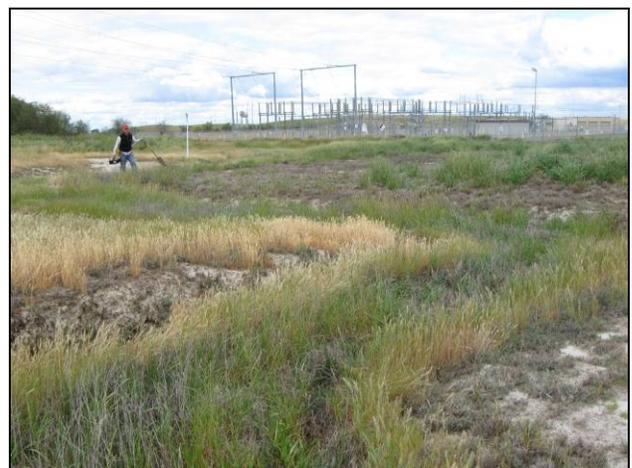
DRAINAGE (1B)
North of Kelso Road, looking northeast at defined earthen channel

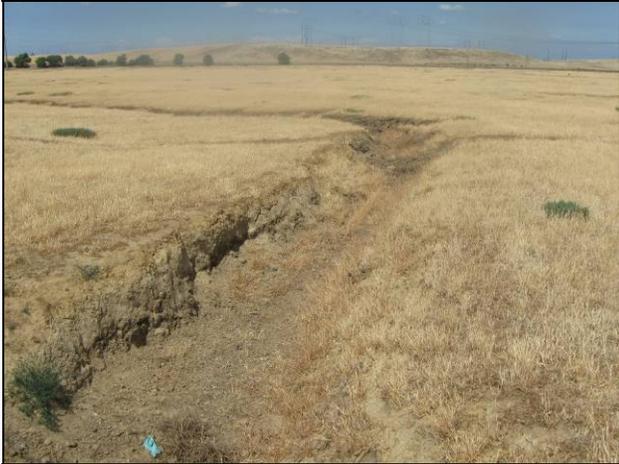
DRAINAGE WETLAND (D-2)
Looking east from Bruns Road

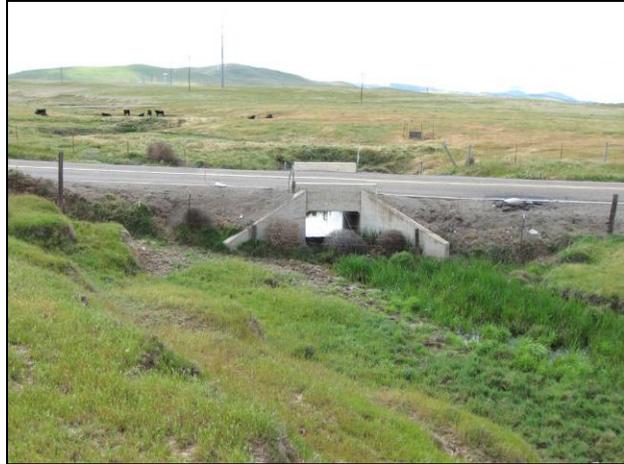
DRAINAGE (2A)
Looking east at earthen channel

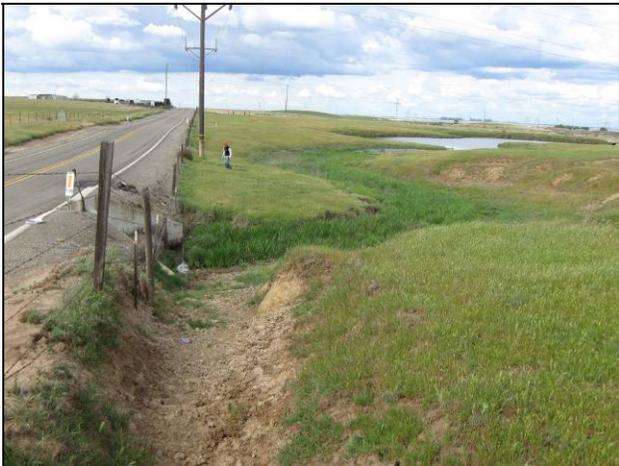
DRAINAGE WETLAND (D-3)
Looking west; 6-foot by 6-foot box culvert under Bruns Road

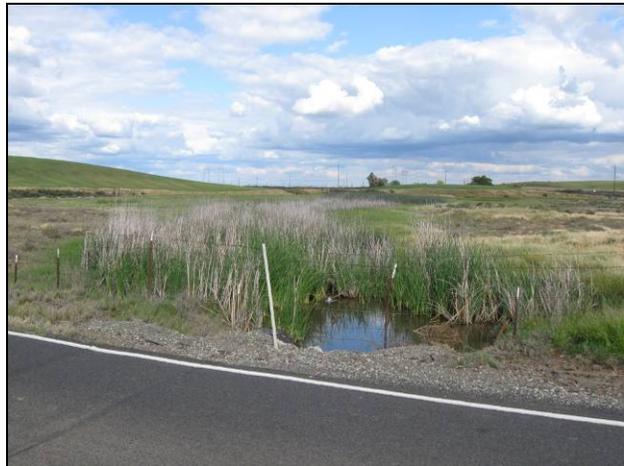
DRAINAGE WETLAND (D-3)
Looking north along east side of Bruns Road

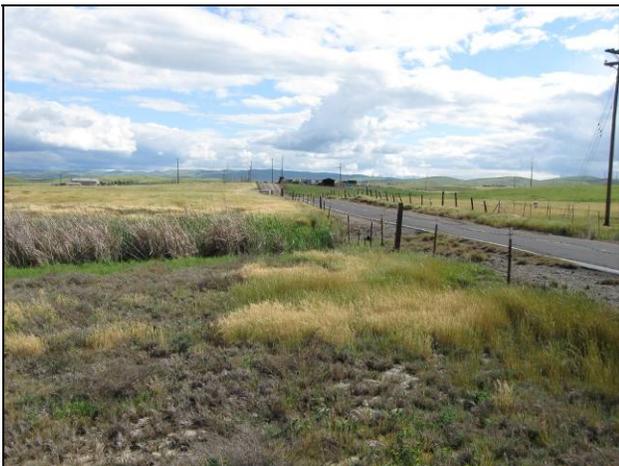
DRAINAGE WETLAND (D-4)
Looking east from Bruns Road (30-inch-diameter cmp under road)

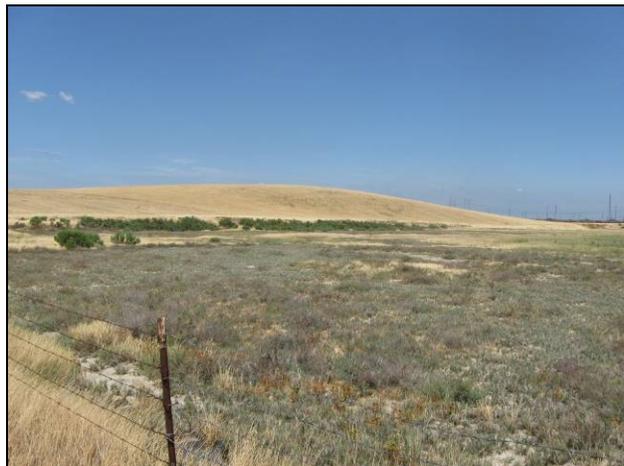
DRAINAGE WETLAND (D-4)
Adjacent alkali sink wetland; looking south along Bruns Road

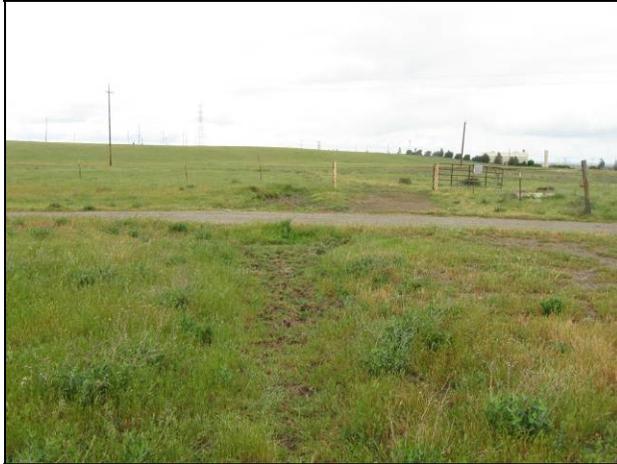
ALKALI SINK WETLAND (ASW-1)
Looking northeast from Bruns Road

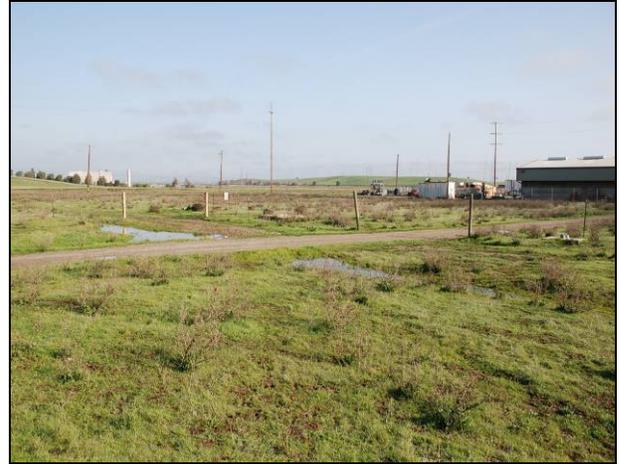
SEASONAL WETLAND (SW-1)
Looking north, basins connected via 18-inch-diameter cmp

Remarks: Small concave depressional areas along gravel access road to the Byron CoGen Plant connected by a partially crushed 18-inch diameter culvert. Problematic area: seasonal wetland hydrology; no hydric soil indicators were noted but were presumed to meet the definition of a hydric soil as noted in the remarks.
