Subject: Mariposa Energy Project, Clean Water Act Section 401 Water Quality Certification Application

**CALIFORNIA REGIONAL WATER QUALITY CONTROL BOARD
CENTRAL VALLEY REGION**

**SECTION 401 WATER QUALITY CERTIFICATION
APPLICATION FORM**

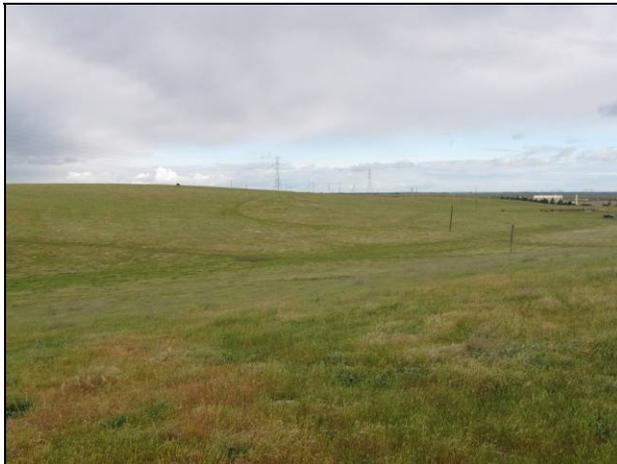
SEASONAL WETLAND (SW-1)
Inundated on February 19, 2009

Remarks: Basin was dry at the time of the survey, but seasonal inundation and aquatic invertebrates were observed in this location during field surveys in February 2009. In addition, the defined topographic basin with an abrupt boundary with the adjacent grassland, abundance of OBL and FACW vegetation, and deep cattle prints all suggest prolonged seasonal saturation and/or inundation occurs at this sample location.

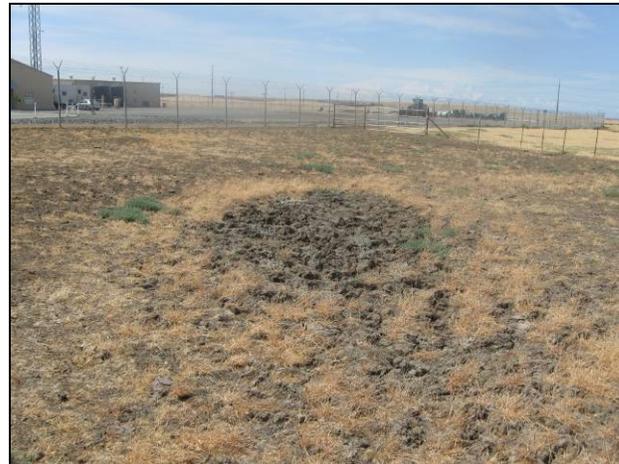
PROJECT SITE
Low upland swale through center of site—no change in vegetation or evidence of any type of flow through this area

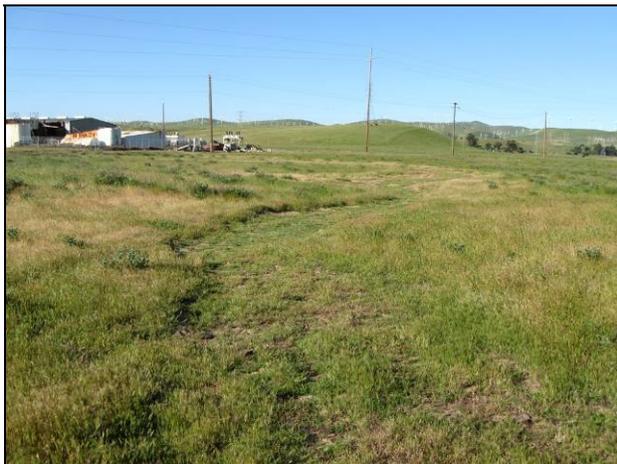
SEASONAL WETLAND (SW-2)
Weakly expressed shallow area with Italian ryegrass and sparse coyote thistle

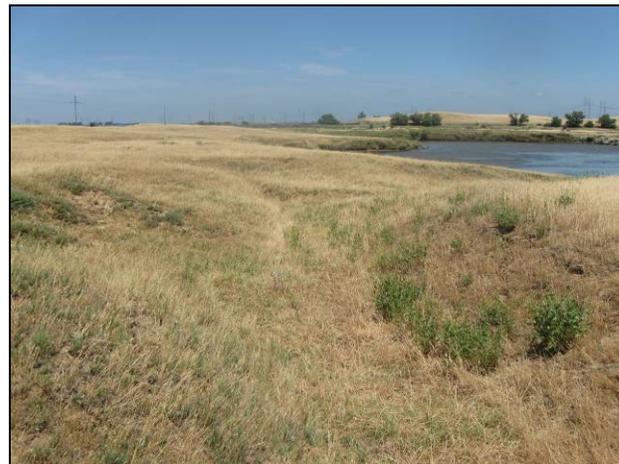
SWALE (SW-1)
Looking west

Three weakly expressed, low topographic swales were observed in the Project area. Two swales were observed along the transmission line route south of Kelso Road (Figure 2-1; Map 2) and one swale was observed along the service water pipeline route north of Drainage Wetland D-3 (Figure 2-1; Map 3).

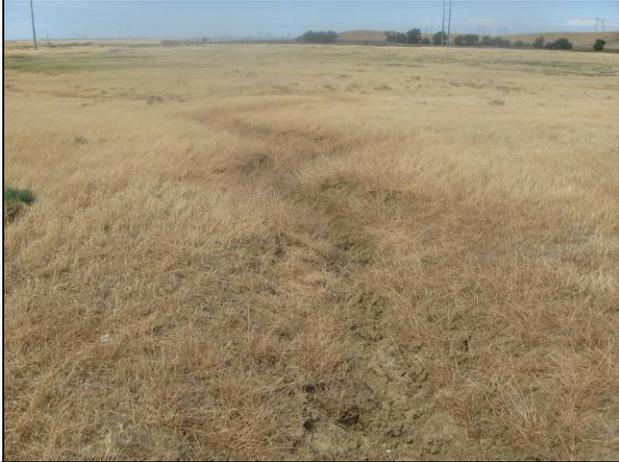
SWALE (SW-3)
Looking east from Bruns Road

The third swale (SW-3), is found along the water supply line, just north of Drainage D-3 on the east side of Bruns Road. A 12-inch-diameter cnp is located under the road just west of the swale feature. Within the Project study area, the swale is generally weakly expressed and exhibits no ordinary high-water mark or evidence of recent flow. Vegetation in this area is similar to the adjacent California annual grassland and includes species such as soft chess, Italian ryegrass, and saltgrass with scattered gumweed, alkali heath, and coyote thistle. To the east of the Project study area, closer to the open water, the swale is characterized by a dense cover of lush saltgrass. Because this swale appears to convey very infrequent and low-volume flows and short-duration flow, it was not considered to be subject to jurisdiction under the Federal CWA.

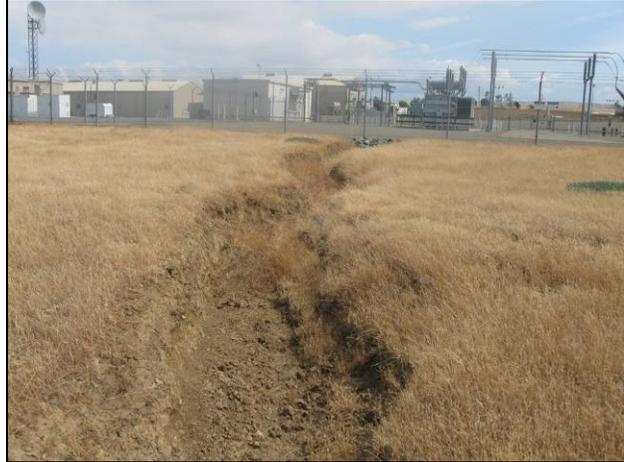
E-1
Small erosional rill; looking north; flows north into seasonal wetland area

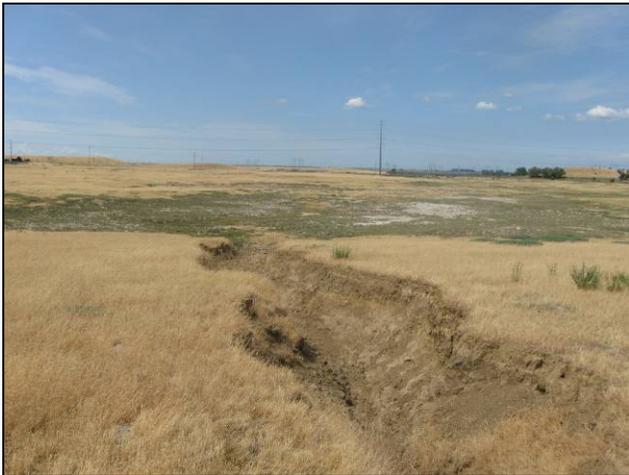
E-2
Erosional feature; looking south toward the PG&E Kelso Substation

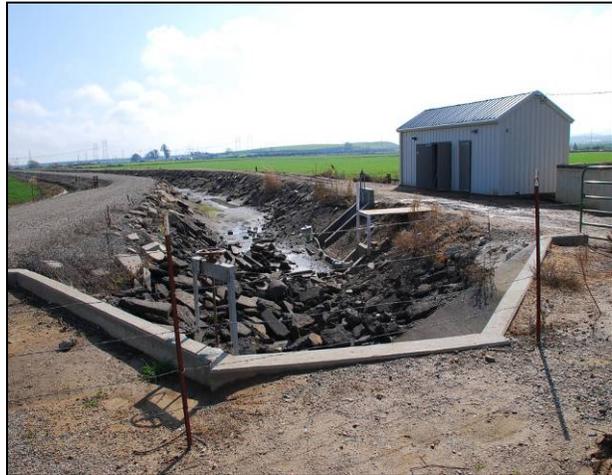
BBID CANAL 45
Looking east from Bruns Road

Temporary fill within the wetland (ASW-1) and drainage areas (D-2 and Canal 45) would result from incidental fall back during excavation activities. Concrete will be used to encase the pipe at the bottom of a 4-foot-deep trench at D-2 and ASW-1. Permanent fill at Canal 45 will result from installation of the new 36 square foot concrete intake structure on the bank of the canal. All temporary impacts will be restored to pre-construction conditions.

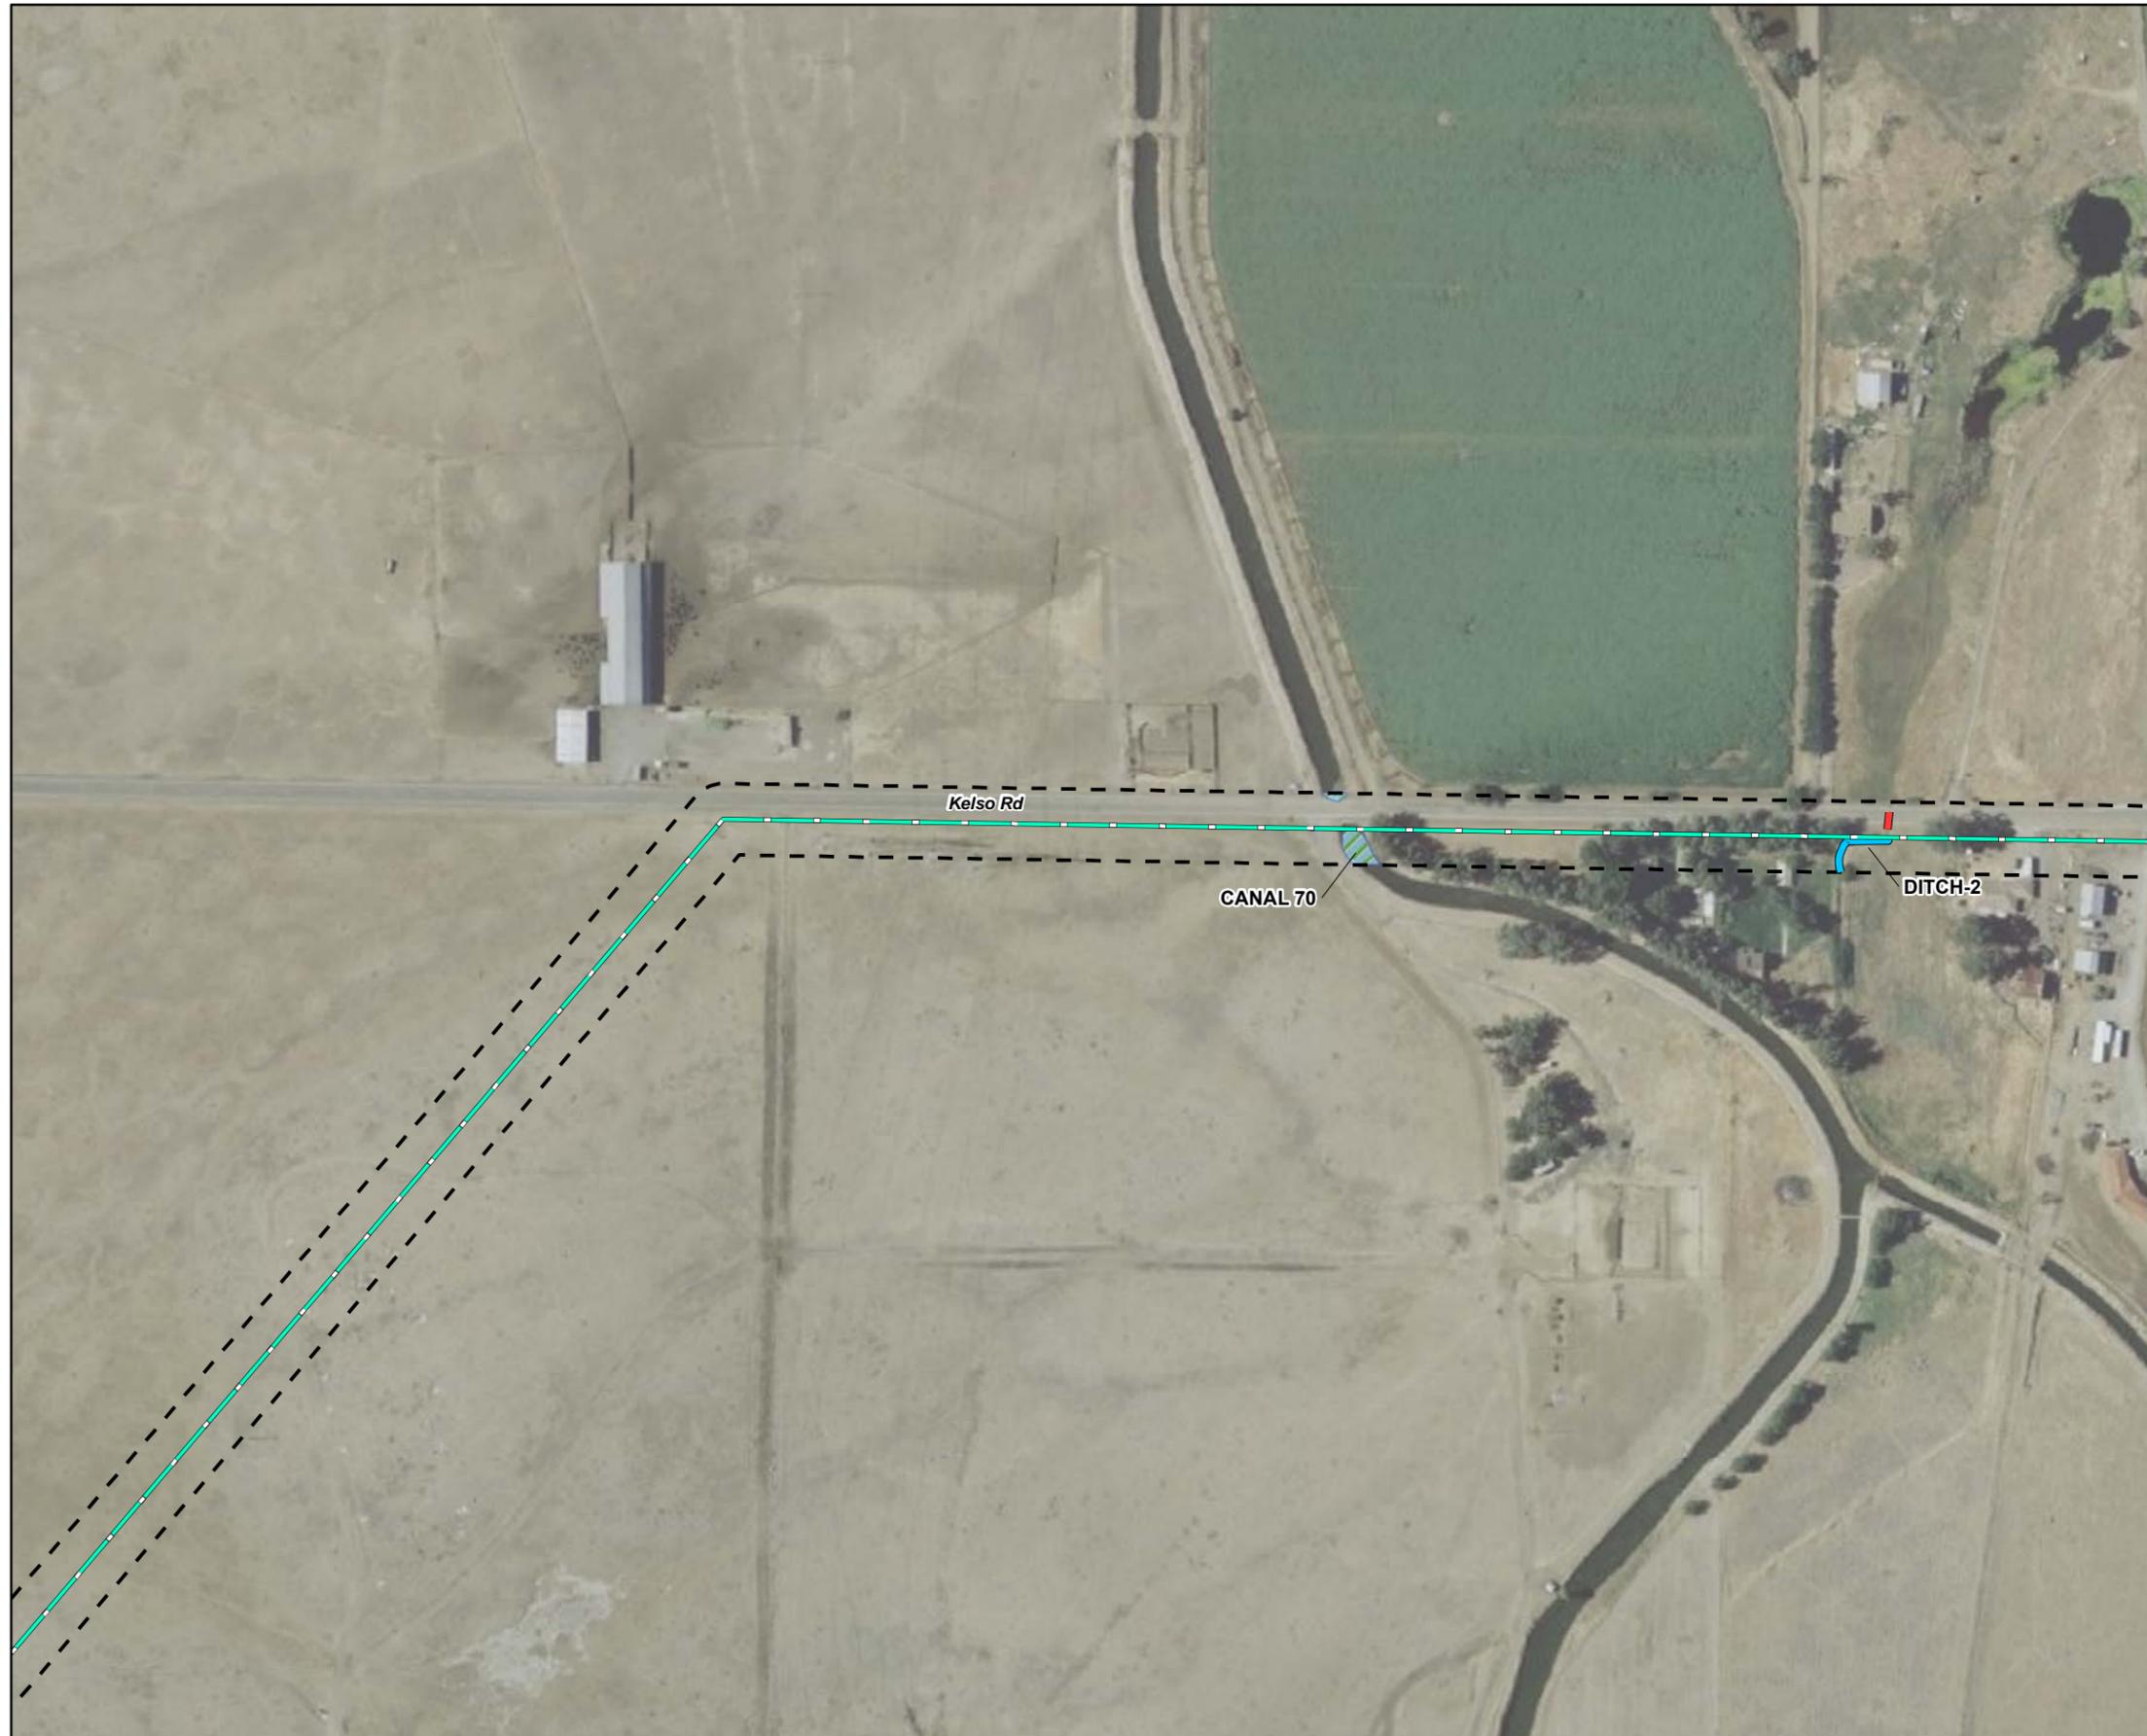
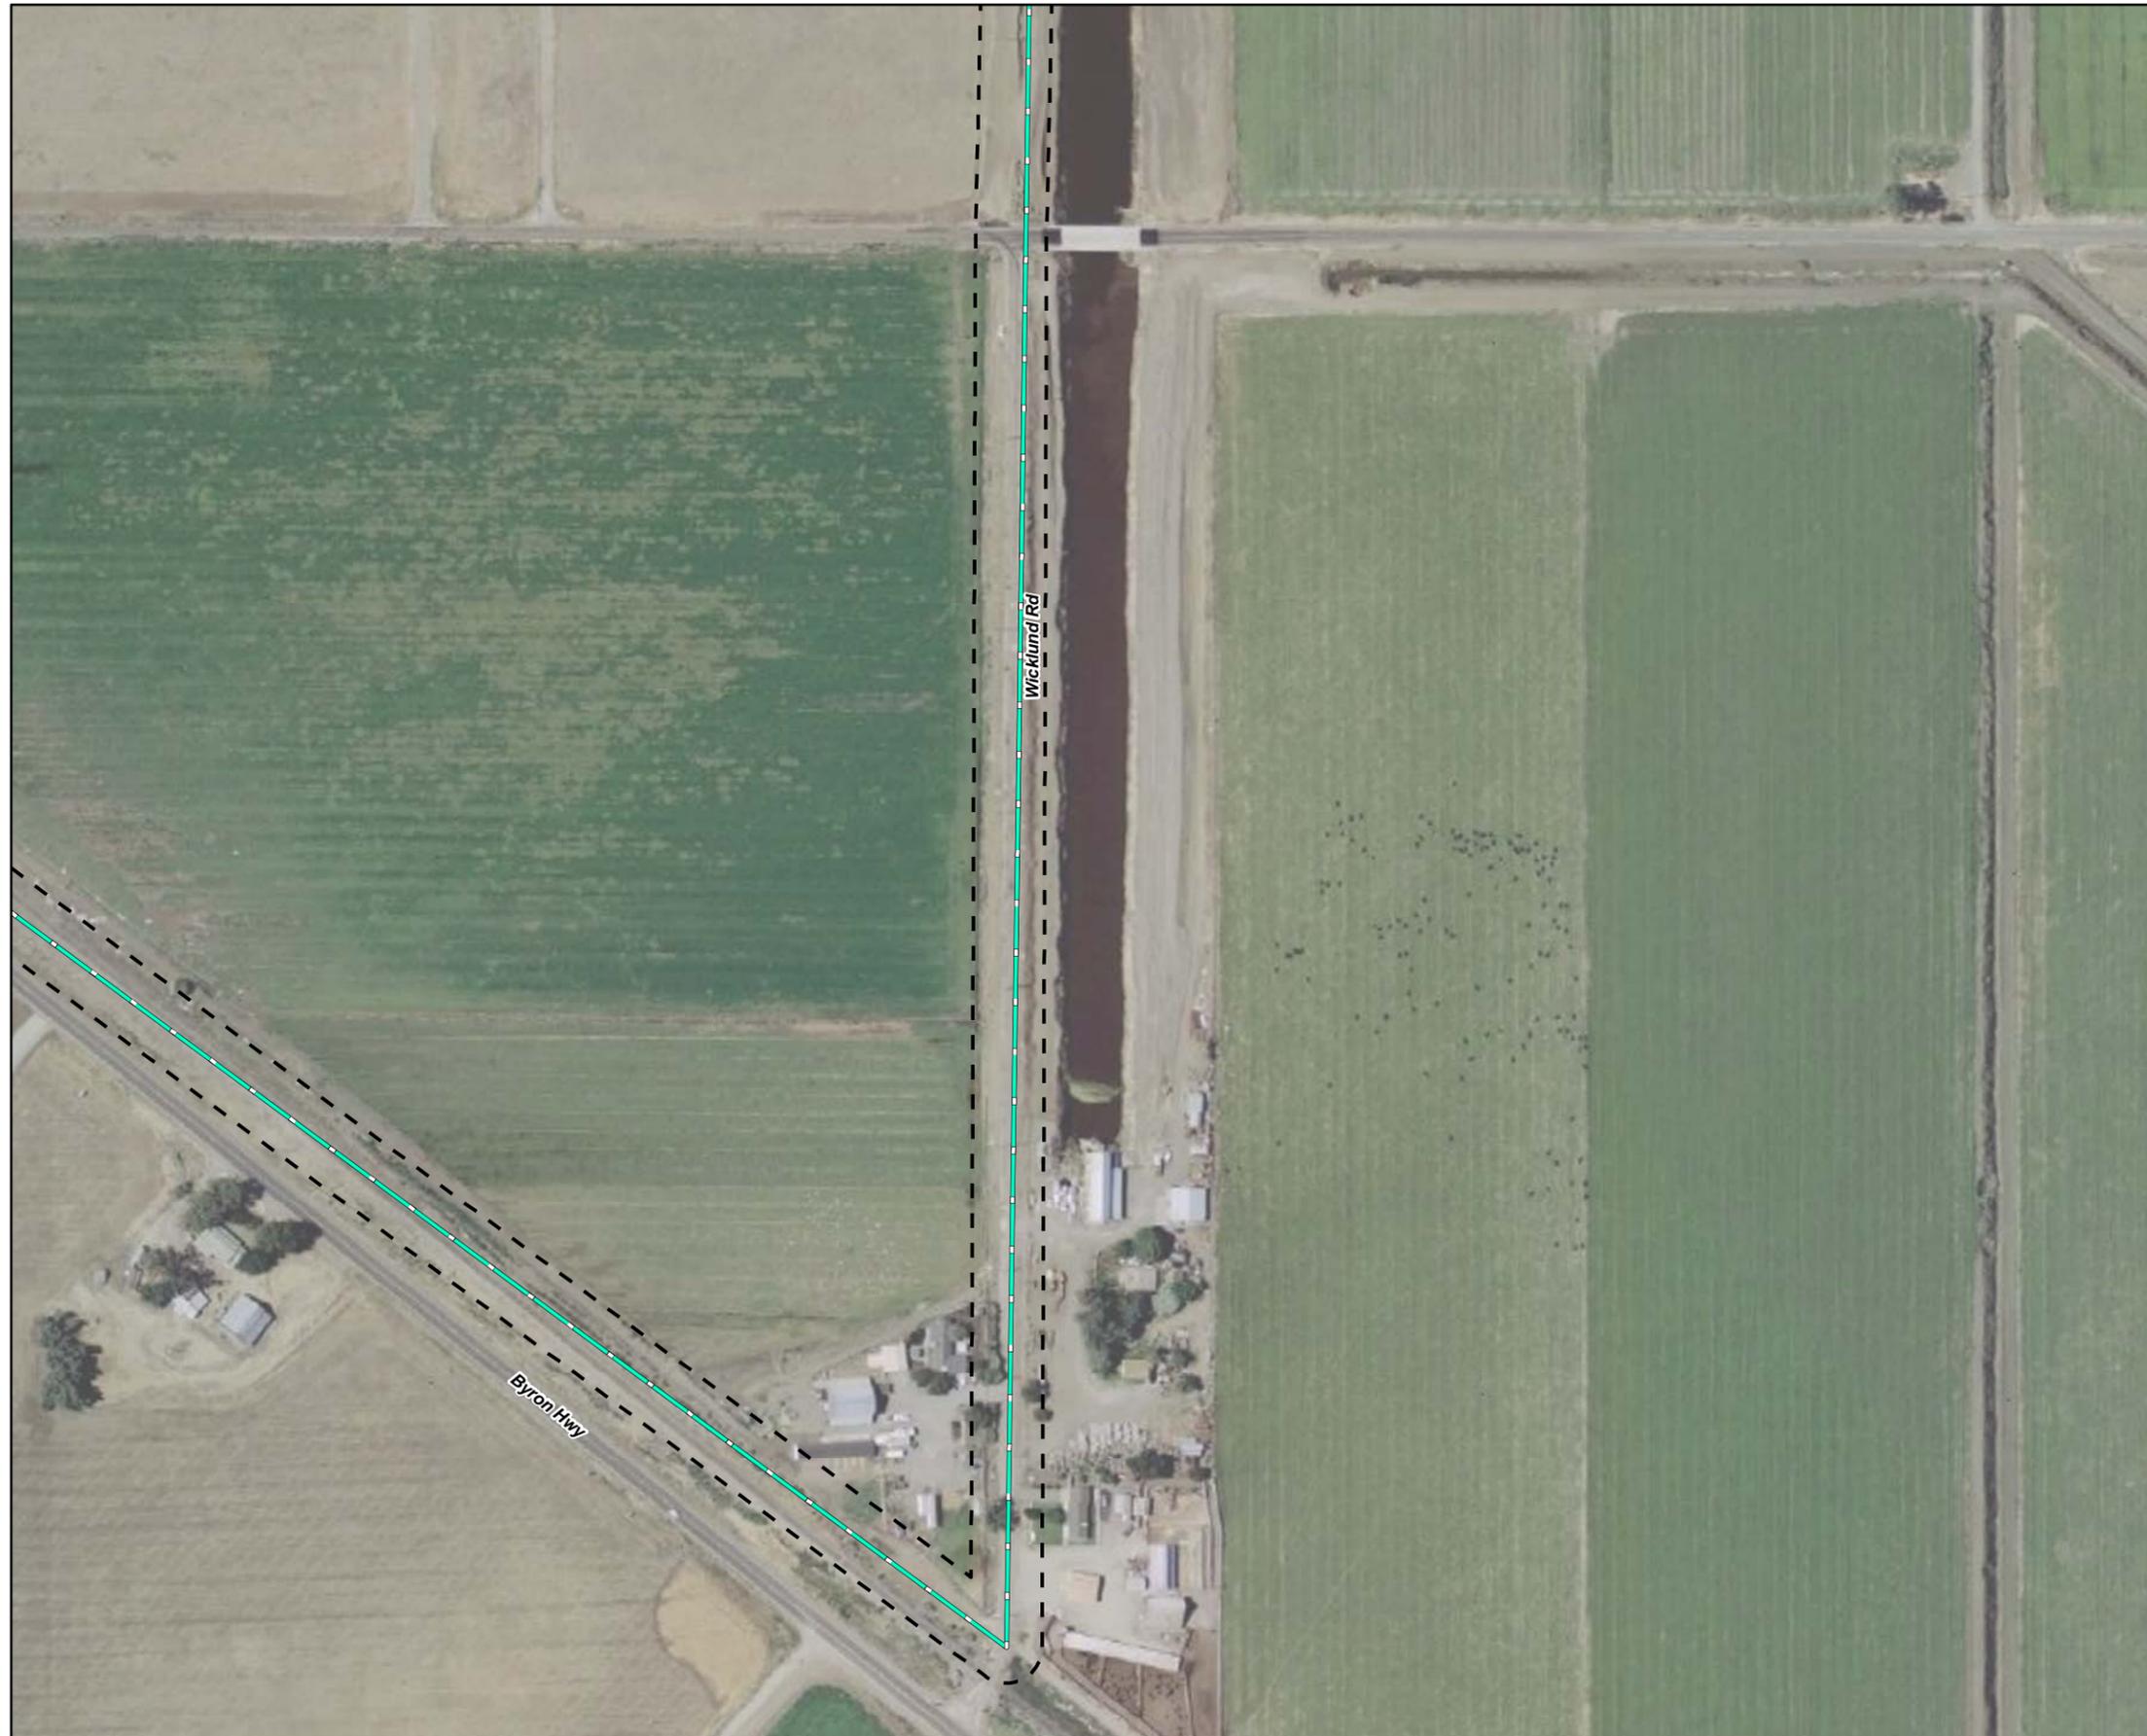
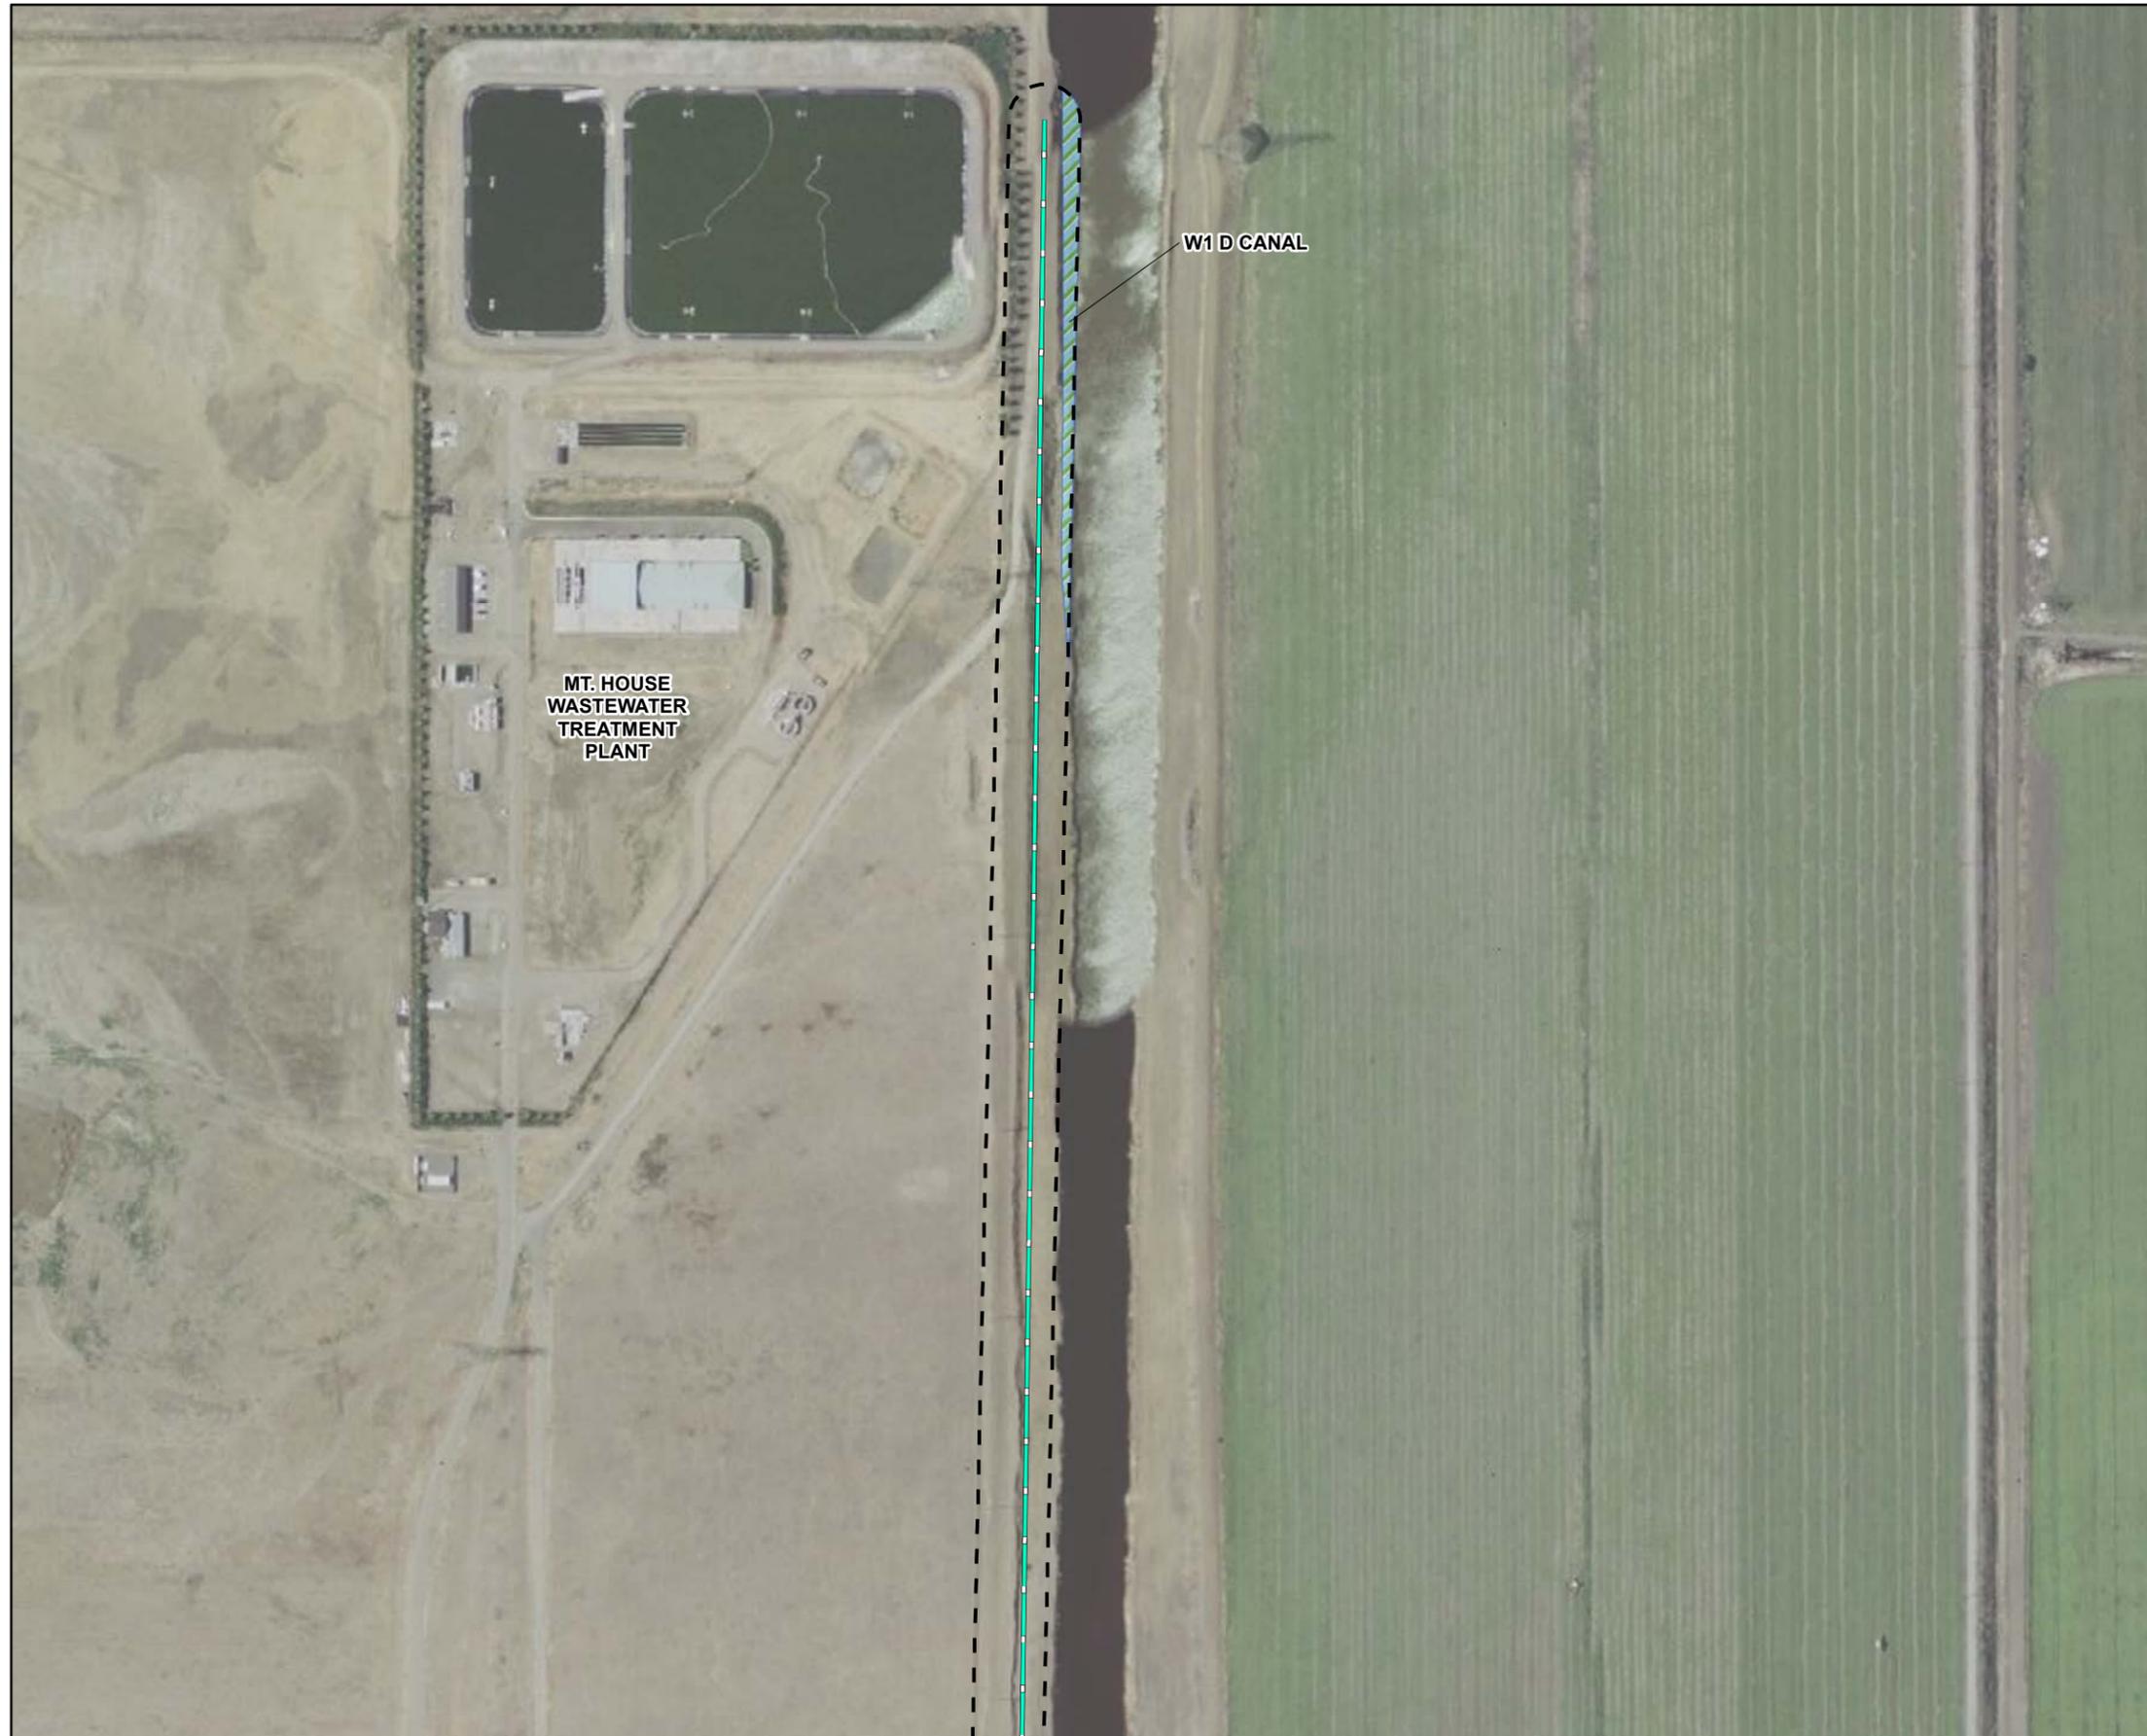
FIGURE 2-2
WETLAND DELINEATION
 MARIPOSA ENERGY PROJECT
 ALAMEDA COUNTY, CALIFORNIA

Delineation: T. Ellwood November 2, 2009
 Revised: November 19, 2009

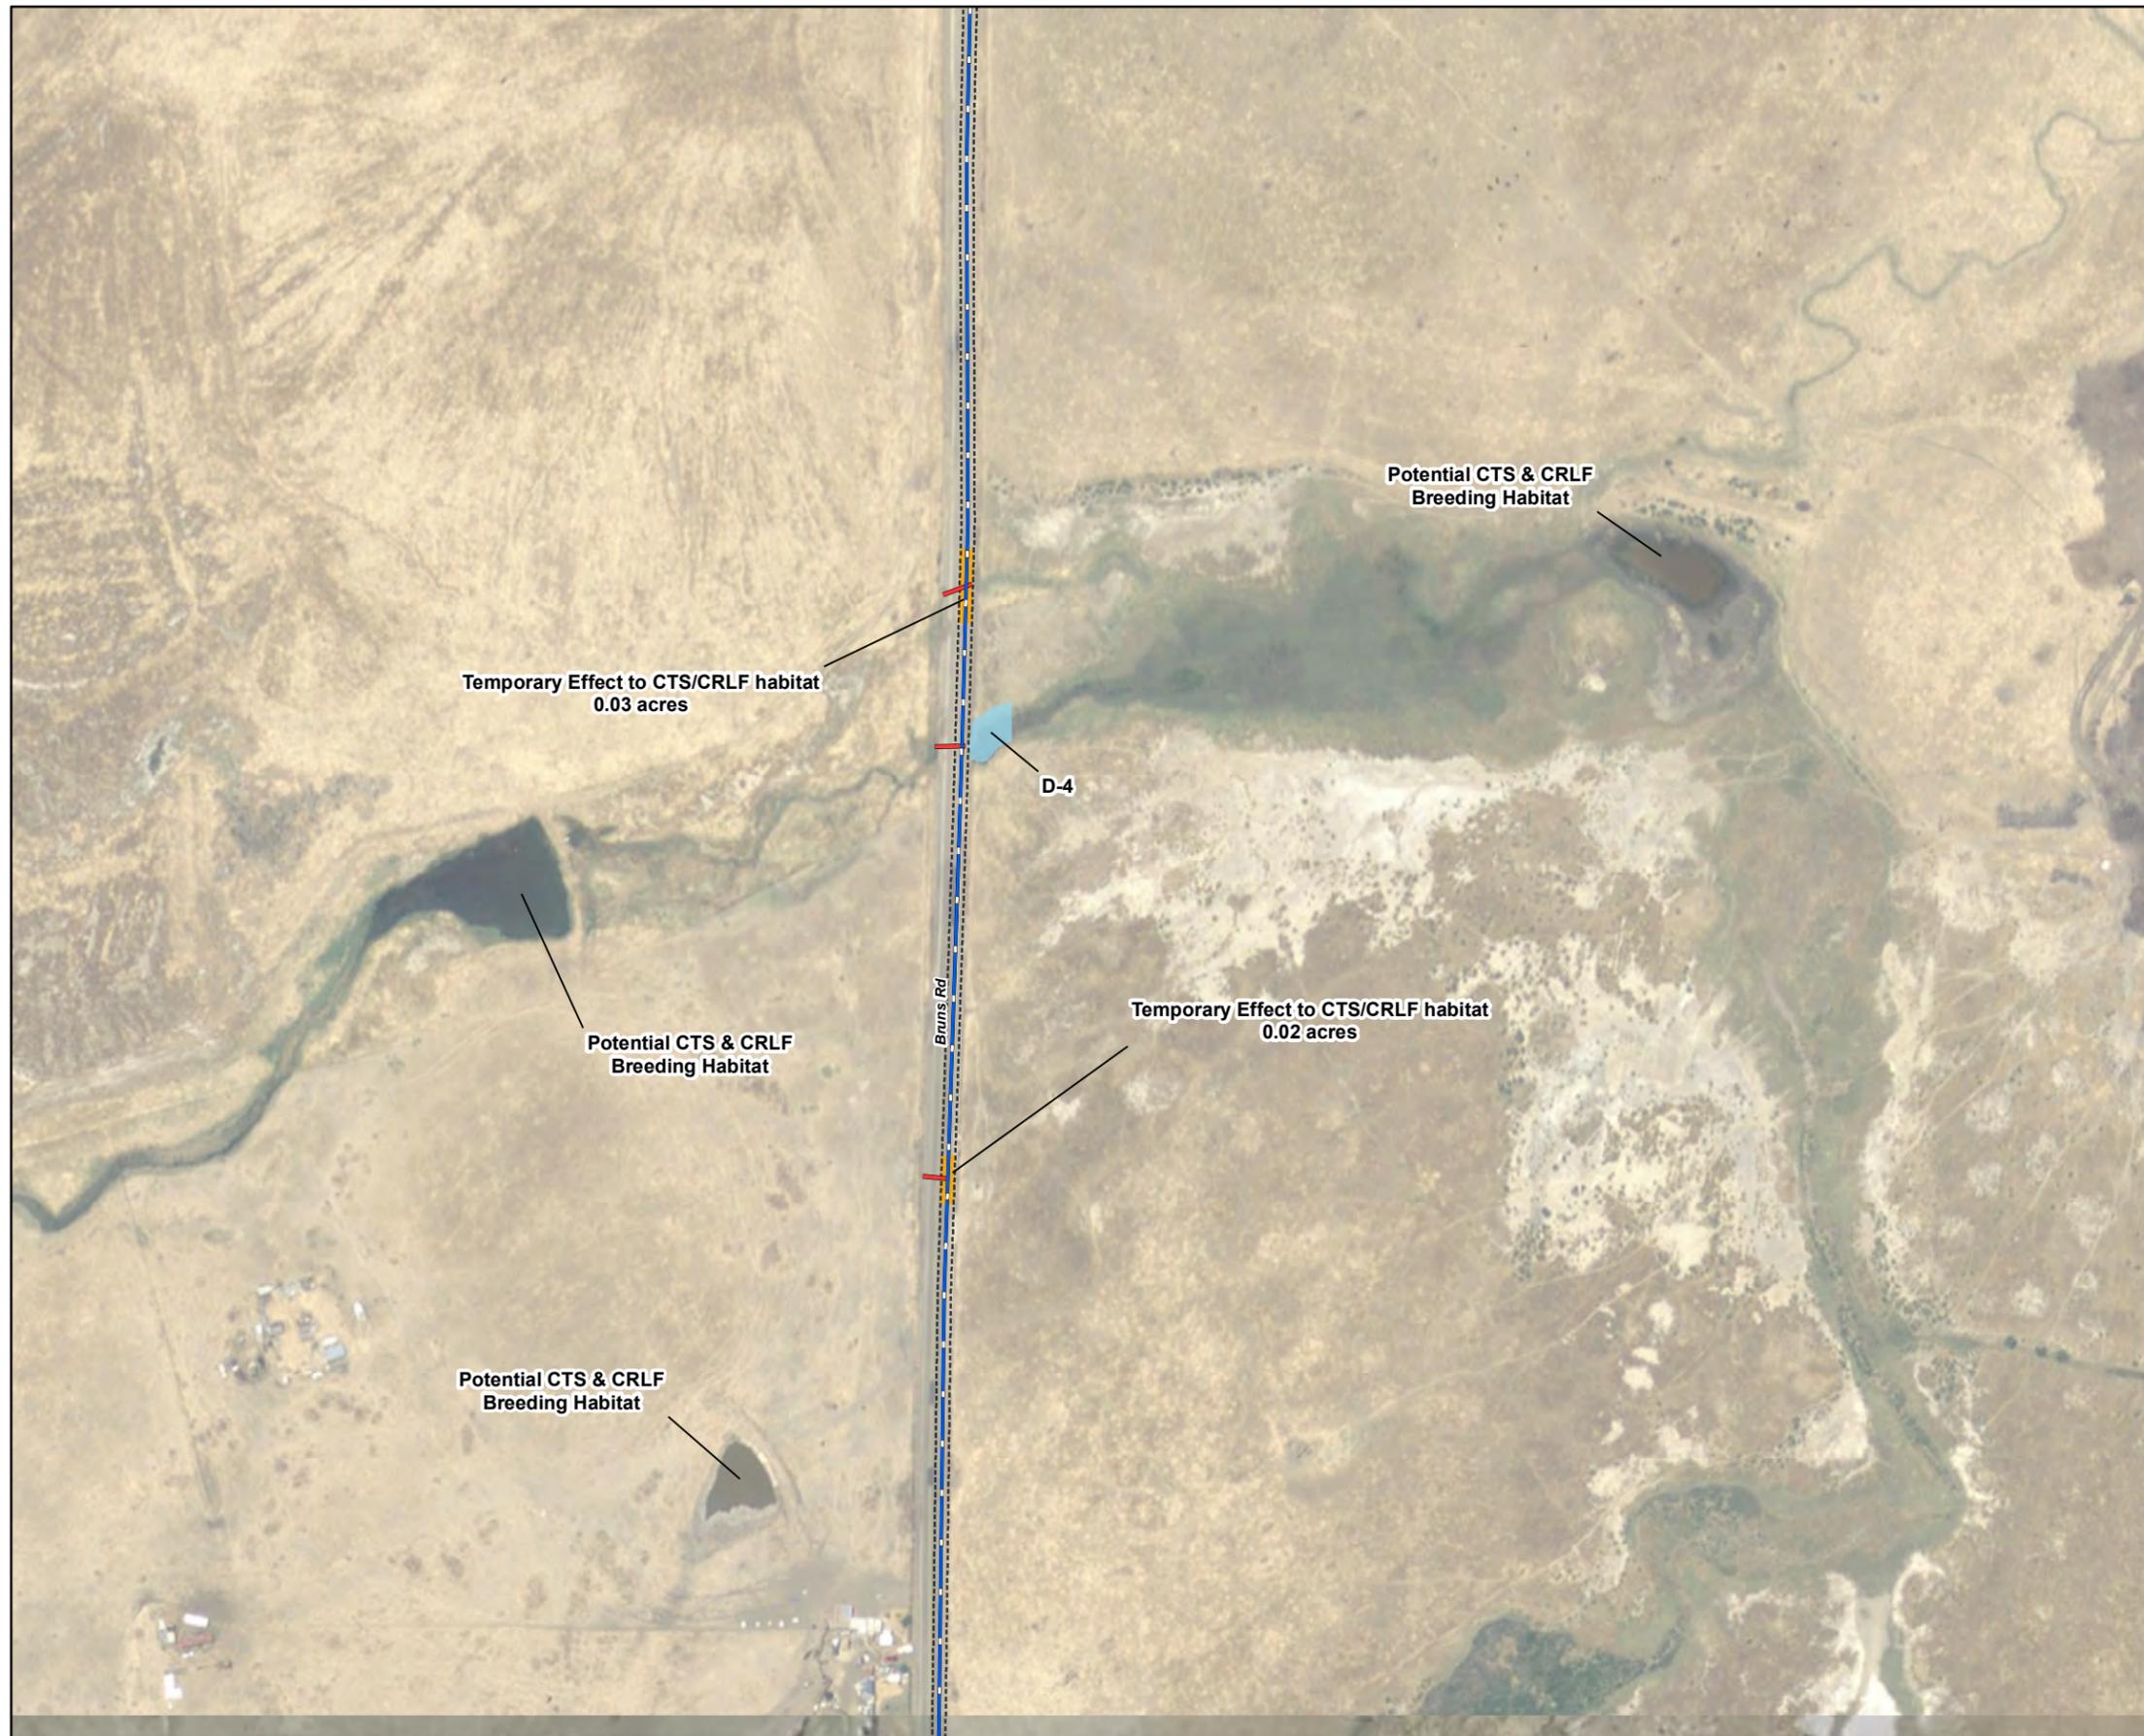
FIGURE 5A
CALIFORNIA TIGER SALAMANDER
AND CALIFORNIA RED-LEGGED FROG
AREA AFFECTS
 MARIPOSA ENERGY PROJECT
 ALAMEDA COUNTY, CALIFORNIA

NOTE: CTS - California Tiger Salamander, CRLF - California Red-Legged Frog. The entire project area is suitable San Joaquin Kit Fox habitat.

Protocol-level surveys were not conducted, because presence of the federally listed amphibian species is being inferred. All suitable dispersal and aestivation habitat within the action area were mapped using GPS or digitized in GIS, as shown on Figures 5A through 5E. Temporary and permanent loss of California tiger salamander dispersal and aestivation habitat was quantitatively determined based on the proximity of known CNDDDB breeding sites less than 100 feet from the action area (shown on Figure 5D) and other potential breeding sites in the vicinity. The acreage calculation included all affected terrestrial areas within the action area, as California tiger salamander are known to disperse into uplands up to and greater than 1.24 mile from breeding sites. No barriers (for example, road curbing or canals) between the known breeding sites and the action area would preclude California tiger salamander dispersal.

Table 6-1 presents the total temporary and permanent construction effects of the proposed project on federally listed species habitats. Figures 5A, 5B, 5C, 5D, 5E, and 5F illustrate these affected areas and acreages.

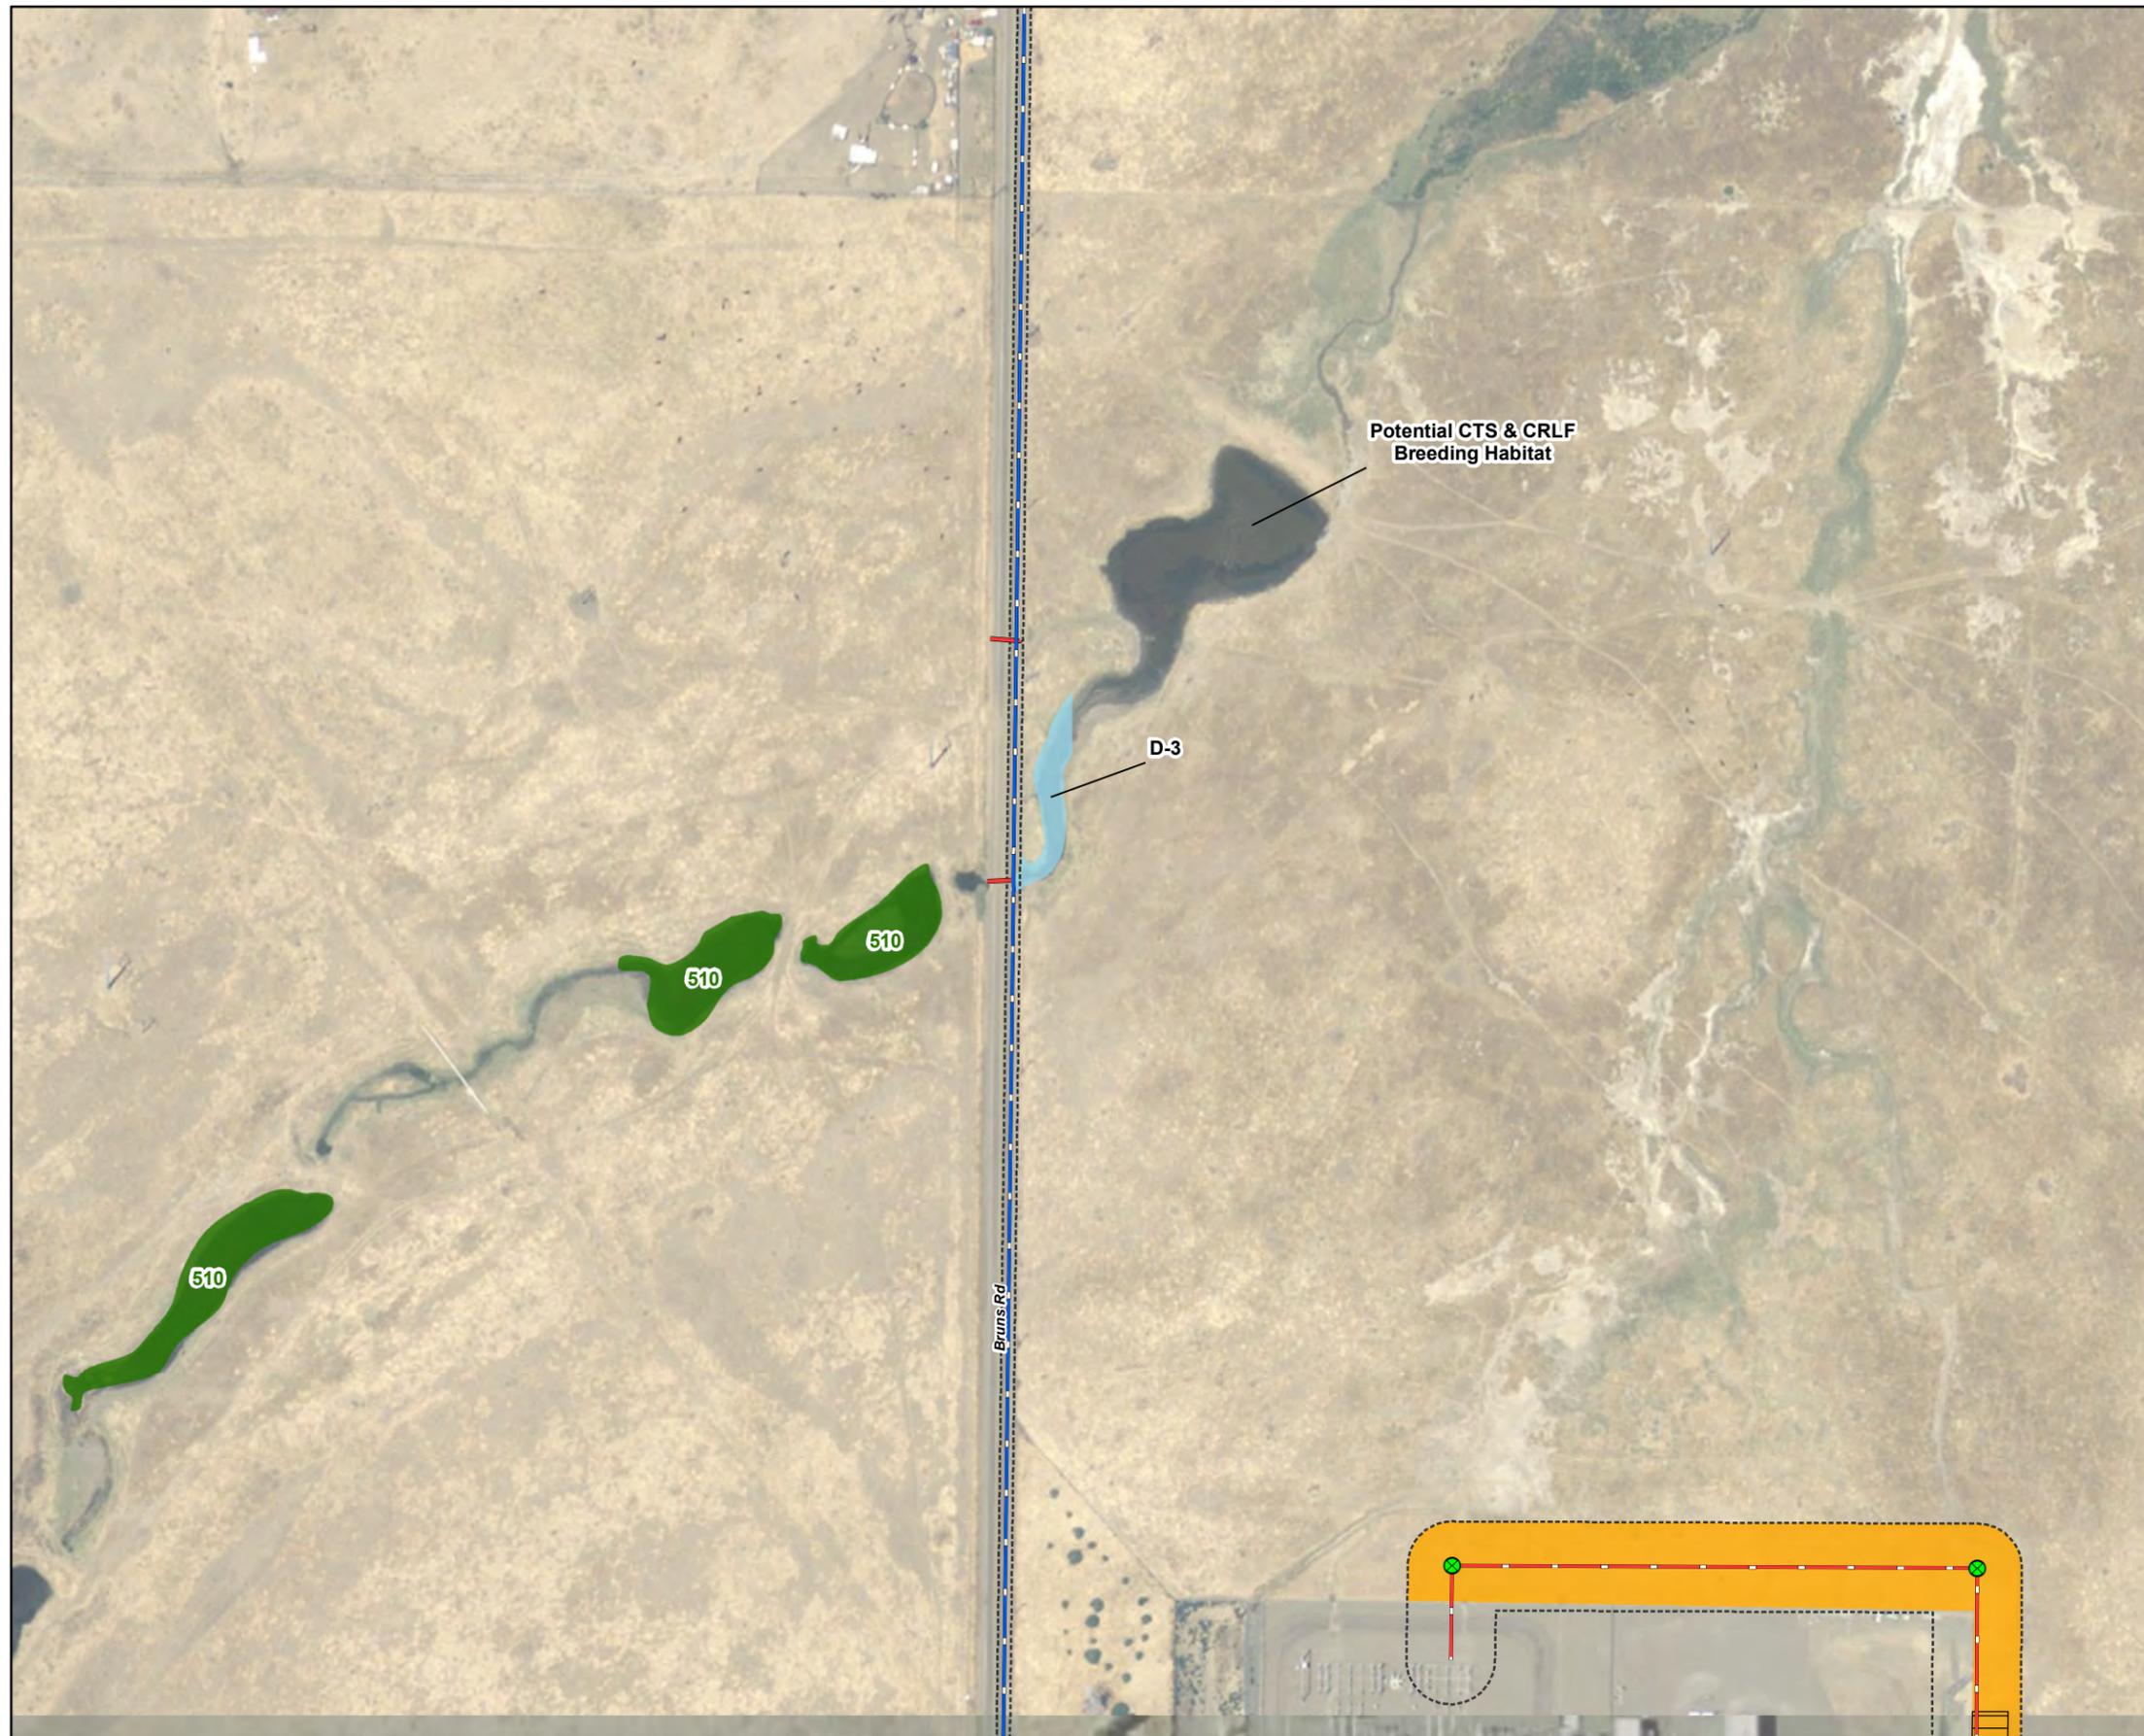
FIGURE 5B
CALIFORNIA TIGER SALAMANDER
AND CALIFORNIA RED-LEGGED FROG
AREA AFFECTS
 MARIPOSA ENERGY PROJECT
 ALAMEDA COUNTY, CALIFORNIA

NOTE: CTS - California Tiger Salamander, CRLF - California Red-Legged Frog. The entire project area is suitable San Joaquin Kit Fox habitat.

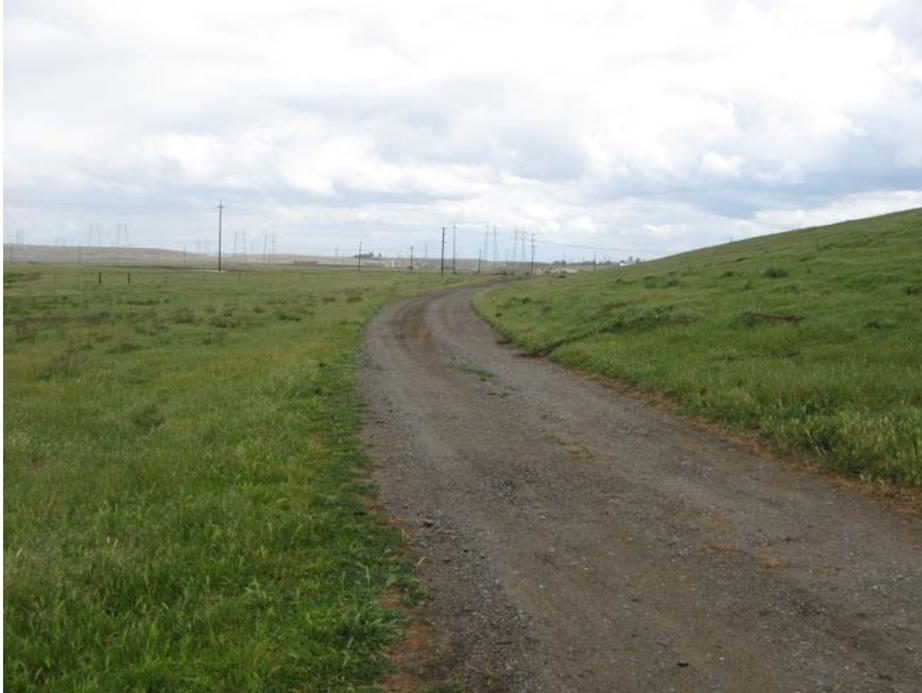
#1: Photograph taken April 8, 2009, facing northeast. Existing parcel gravel access road servicing the 6.5 MW Byron Cogen Power Plant. This road will be widened and paved during MEP construction.
