Subject: Mariposa Energy Project, Clean Water Act Section 401 Water Quality Certification Application

**CALIFORNIA REGIONAL WATER QUALITY CONTROL BOARD
CENTRAL VALLEY REGION**

**SECTION 401 WATER QUALITY CERTIFICATION
APPLICATION FORM**

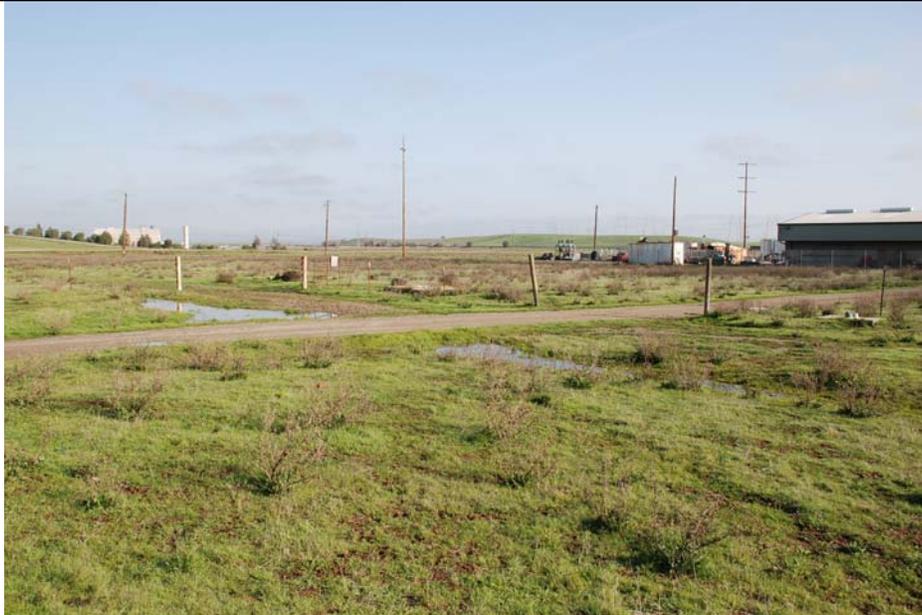
#4: Photograph taken February 19, 2009, facing north. The 6.5 MW Byron Cogen Power Plant is shown on the right side. The inundated seasonal wetland (SWL-1) shown near the center of this photograph supports *Branchinecta* species.

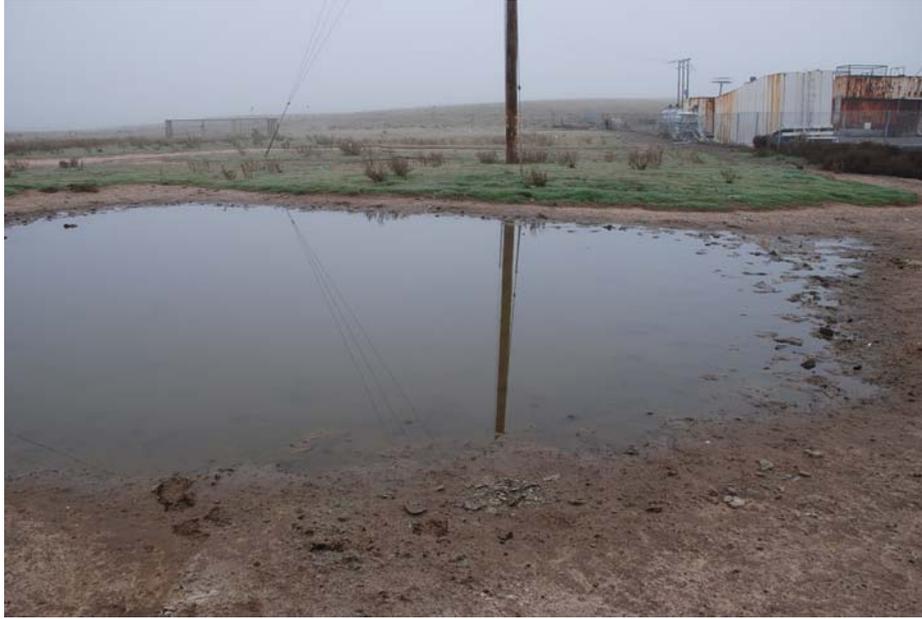
#5: Photograph taken December 31, 2008, facing southeast. Inundated depression located near northeast corner of the 6.5 MW Byron Cogen Power Plant. California fairy shrimp (*Lindieriella occidentalis*) observed in this seasonal pool on November 2, 2009.

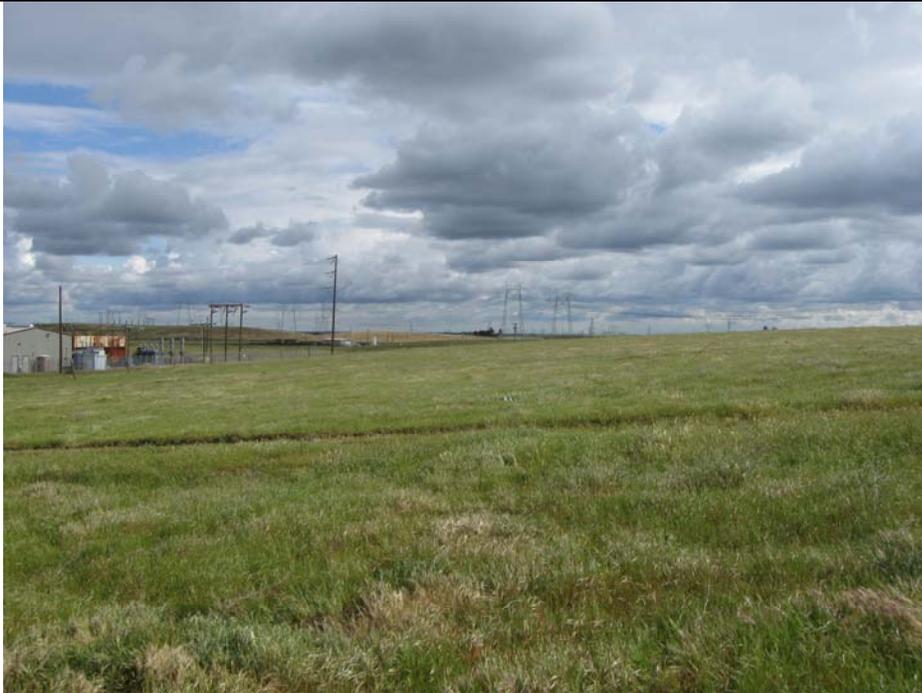
#6: Photograph taken April 8, 2009, facing east. Representative view of the proposed natural gas pipeline route. The 6.5 MW Byron Cogen Power Plant is on the left side of this photograph.

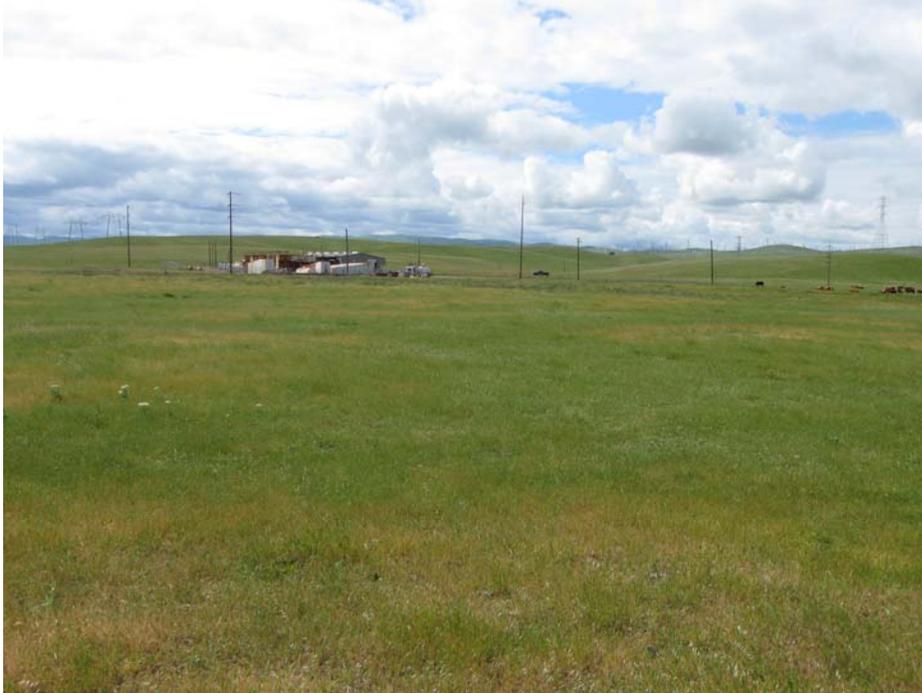
#7: Photograph taken April 8, 2009, facing south. Representative view of the proposed transmission line route. The 6.5 MW Byron Cogen Power Plant is in the background.

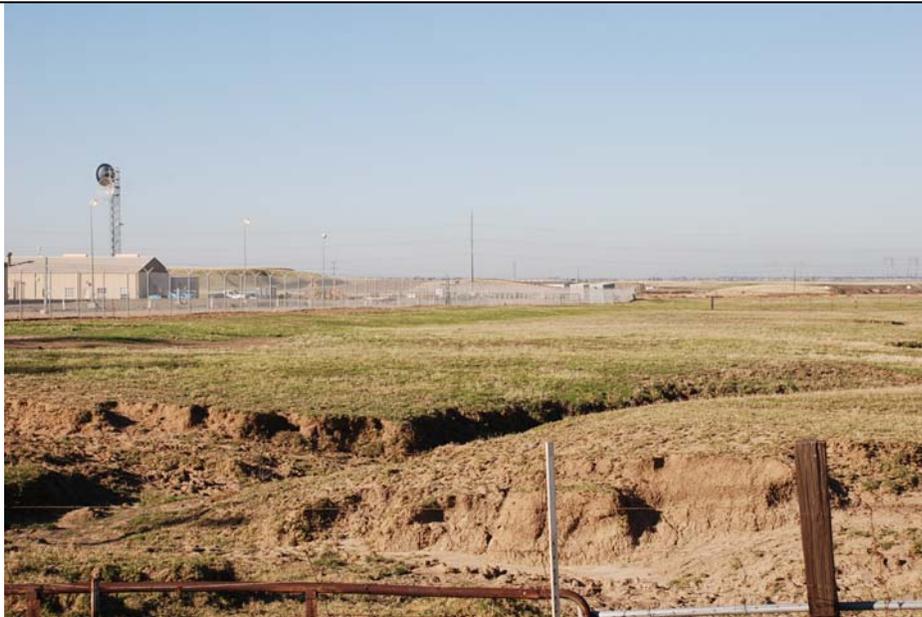
#8: Photograph taken November 2, 2009, facing north. The temporary staging area for the MEP transmission line will be along the chain link fence in the background. A continuation of D-1 is shown here in the foreground. Moderate to heavy cattle grazing occurs on this property.

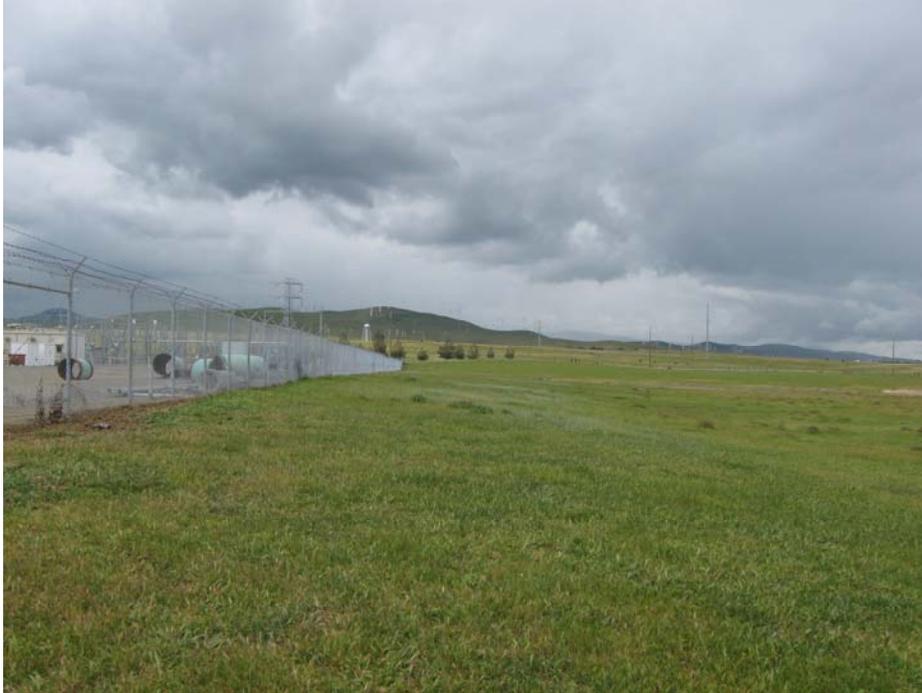
#9: Photograph taken April 8, 2009, facing west. This area is located on the north side of PG&E's Kelso Substation, a location where the MEP transmission line will interconnect with the existing power grid.

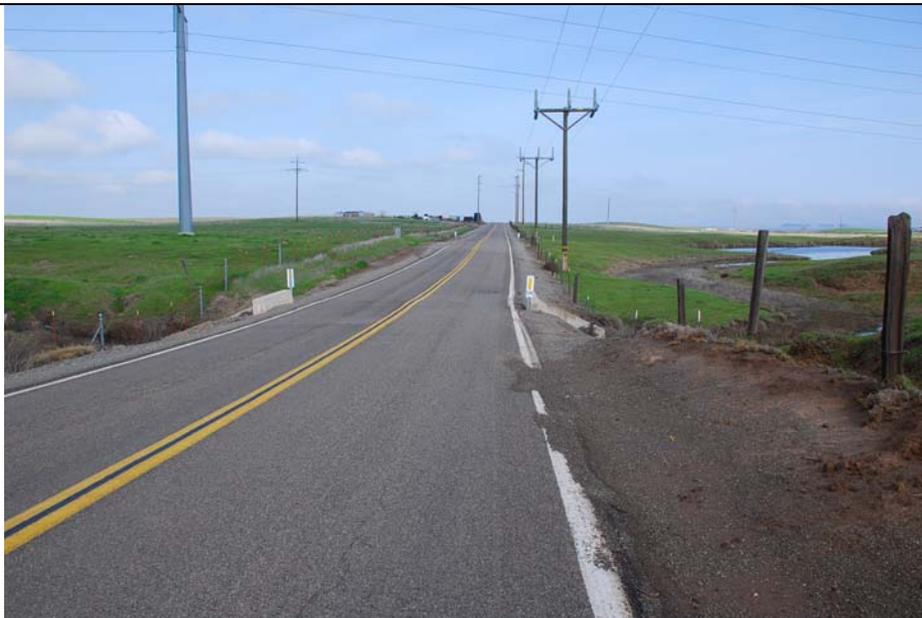
#10: Photograph taken February 19, 2009, facing north. Representative view of the proposed water supply pipeline route along Bruns Road.

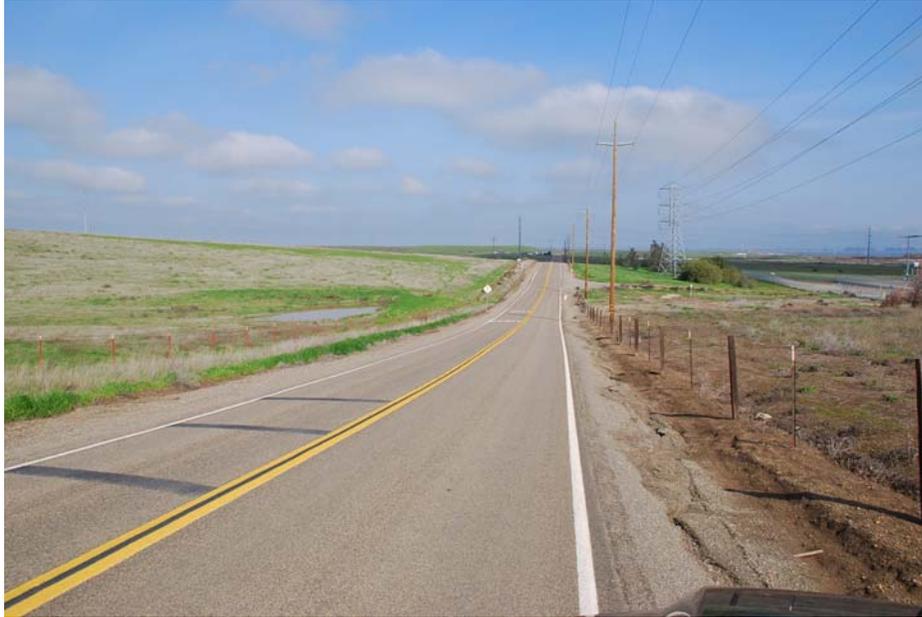
#11: Photograph taken November 2, 2009, facing north. Representative view of the proposed water supply pipeline route along Bruns Road. A known breeding site for California tiger salamander shown here on the left (west) side of Bruns road. The stock pond is associated with D-2 (**Photo #13**).

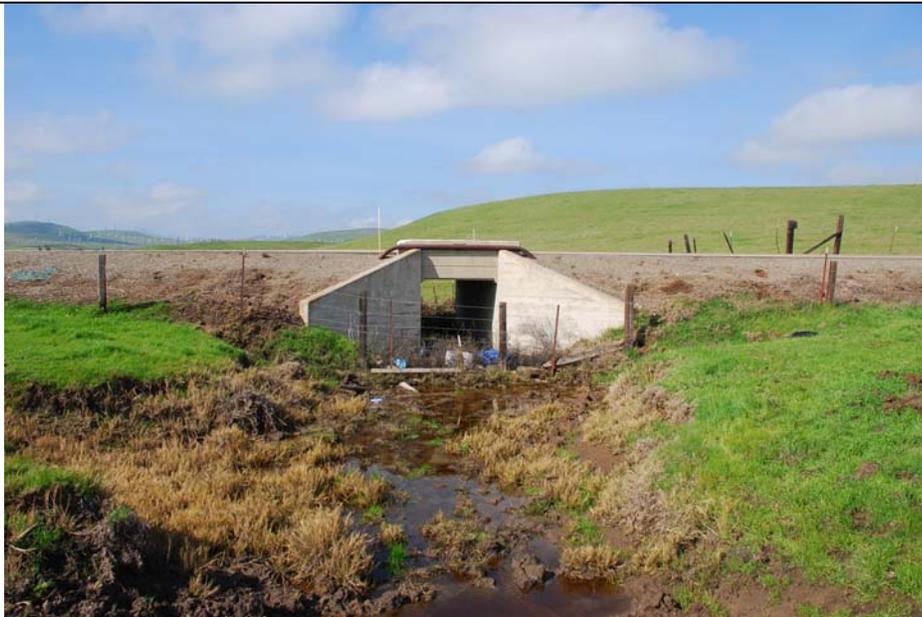
#12: Photograph taken on February 19, 2009, facing west. Ephemeral drainage (D-1) at Bruns Road along the water supply pipeline route. D-1 provides suitable dispersal habitat for California red-legged frog and California tiger salamander.

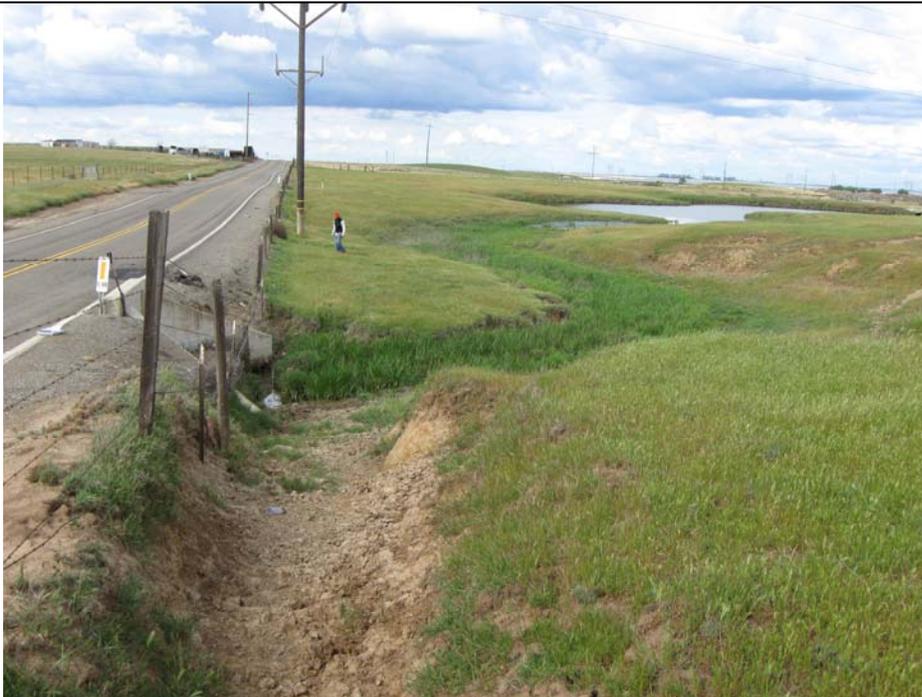
#14: Photograph taken on April 8, 2009, facing north. Ephemeral drainage (D-3) at Bruns Road along the water supply pipeline route. D-3 provides suitable foraging and dispersal habitat for California red-legged frog and California tiger salamander. A seasonal pond shown in the background provides potential breeding habitat for these species.

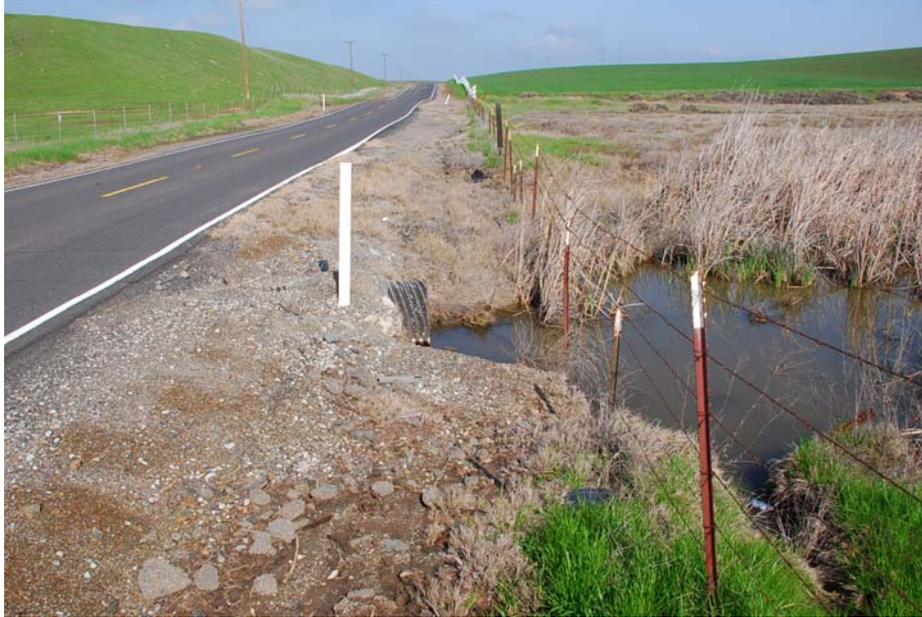
#15: Photograph taken on February 19, 2009, facing north. Ephemeral drainage (D-4) and seasonal marsh at Bruns Road along the water supply pipeline route. D-4 provides suitable foraging and dispersal habitat for California red-legged frog and California tiger salamander. The depth of ordinary high water at this location is less than 6 inches.

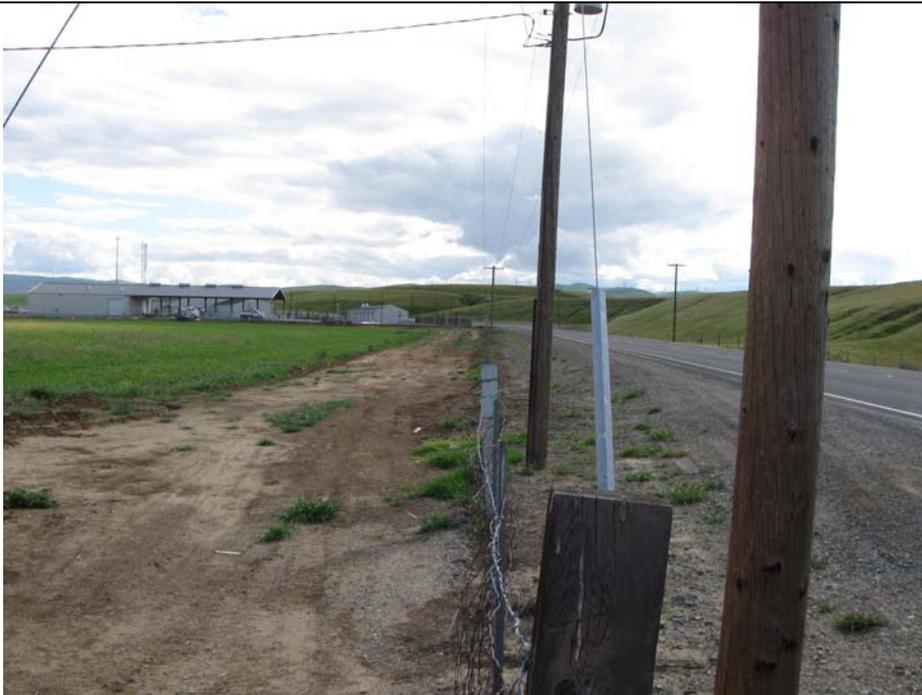
#16. Photograph taken April 8, 2009, facing south. The first 1000 feet of the MEP water supply pipeline will be installed within this BBID agricultural road.

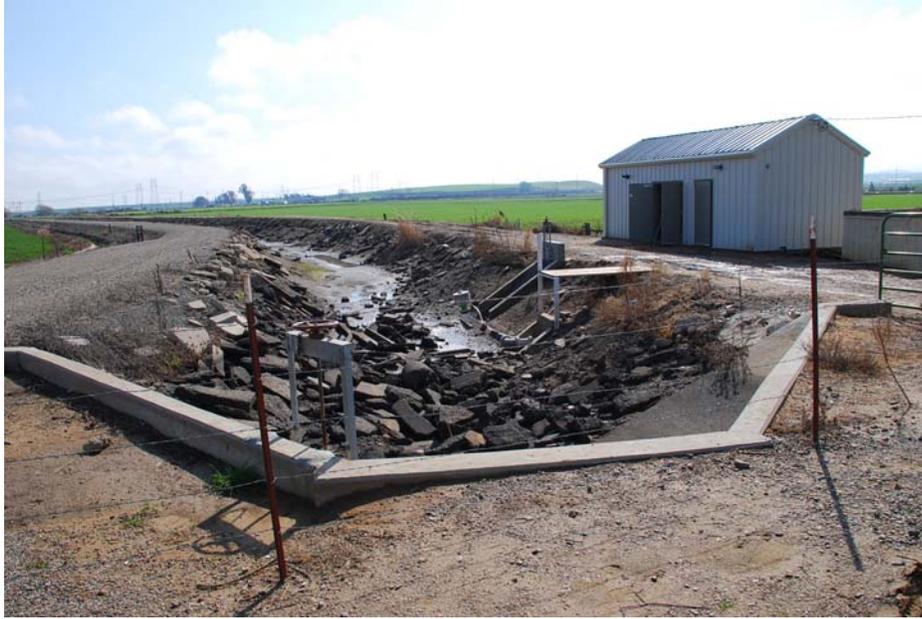
#17: Photograph taken on February 19, 2009, facing southeast. The water supply line begins at this location, the Byron Bethany Irrigation District's Canal 45. The MEP pump house and concrete turnout structure will be adjacent to the existing building and intake structures.

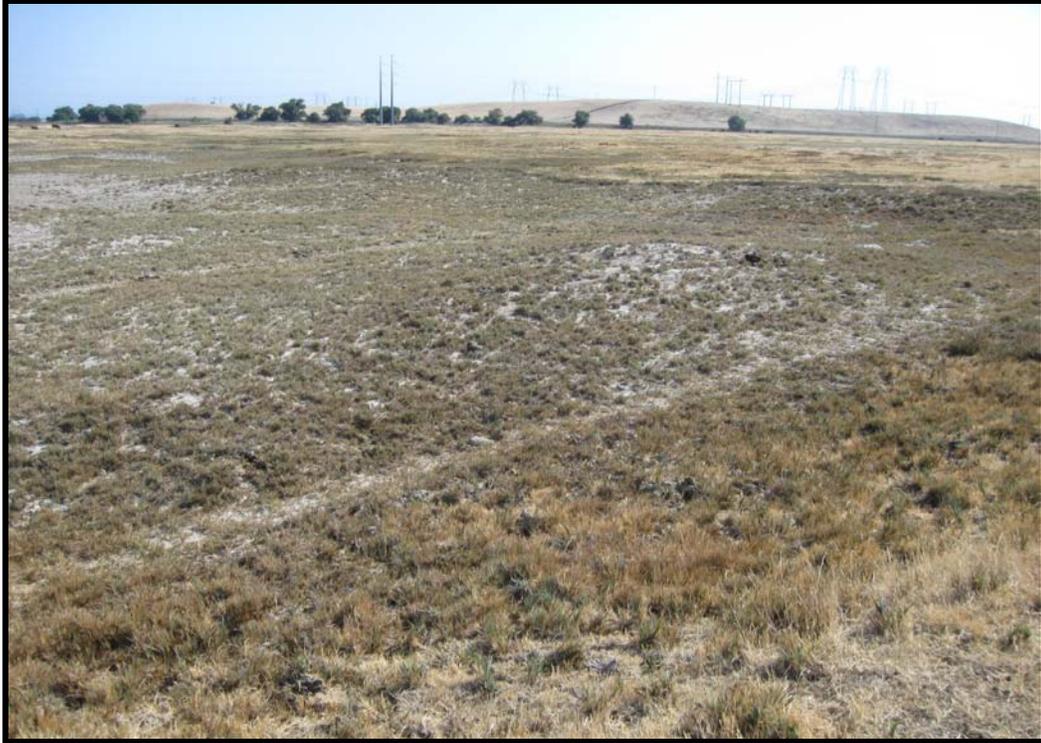
Alkaline meadow habitat north of PG&E's Kelso substation, just north of the Project survey area for the proposed transmission line; *Atriplex cordulata* (CNPS 1B) observed in this area.

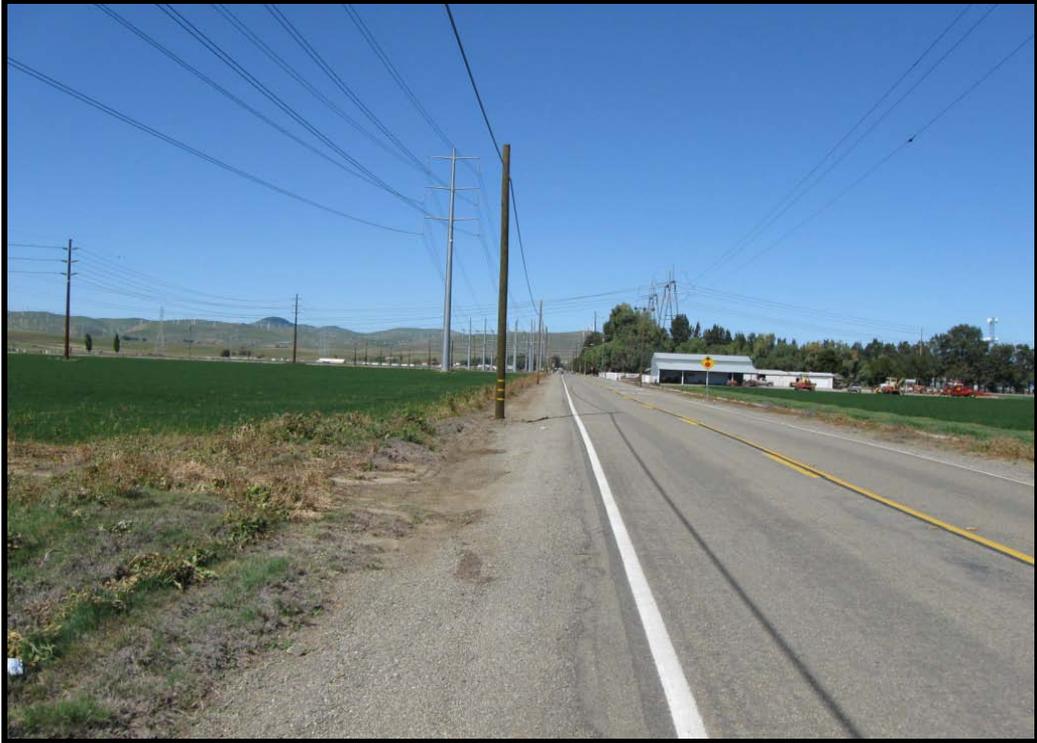
Alternate service water pipeline route; looking west along south side of Kelso Road, east of Mountain House Parkway

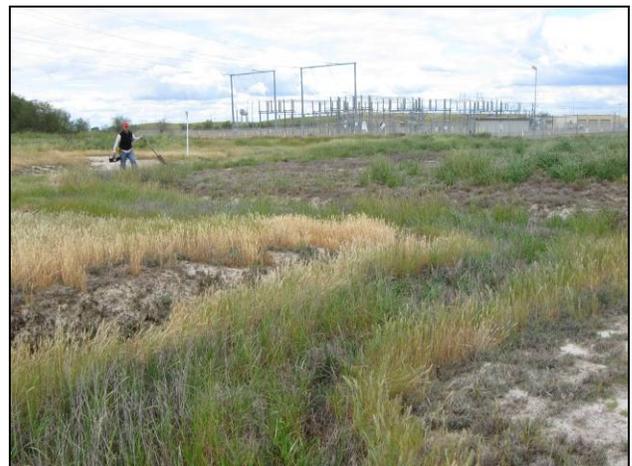
DRAINAGE (1B)
North of Kelso Road, looking northeast at defined earthen channel

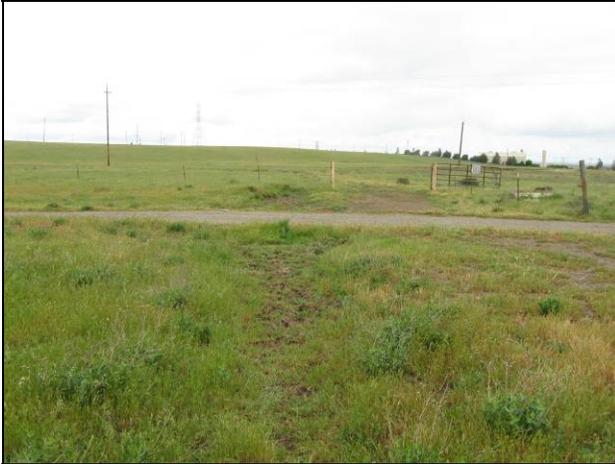
ALKALI SINK WETLAND (ASW-1)
Looking northeast from Bruns Road

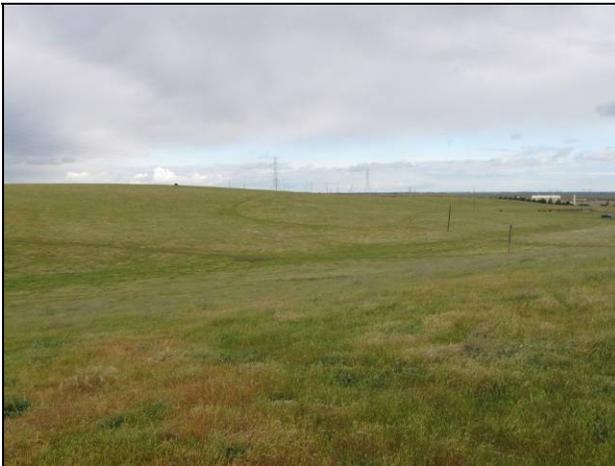
SEASONAL WETLAND (SW-1)
Inundated on February 19, 2009

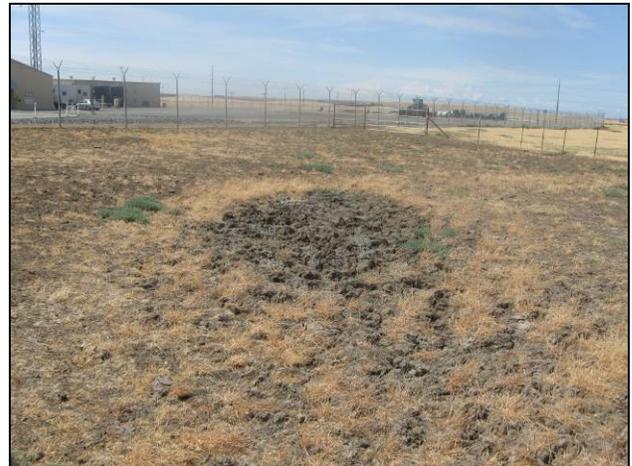
PROJECT SITE
Low upland swale through center of site—no change in vegetation or evidence of any type of flow through this area

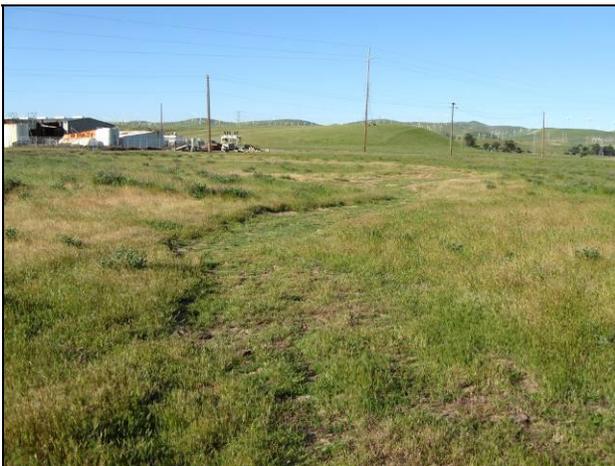
SEASONAL WETLAND (SW-2)
Weakly expressed shallow area with Italian ryegrass and sparse coyote thistle

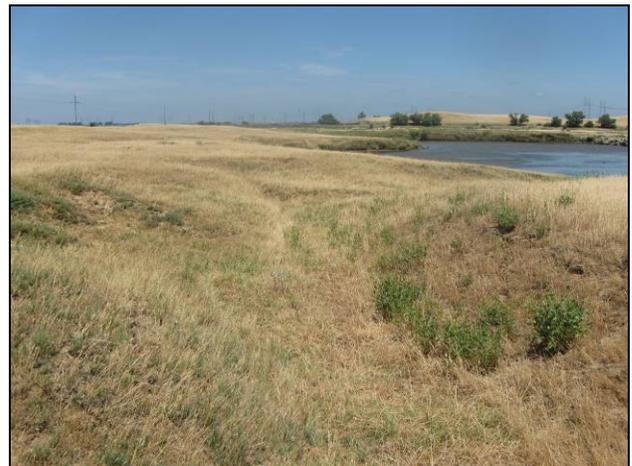
SWALE (SW-1)
Looking west
