PHASE II ENVIRONMENTAL SITE ASSESSMENT REPORT
PECHINEY CAST PLATE FACILITY

Vernon, California

March 9, 2006

Project No. 10627

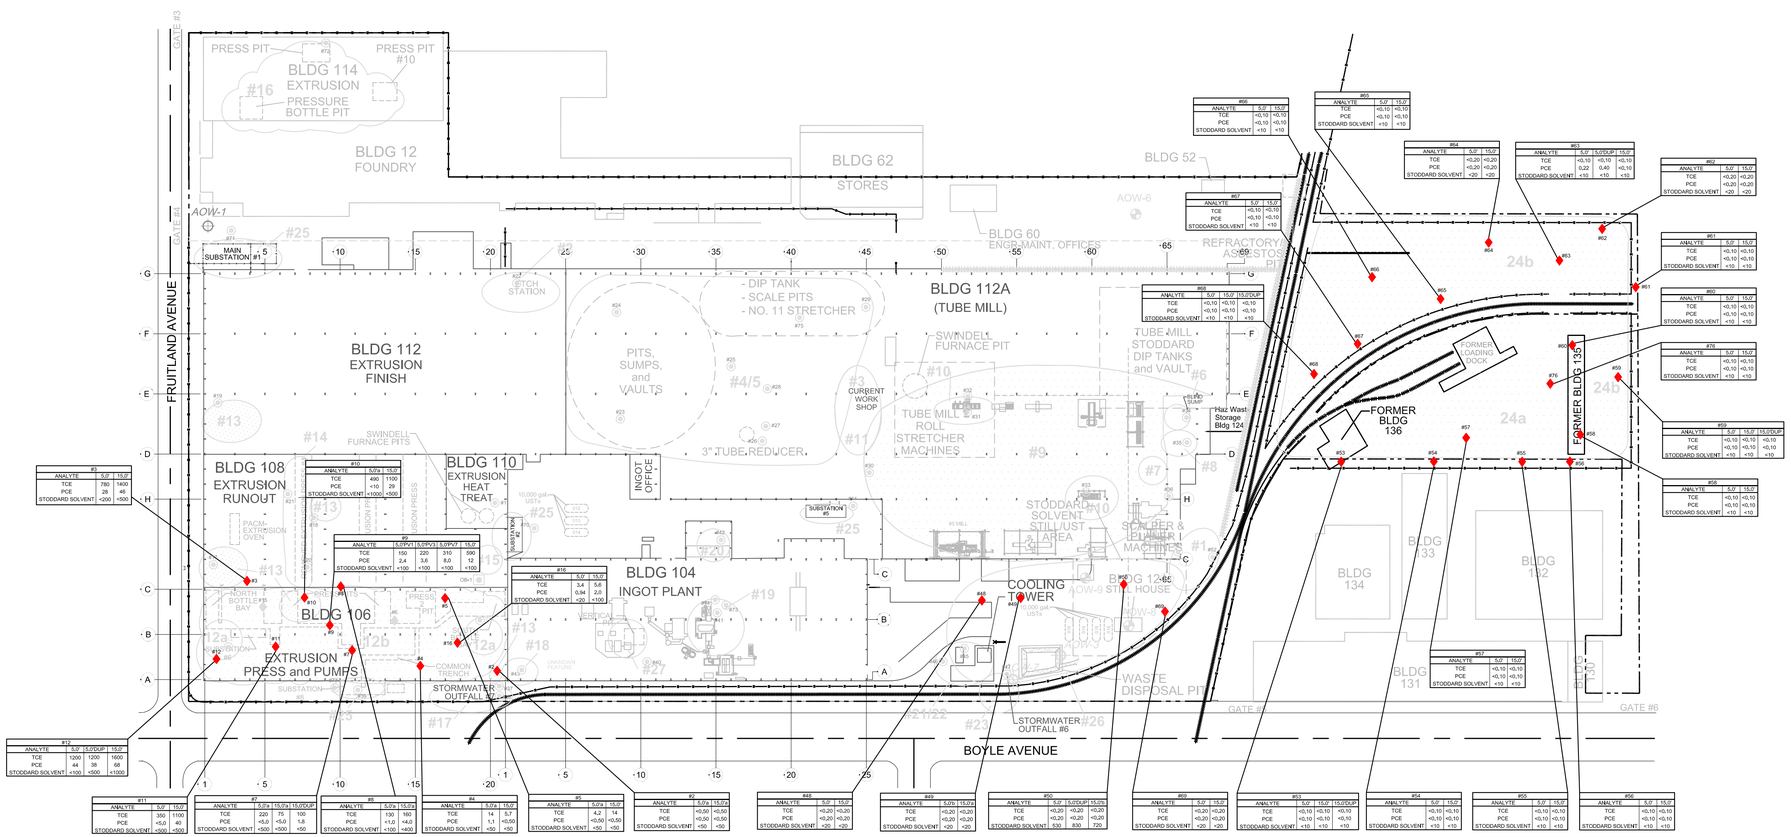
By: SBN	Date: 3/9/06	Project No.10627
Geomatrix	Figure	4

A vault was observed near boring location 30 (located in the work shop; Figure 4). This vault appeared to have a relatively thin layer of sediment at the bottom (estimated at approximately 3 feet bgs). Geomatrix drilled a boring adjacent to this vault and collected soil samples, and also sampled the sediment at the bottom of the vault. Analytical results associated with this vault are presented in Section 4.0.

A blind sump was observed near boring location 34 (Figure 4). Geomatrix was unable to remove the lid from this sump or estimate its depth, but it appeared that sediment was present inside the sump (Photograph page C-12). Geomatrix drilled a boring next to this sump and collected soil samples. Analytical results are presented in Section 4.0.

Oil staining was present beneath a leaking loader at location OB-1 in Building 108 (Figure 4). The oil staining was present on the surface of the concrete flooring and the concrete appeared to be in good condition without significant cracking or deterioration of the concrete surface. No soil borings were placed at this location based on the aforementioned visual observations.

TCE and PCE were the most frequently detected VOCs at the site, and the sample locations where these compounds were detected in soil vapor are shown on Figure 4.

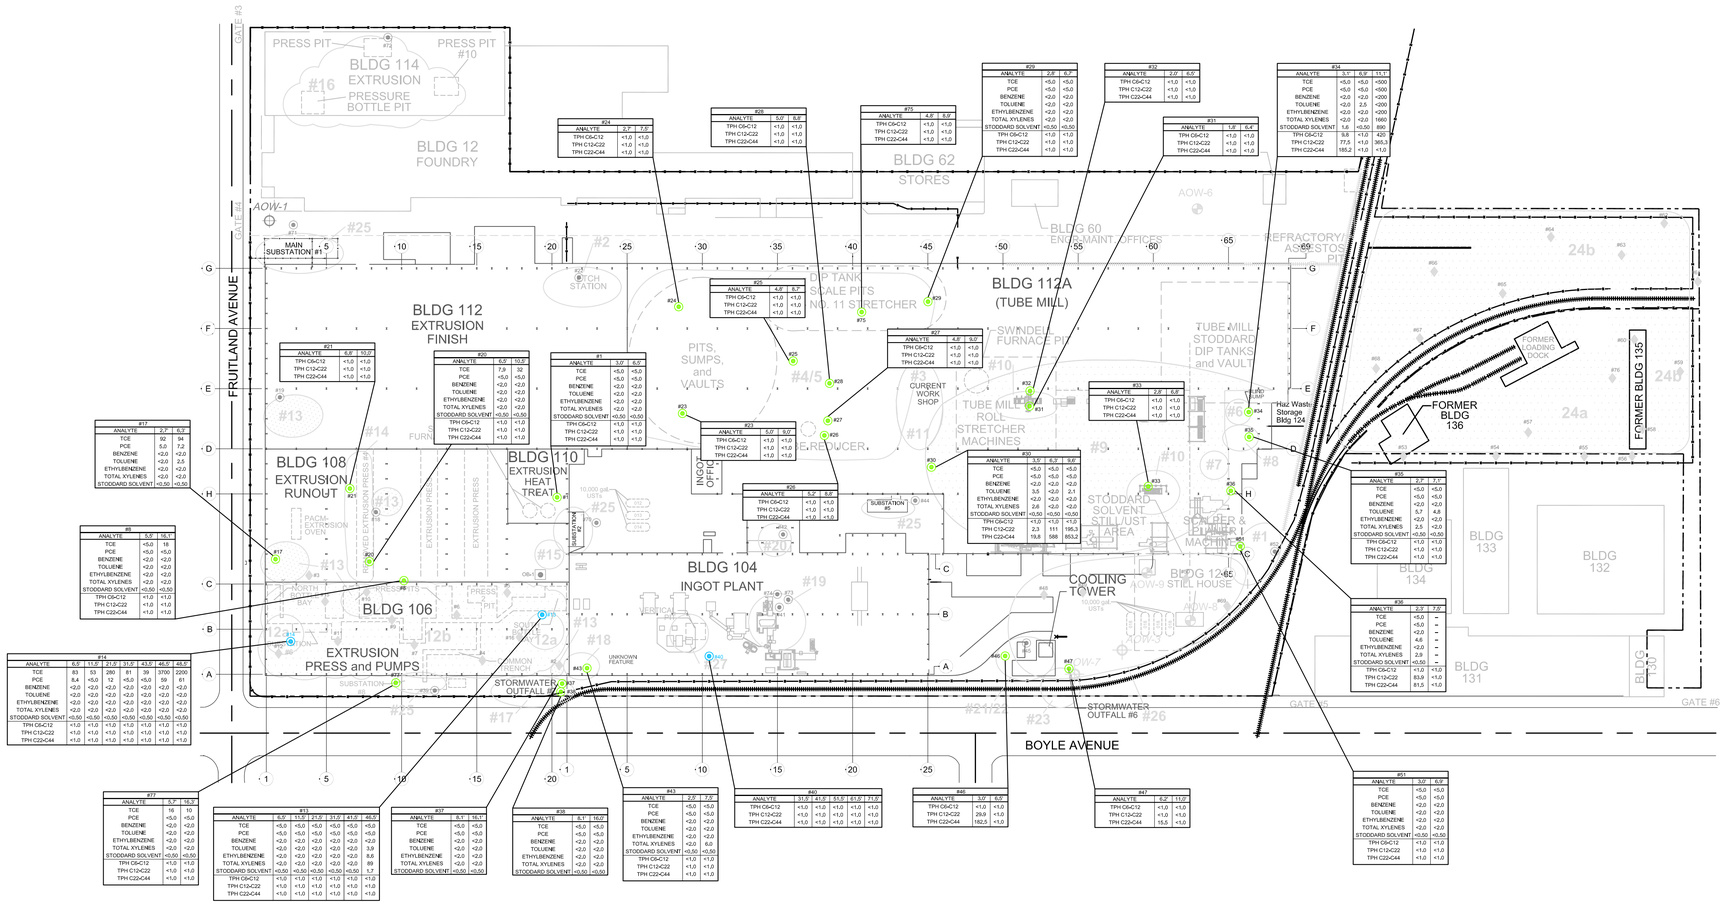
By: SBN	Date: 3/9/06	Project No.10627
Geomatrix		Figure 5

The samples locations where these compounds were detected in soil are shown on Figure 5.

The samples locations where petroleum hydrocarbons were detected in soil are shown on Figure 5.

#17	2.7'	6.7'
TCE	92	94
PCE	5.0	7.2
BENZENE	<2.0	<2.0
TOLUENE	<2.0	2.5
ETHYLBENZENE	<2.0	<2.0
TOTAL XYLENES	<2.0	<2.0
STODDARD SOLVENT	<0.50	<0.50

#8	5.5'	16.7'
TCE	<5.0	18
PCE	<5.0	<5.0
BENZENE	<2.0	<2.0
TOLUENE	<2.0	<2.0
ETHYLBENZENE	<2.0	<2.0
TOTAL XYLENES	<2.0	<2.0
STODDARD SOLVENT	<0.50	<0.50
TPH C6-C12	<1.0	<1.0
TPH C12-C22	<1.0	<1.0
TPH C22-C44	<1.0	<1.0

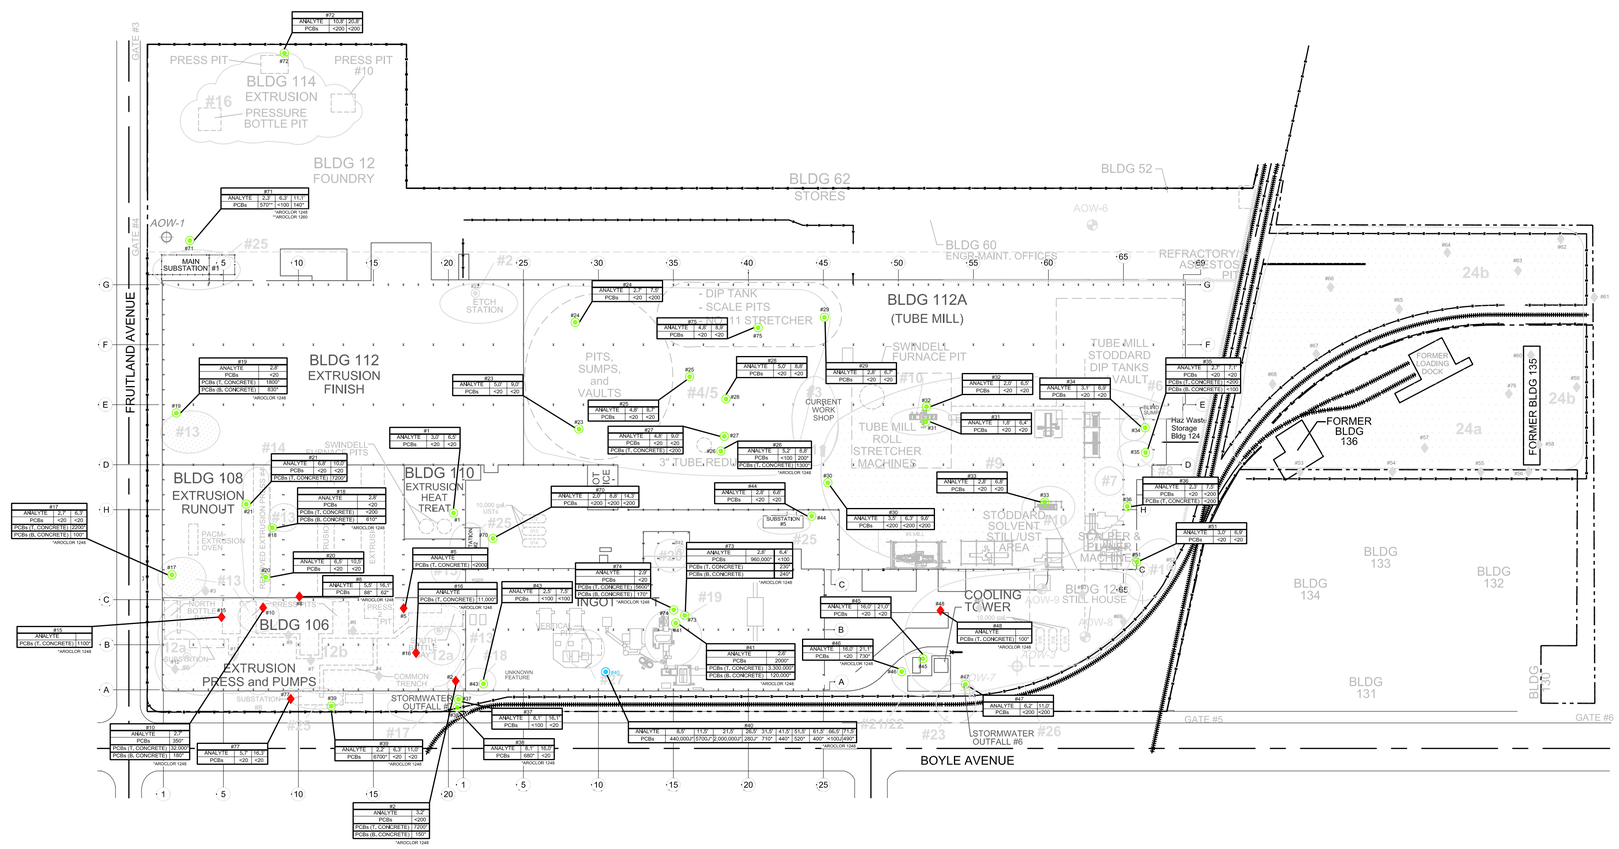
In addition, Geomatrix collected concrete core samples for PCB analysis in areas proposed for the assessment of the PCBs in concrete flooring (noted as Area 13 on Figure 5). For each concrete core, the upper 2 to 3 inches of the core were removed and placed in new laboratory-provided 8-ounce glass jars for shipment to the laboratory. At 9 core locations, the bottom few inches of the core were removed and analyzed.

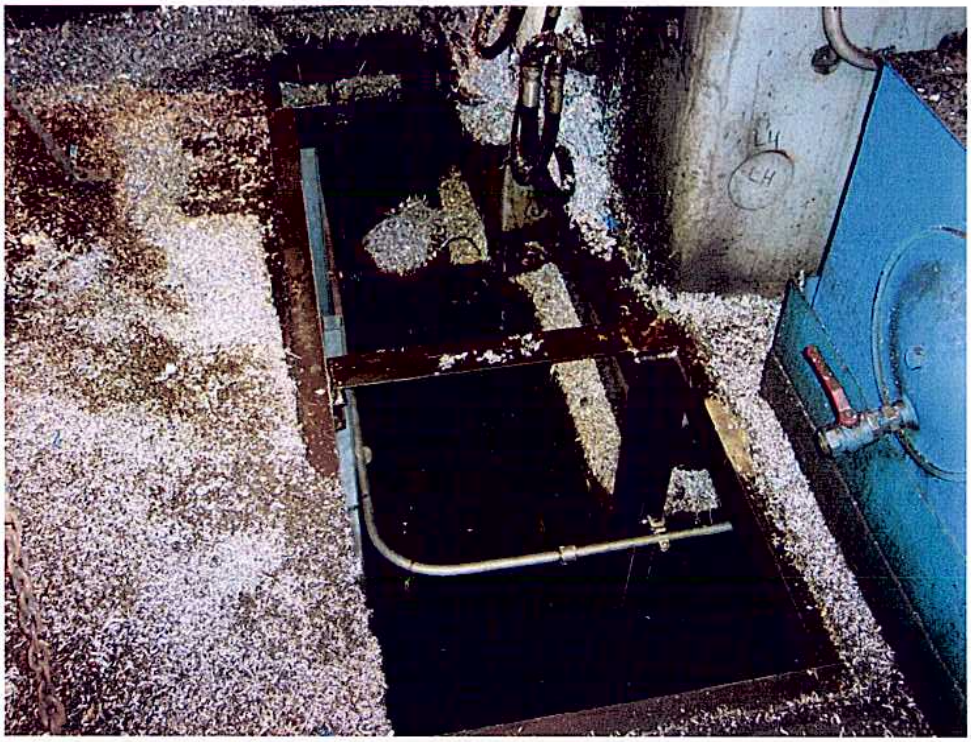
Trenches observed around #5 Mill contained up to approximately 6 to 10 inches of oily liquid, and varying amounts of aluminum chips (Photograph pages C-1 through C-5).

INSPECTION OF TRENCH NEAR #5 MILL (BUILDING 112A).

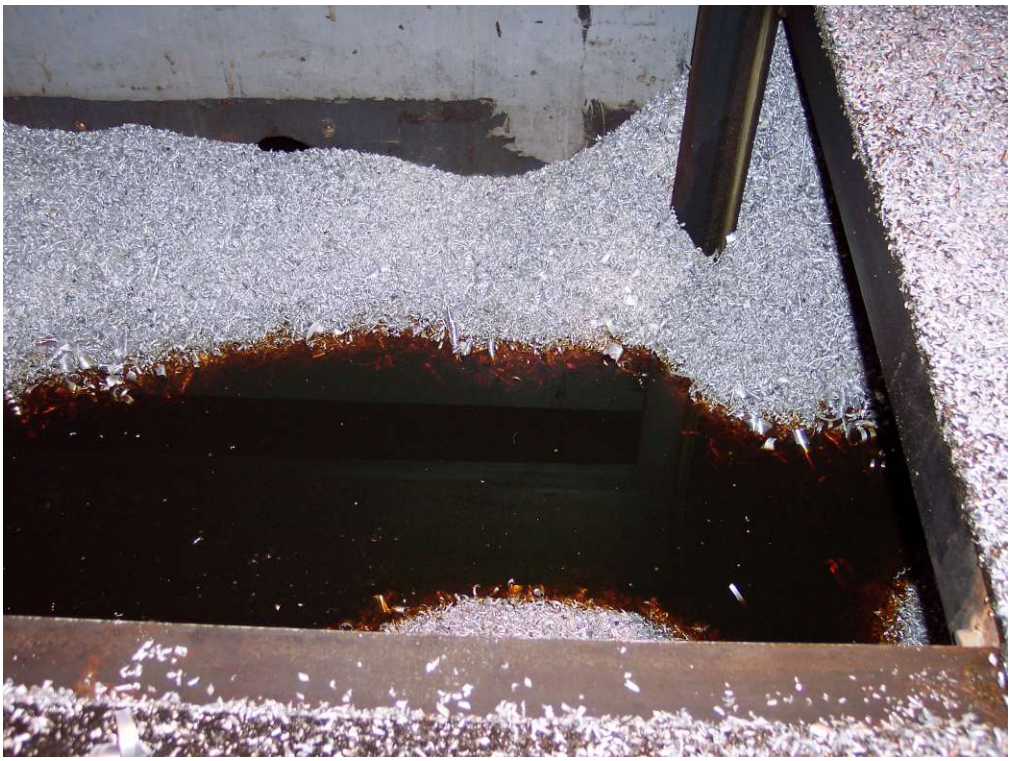
INSPECTION OF TRENCH NEAR #5 MILL (BUILDING 112A).

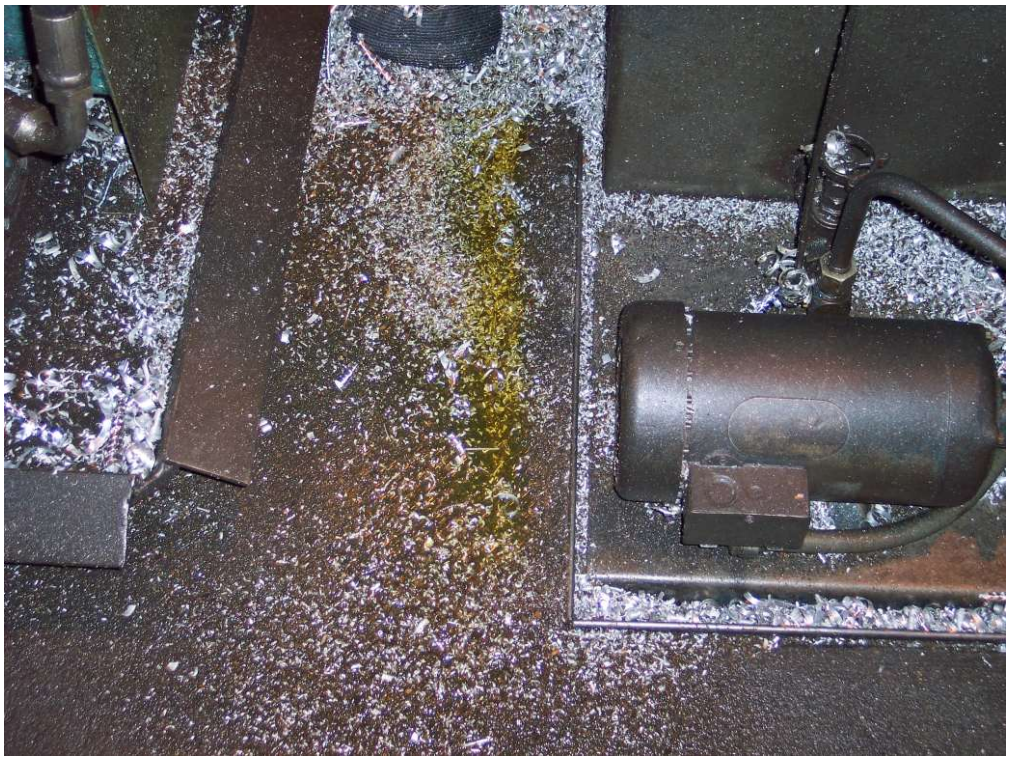
Geomatrix did not observe below grade trenches around the 2nd unnamed mill; however, an oily substance was observed on the concrete flooring around the 2nd unnamed mill and may have been leaking from the machinery (Photograph page C-6).

INSPECTION OF AREA SURROUNDING 2ND MILL, ADJACENT TO 1ST MILL (BUILDING 112A).

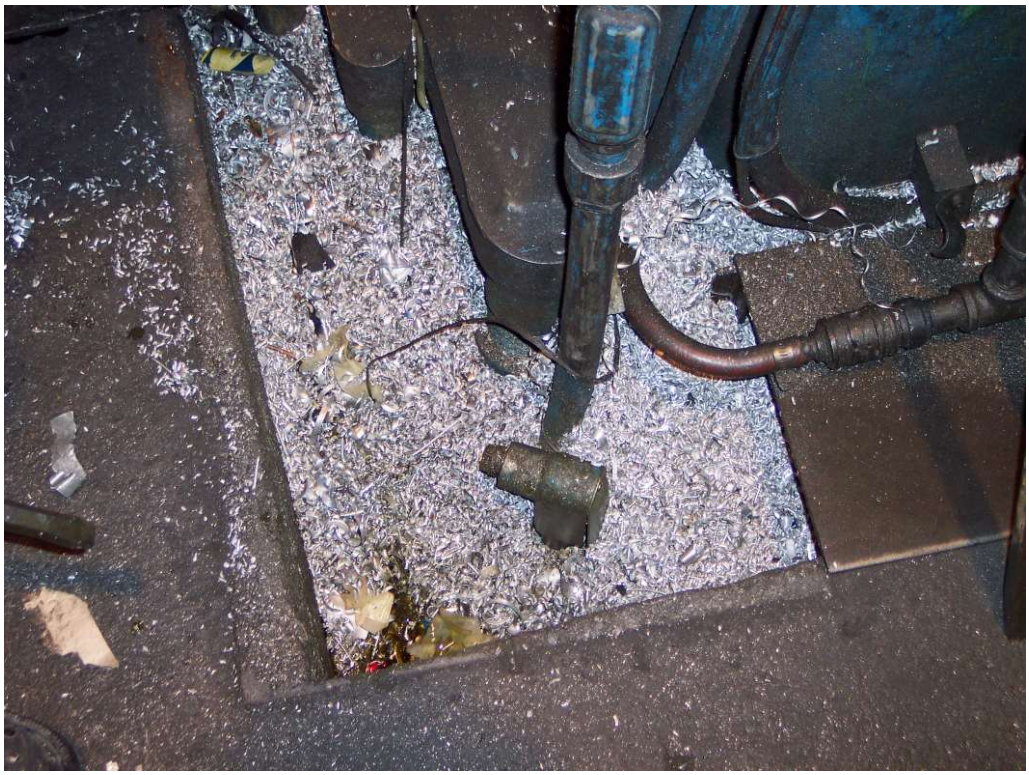
By: AY	Date: 03/09/06	Project No. 10627.000.0
Geomatrix		Figure **C-7**

Trenches observed in this area contained varying amounts of oil and aluminum chips, and an oily substance was observed on the concrete surface in some areas near the Scalper and Planer (Photograph pages C-7 through C-11).

INSPECTION OF TRENCH NEAR SCALPER AND PLANER (BUILDING 112A).

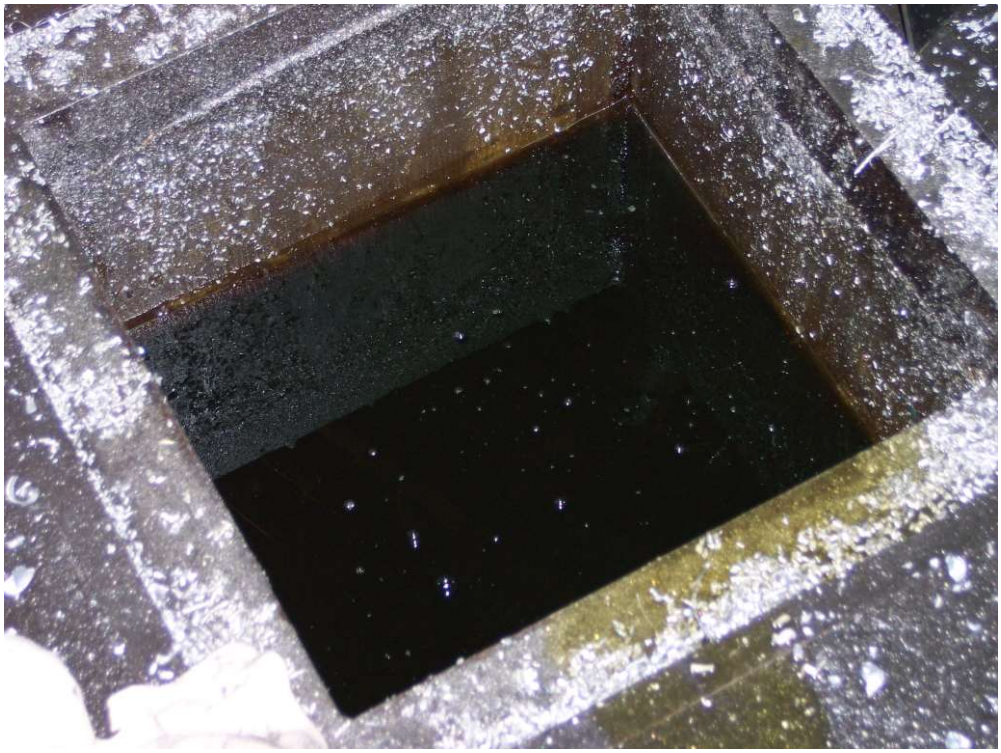
A shallow square sump (approximately 4 feet deep) was observed to contain approximately 3 feet of oily liquid (Photograph page C-8).

INSPECTION OF SQUARE VAULT NEAR SCALPER AND PLANER (BUILDING 112A).

INSPECTION OF TRENCH NEAR SCALPER AND PLANER (BUILDING 112A).

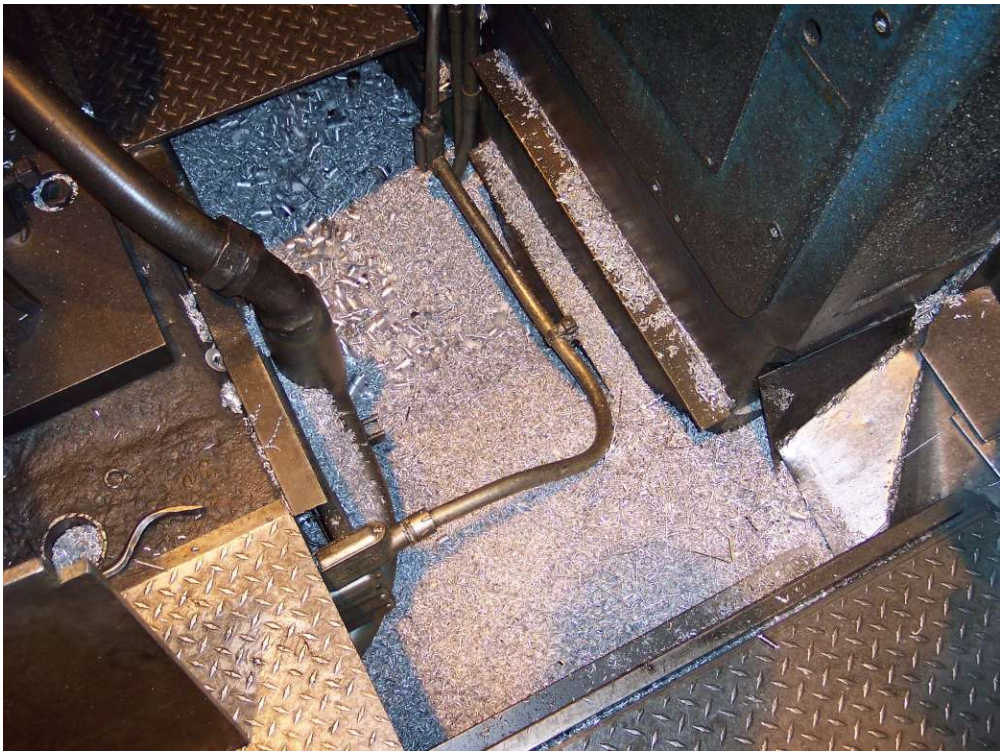
INSPECTION OF TRENCH NEAR SCALPER AND PLANER (BUILDING 112A).

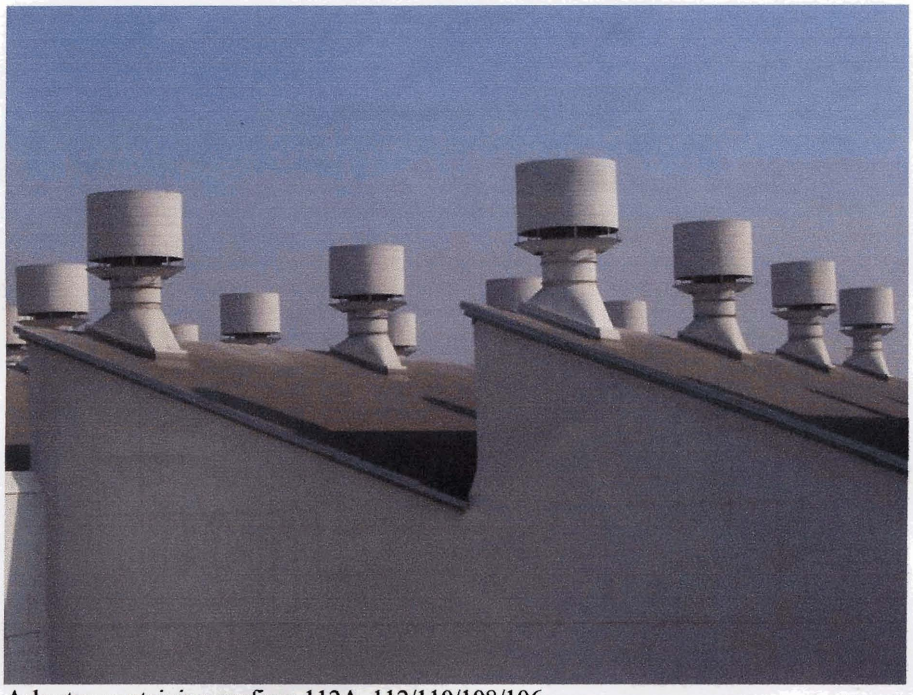
Asbestos-containing roofing; 112A, 112/110/108/106

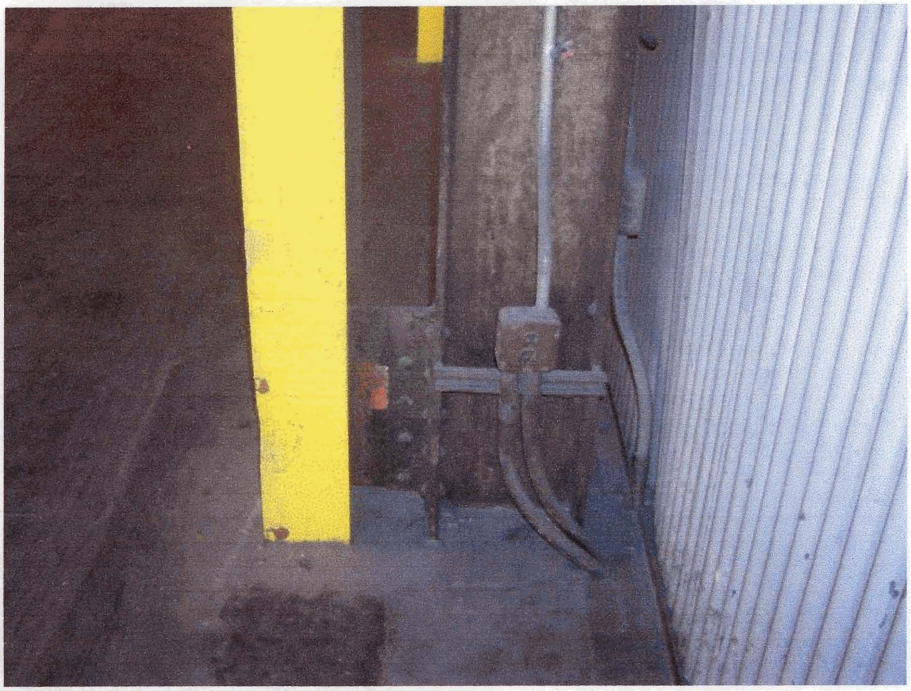
104 Textured tar-like paint on I-beam

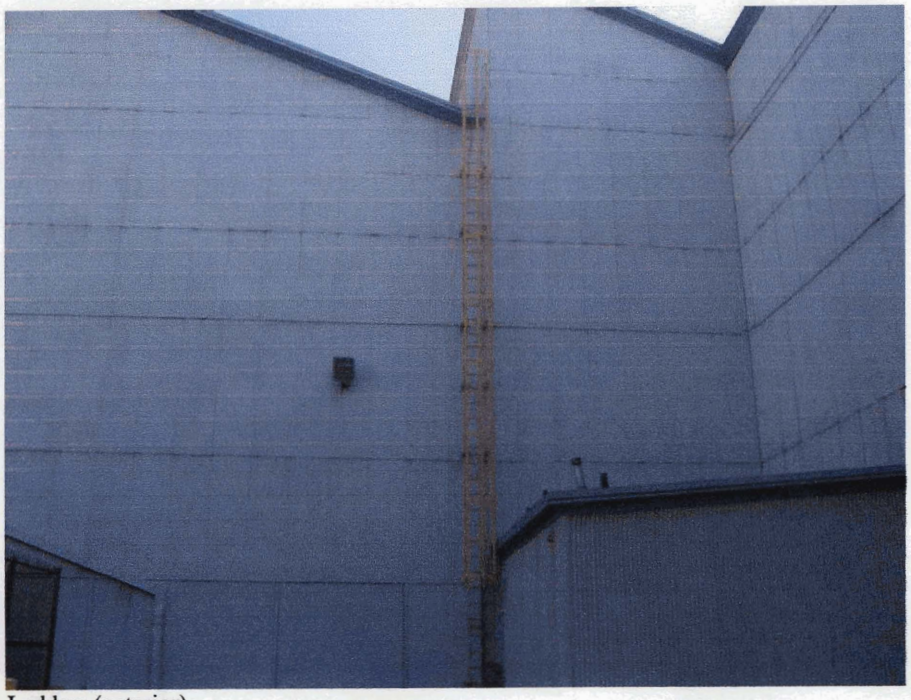
Ladders (interior)

Ladders (exterior)

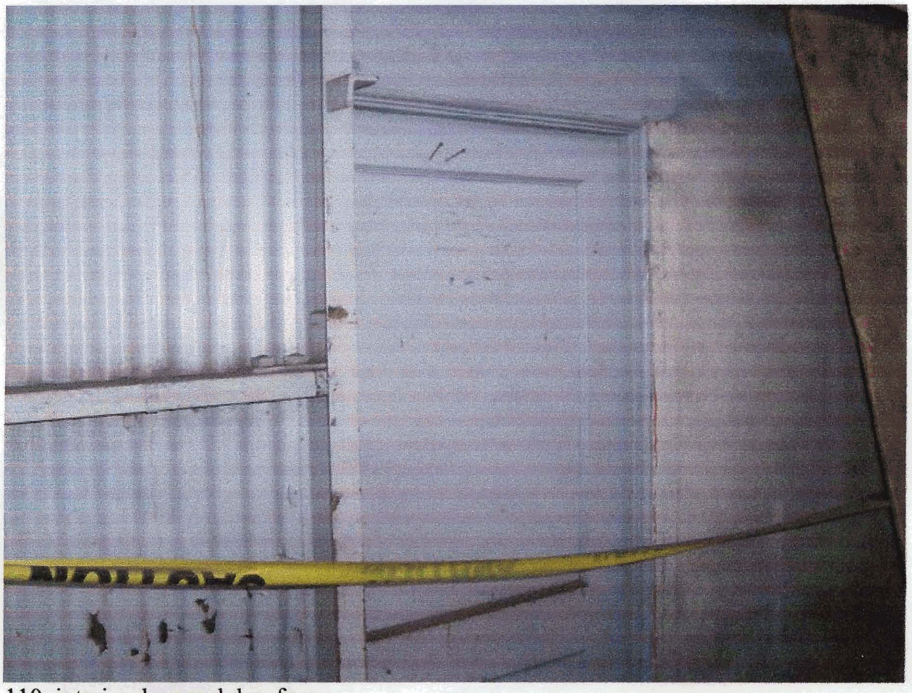
Ingot Office exterior/safety posts

110; interior door and doorframe

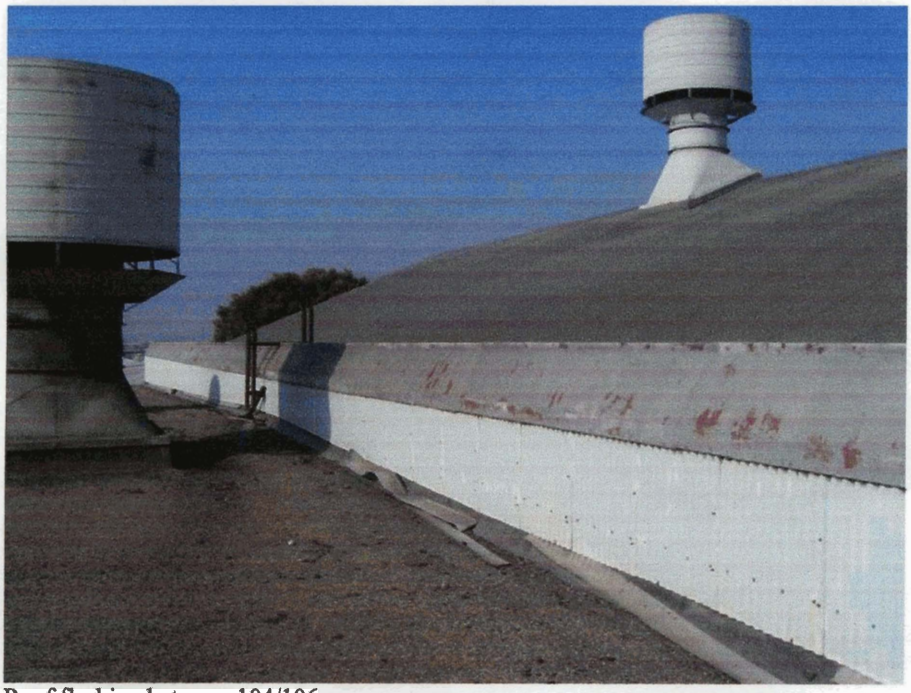
Sprinkler pipe risers

Roof flashing between 104/106
